STRUCTURAL INSPECTION REPORT

**Cheyenne Pump House Restoration
1504 Dillon Ave
Cheyenne, WY 82001**

Job No. 215036

November 16, 2015

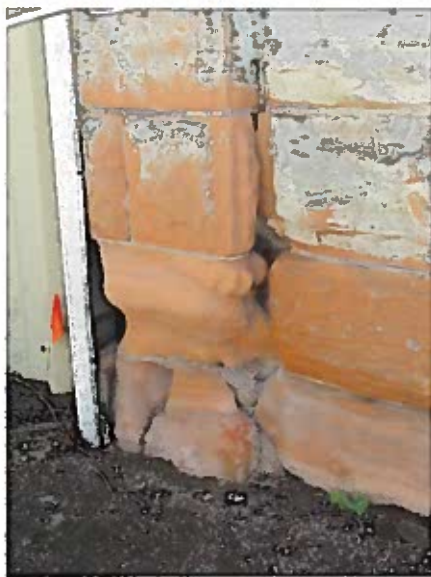
Considerable stone surface deterioration, stone, mortar and brick fallouts are present from the years of exposure to the wind, moisture and lack of maintenance. The repair and/or replacement of the 4" stone veneer will be time consuming and expensive.

The surface deterioration from wind and moisture is indicated in Photo #3 and fallouts of stone due to mortar deterioration, Photo #4.

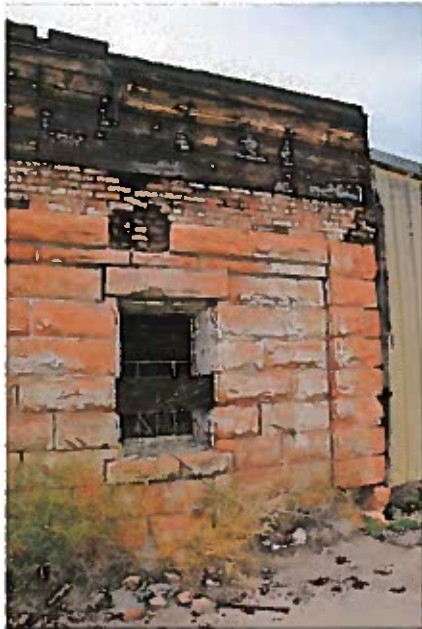
Photo #5 is of the south side that had a "false front" constructed to support an apparent shed roof. It would appear the false front served to also trap water and snow and allowed the moisture to attack the wood, mortar and masonry units. (Photo #6) Stone and brick fallouts are present, shown in Photo #5, weakening the structure and creating a safety hazard.

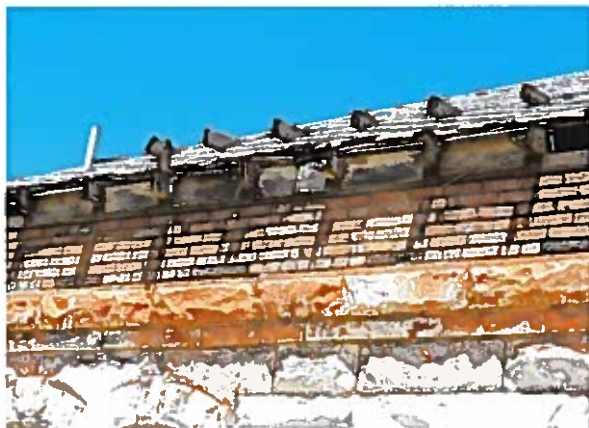
Photo #7

The west side of the pump house once carried a shed roof. Photo #7. The upper roof rafters, in Photo #7, were cut off and gives an indication of the changes in the structure and use of the building.

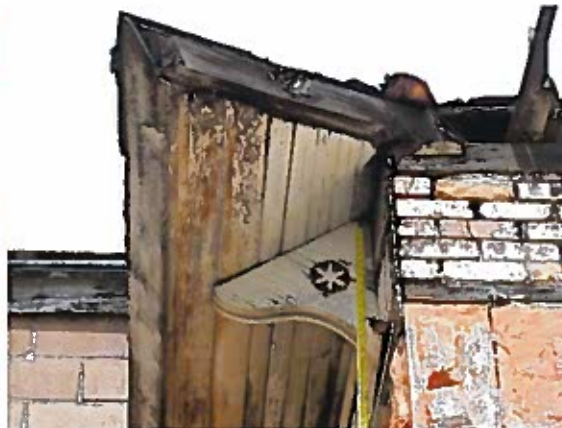
Photo #8

The eaves outlooker, shown in Photo #8, appears to have been constructed on the south, west and north sides. This eaves detail may have existed all around the roof line on the original construction.

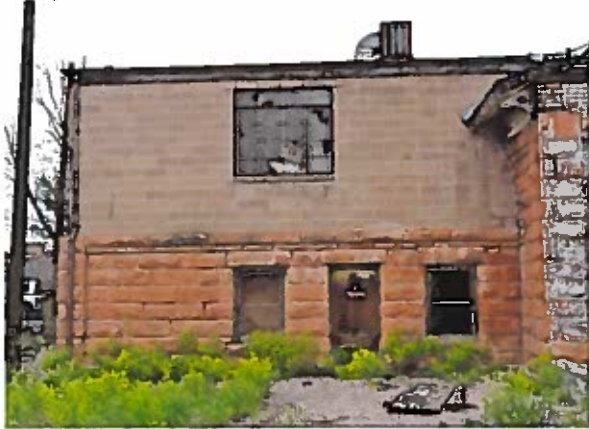
Photo #9

The second floor roof is in poor condition. The block walls are in need of repointing but are in reasonable condition. The windows, interior partitions and stairs are in poor condition. Because the remodel does not fit the historic nature of the building, the removal of the second floor should be considered to restore the historic value of the original structure. This report will assume the removal and further evaluation will not be attempted.

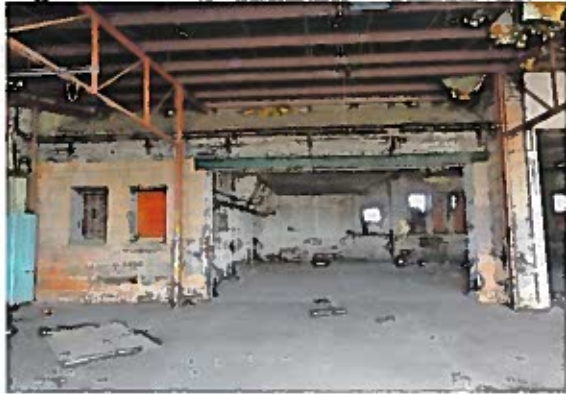
Photo #11

Photos #11 and #12 show the interior rooms. #12 shows the pilaster on the west wall that was constructed to support a girder truss in the revised roof framing. A similar pilaster was constructed on the east wall to support the same roof girder truss. It appears the original building construction consisted of a wall across this room with possible door openings. Further subgrade exploration is recommended to determine the location and extent of the supporting footing.

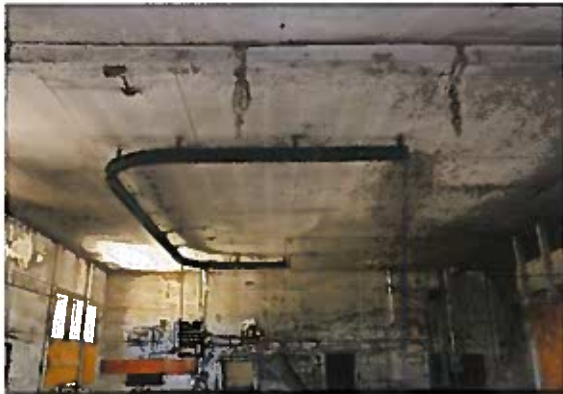
Photo #13 shows the main shop room with a crane rail system mounted to the ceiling structure. The support of the rail system extended to the roof girder system in the attic. The manner in which the rail system was attached to the girders was inappropriate and caused some damage to the trusses. A small tool room was constructed on the south end of the facility as shown in Photo #14. A stair was added for access to the attic where additional storage is evident. See Drawings S2 and S3.

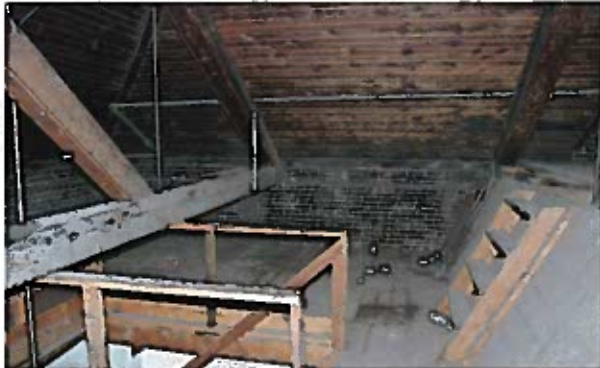
Photo #15

The first level attic is shown in Photo #15. The attic floor follows the ceiling of the south wing. There are three floor levels present in the attic space. Photo #16 shows the top level with the west girder truss and roof rafters. Cables have been wrapped around the girders, Photo #21, to support the crane rail in the shop area below. This attachment caused the joints of the girder to open and changed the girder member loading. The cable wraps were installed to distribute the point loads. Note the charred material of the girder and the rafters.

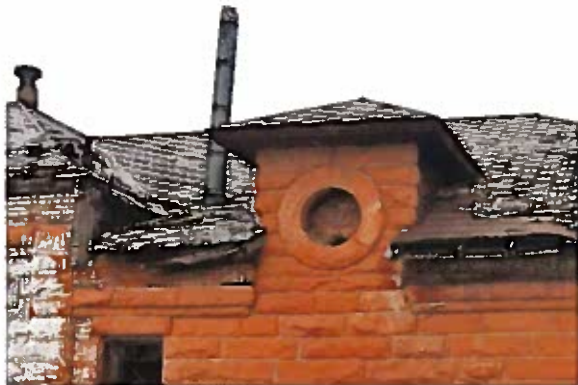
Photo #17

The Dormer shown in Photo #17, had a presumed purpose of supporting a vent for steam or exhaust. The trusses and the rafters adjacent to this area suffered a severe fire at one time. Photos #18 and #19 show the rafters that were exposed after removal of the siding material installed over the charred members.

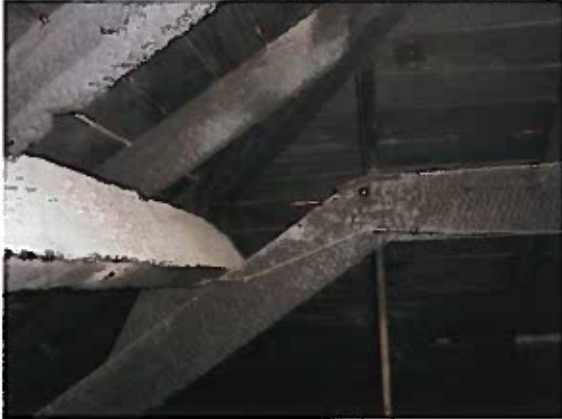
Photo #20 was taken at the north end of the main structure. The rafters supported by large trusses have also been grossly damaged from the fire. Charring varies from 1/8" to 3/16" reducing the member's usable area by 27%. The original span of the rafters was excessive (11' 7") with a single span and only marginally worked by having a continuous double span of 23' 2". Photo #21. Wood heated in a fire to over 150 degrees loses its' flexibility and strength of the material. The resulting strength is unknown but estimated to be inadequate for the anticipated snow loads.

Therefore, I recommend all of the sheathing, shingles, rafters and eaves be replaced if a restoration is to be considered.

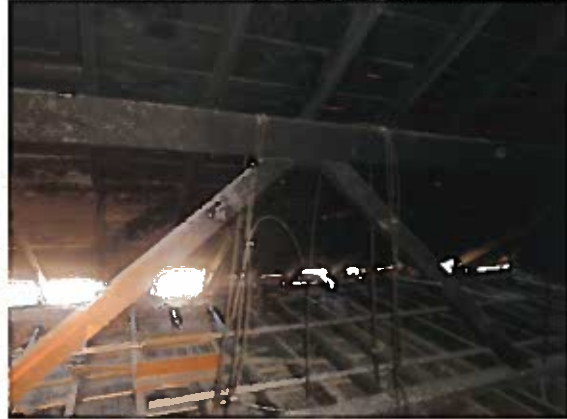
Photo #21 and #23 show the cable wraps to prevent the truss from spreading with the crane rail loading on the bottom chord. Photo #24 is a closer view of the separation of the joint caused by a compression type of connection being subjected to a tension force application. The truss joints must be tightened up but that can be accomplished with a reasonable cost and effort.

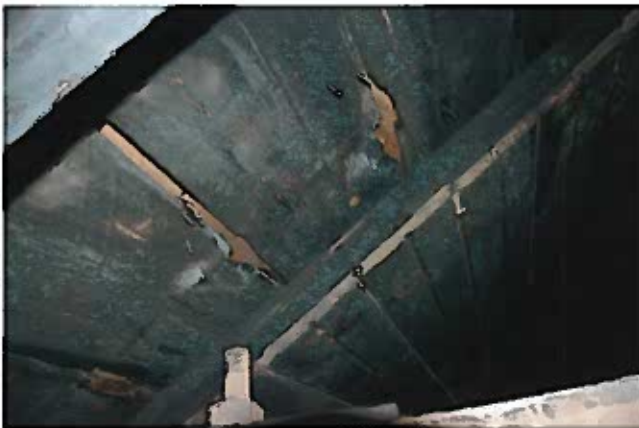
The roof sheathing in some of the burned areas was badly charred resulting in a loss of strength. It was then covered with additional sheathing adding to the dead load of the assembly. Photo #22

2. **Roof Structure:** The roof structure has been subjected to a sizable fire and the rafters should be removed. The rafters and the sheathing, shown in Photo #22, have been evaluated and the snow load capacity has been reduced by approximately 25%. In as much that the continuous two span rafter member design was originally marginal, the fire has rendered them unacceptable.

The sheathing has also been compromised and with potential removal of the rafters and the shingles, the sheathing should also be removed.

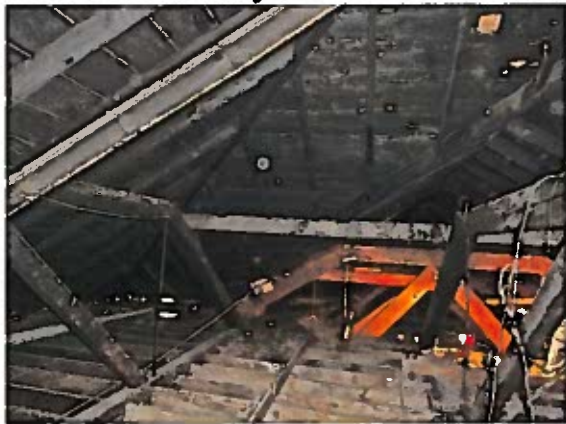
Photo #25 was taken of the SE corner of the center portion roof. Note the burned areas, the rafter spans and the supporting trusses. The foreground trusses have been charred but not as badly as the rafters. The middle ground truss, illuminated by a lantern, does not show any charring and for a while was a mystery as to its' escape from the roof fire. The Girder truss "B", shown on Dwg S2 was designed, assembled and installed after the fire. This provided a large opening in the common wall between the main Pump House and the south addition. The design of the Girder truss was unusual in that the bottom chord (8"x10") was extended an additional 3' to bear on the improvised pilasters constructed onto the original east and west walls of the main room. This extension violates the capacity of the girder truss by exceeding the bending and shear strength of the bottom chord. The correction can be easily made by adding a column at each of the outside panel points and taking the vertical load directly to a column and footing.

One important issue to be considered is what type and size of footing was placed under the bearing walls of the Pump House. There does not appear to be any settlement of the walls and corners of the existing structure. Before we were to proceed to design two additional columns to support the girder truss "B", exploration of the stem wall and footings should be undertaken. This would also allow us to presume and evaluate the footings under the other walls. This is a "must" exploration of the foundation for assurance of the integrity of the footings. This evaluation should proceed if the building is proposed to be restored.

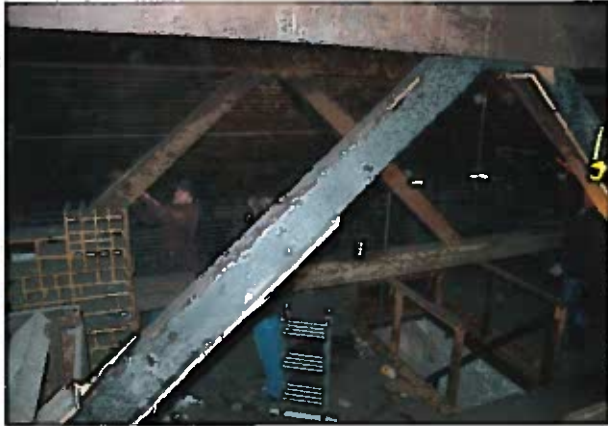
Photo #26

The three E-W trusses, C-1, C-2 and C-3, were located very near the Dormer vent area and exhibit considerable charring. The top and bottom chords, because of their mass, are not damaged in excess.

The sloping struts shown in Photos #26 and #27 are smaller, (3 3/4" X 6"), and have been charred down to 3 1/4" x 5 1/2", in addition to the potential loss in wood strength capacity because of the heat. The main failure would be the buckling of the compression member. I recommend maintaining a 1" board covering, nailed or screwed to the strut, to assure the restraint to buckle under loading. The existing wood siding can remain if the joint patterns are staggered.

The support framing of the roof structure can be salvaged with the protective covering of the "C" trusses as previously described. In some cases, the perimeter plates for the rafter bearing and uplift restraint will need replacing. All other members exposed during demolition and or construction must be evaluated for replacement if the fire has caused structural damage and support loss.
