**RE: Cheyenne, Wyoming 15 UPRR Railcars
Hazardous Material Inspection Summary Letter Report
Earth Services & Abatement Project Number: DENP000352**

HAZARDOUS MATERIAL INSPECTION SUMMARY LETTER REPORT

15 UPRR RAILCARS CHEYENNE, WYOMING

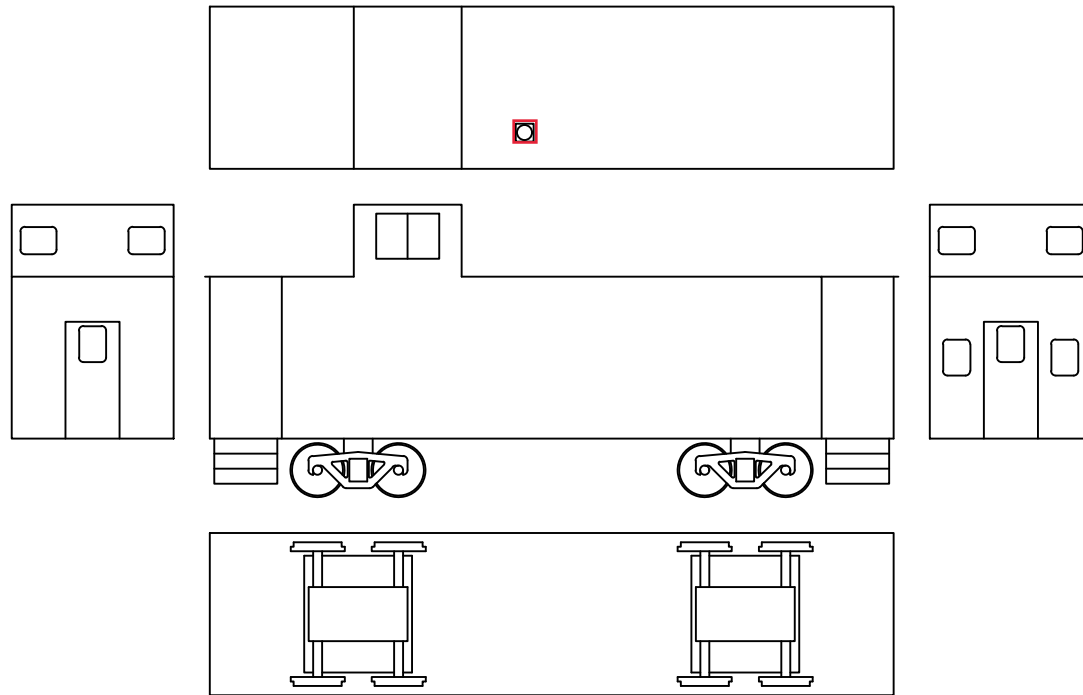
— ACM BLACK BAKELITE

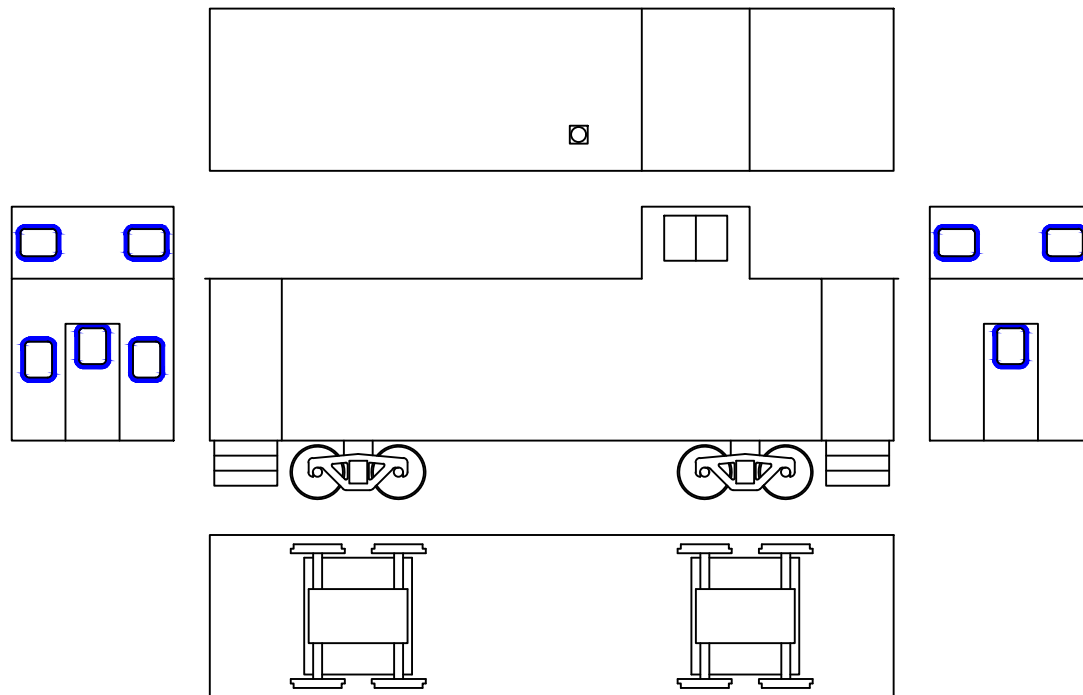
- Gray paint, 0.51% lead, interior of car – assuming 50% damaged, Rank 2, \$12,500
- D&RGW01489 – Abatement Estimate \$2,900
 - White Fiberboard, 60% asbestos, 16 SF, Rank 1, \$400

— ACM WHITE FIBERBOARD

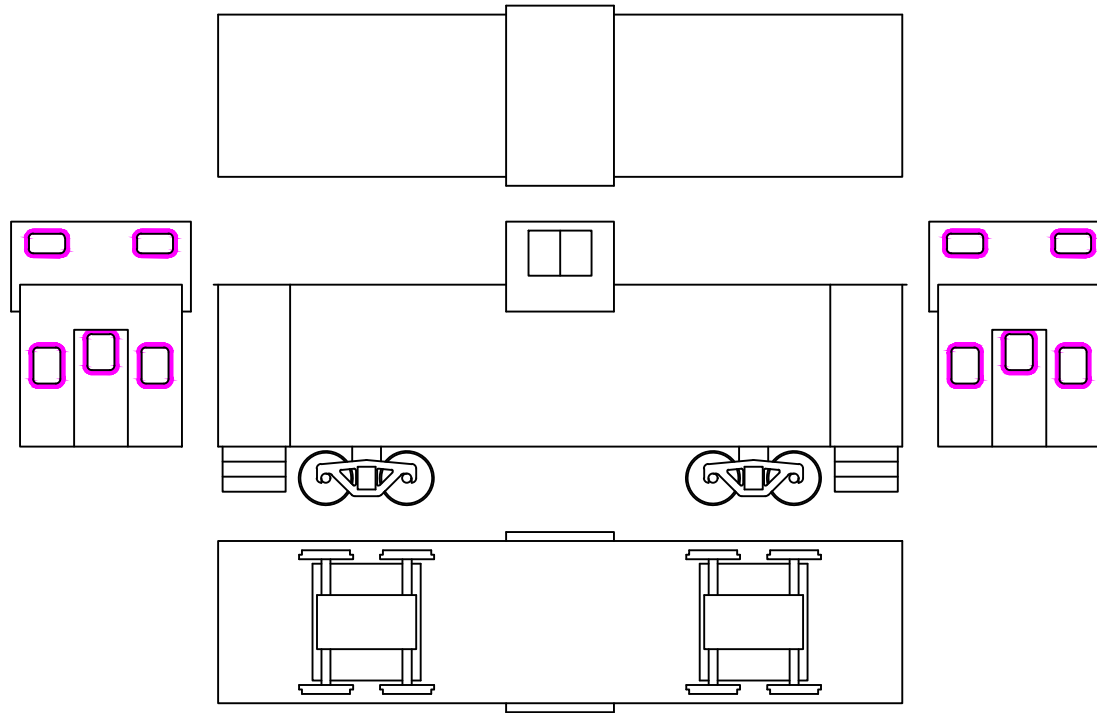
- Green paint, 7% lead, interior of car – assuming 10% damaged, Rank 2, \$2,500
- D&RGW01524 – Abatement Estimate \$3,400
 - White coating, 6.4% asbestos, 12 SF, Rank 2 \$900

- White coating, 4.7% asbestos, 50 SF, Rank 2 \$1,250
 - Yellow paint, 12% lead, exterior sides and interior handrails – assuming 5% damaged, Rank 2, \$1,250

- ACM WHITE COATING

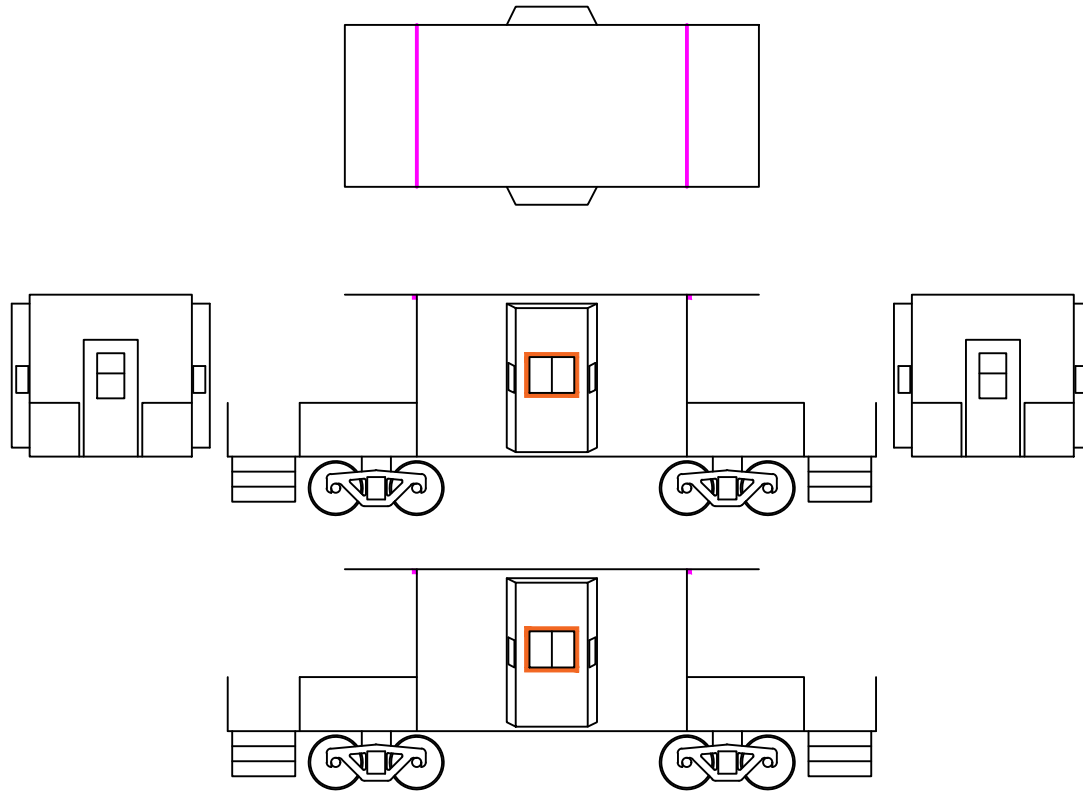
- ACM GRAY DOOR SEALANT
