RESOLUTION NO. 6156

Conditions of Blight

City of Cheyenne

Exhibit A: Produced to support the Initiative Resolution

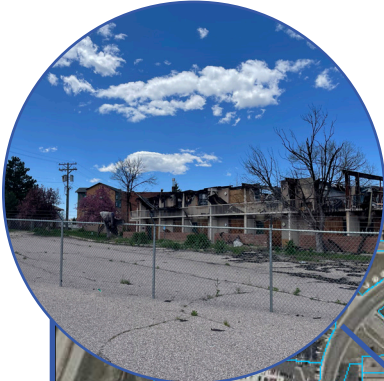
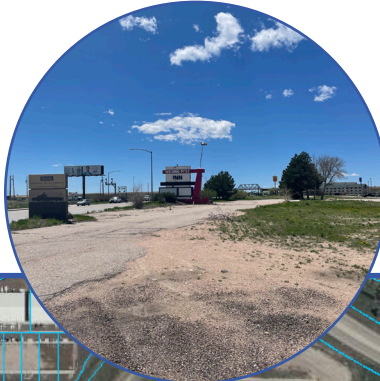
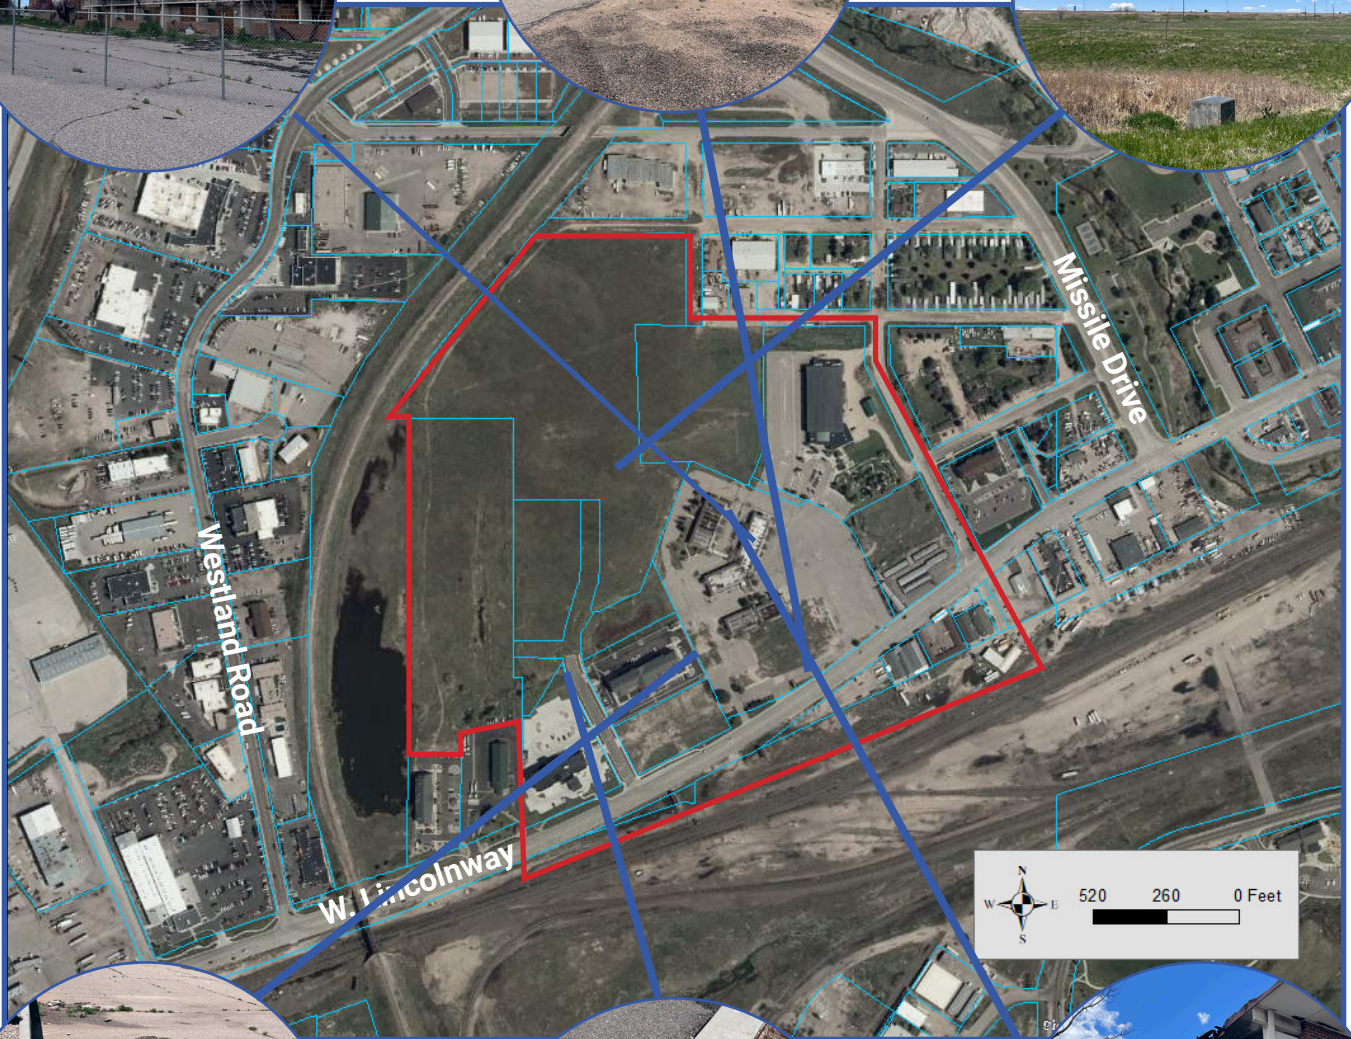
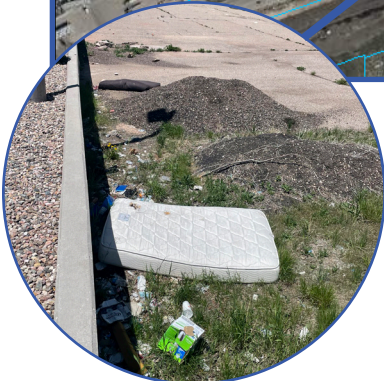
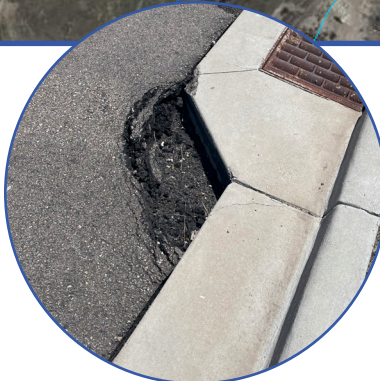
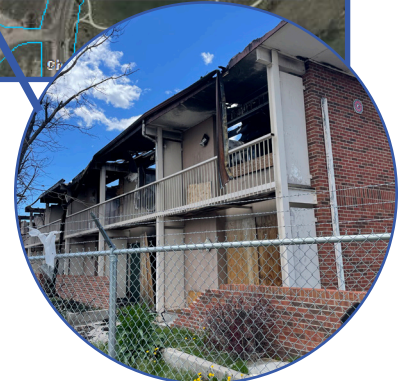
Figure 1: Hitching Post Study Area

1. Deteriorated or Deteriorating Structures

2. Predominance of Defective or Inadequate Street Layout

3. Faulty Lot Layout in Relation to Size, Accessibility or Usefulness

4. Unsanitary or Unsafe Conditions

5. Deterioration of Site or Other Improvements

6. The Existence of Conditions which Endanger Life or Property by Fire and other causes

The Hitching Post study area is shown in Figure 1. The study area includes the Hitching Post property and several surrounding properties, including several across Lincolnway. The site contained six (6) of the nine (9) conditions of blight identified on the survey, demonstrating one area of blight in the community.

The Hitching Post study area contains several examples of deteriorated or deteriorating structures, as shown in the photo on the previous page. Most of the buildings on the Hitching Post property are either boarded-up or burned, and the walkway between two of the buildings has partially collapsed. In addition to the buildings on the Hitching Post site, other buildings in the area show evidence of deterioration. The prevalence of deteriorating buildings as depicted in the supporting photographs in Appendix A fulfills this condition of blight.

The Hitching Post study area contains approximately 50 acres. The subject area has very few connections and many of the connections present are access easements. The street network through the area is not sufficient for urban development and many connections will need to be planned and built. Furthermore, the access easements are not built to city street standards and will need improvements in the future (shown in Figure 1, #2). Lastly, staff has had many discussions on the status of W. 18th Street and whether it has been vacated in the past, further complicating the street network in the area. Due to the faulty street network through the Hitching Post, the status of W. 18th Street, and the lack of connections through the Back 40 subdivision, staff is satisfied this condition of blight is met.

Several of the parcels in the Hitching Post property are large with no lot frontage or direct right of way access. One of these is shown in Figure 1 with the Back 40 subdivision. Again, the lack of internal connections through the site lead to accessibility issues and a lack of pedestrian connections. The study area is designated as a Community/Regional Activity Center in PlanCheyenne, yielding a maximum block size with a 2000' perimeter and 600' maximum on any one block face per Unified Development Code Table 4-6. Currently, the site has approximately 1500' of frontage on one block face and an incomplete block structure due to lack of connections; though, if one were to complete the block, it would be approximately 5250' of perimeter. The size of the blocks, lack of pedestrian routes, and lack of internal connections yield a faulty lot layout in relation to size, accessibility and usefulness; thus, meeting this condition of blight.

Staff noted several conditions of deterioration of site improvements at the Hitching Post study area. The deterioration included curb, gutter, sidewalk, and areas around a storm sewer drain (Figure 1). In addition to these conditions of deterioration, staff also noted a downed light pole on the Hitching Post property. The deterioration of site conditions is illustrative of blight in the study area.

The two main indicators of the site that meet these conditions include the fire-damaged building (Figure 1) and the presence of environmental contamination. A recent Phase I Environmental Site Assessment documented several conditions that are recognized as hazardous by the Environmental Protection Agency. The existence of fire-damaged building also leads to a concern, as the buildings have become unstable and possibly life endangering.

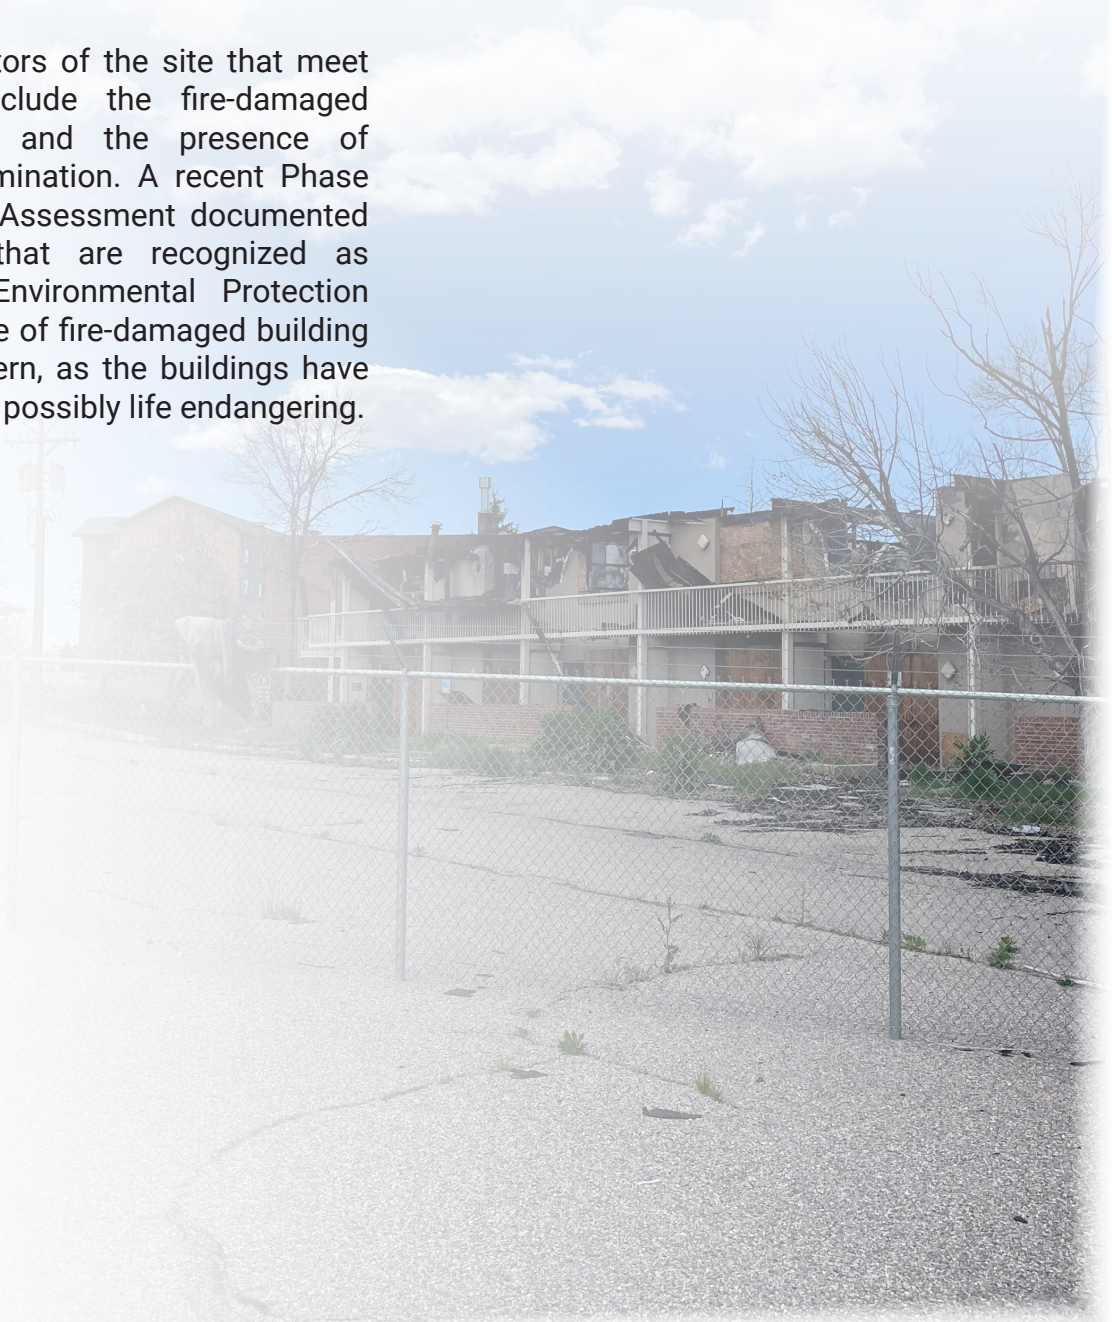
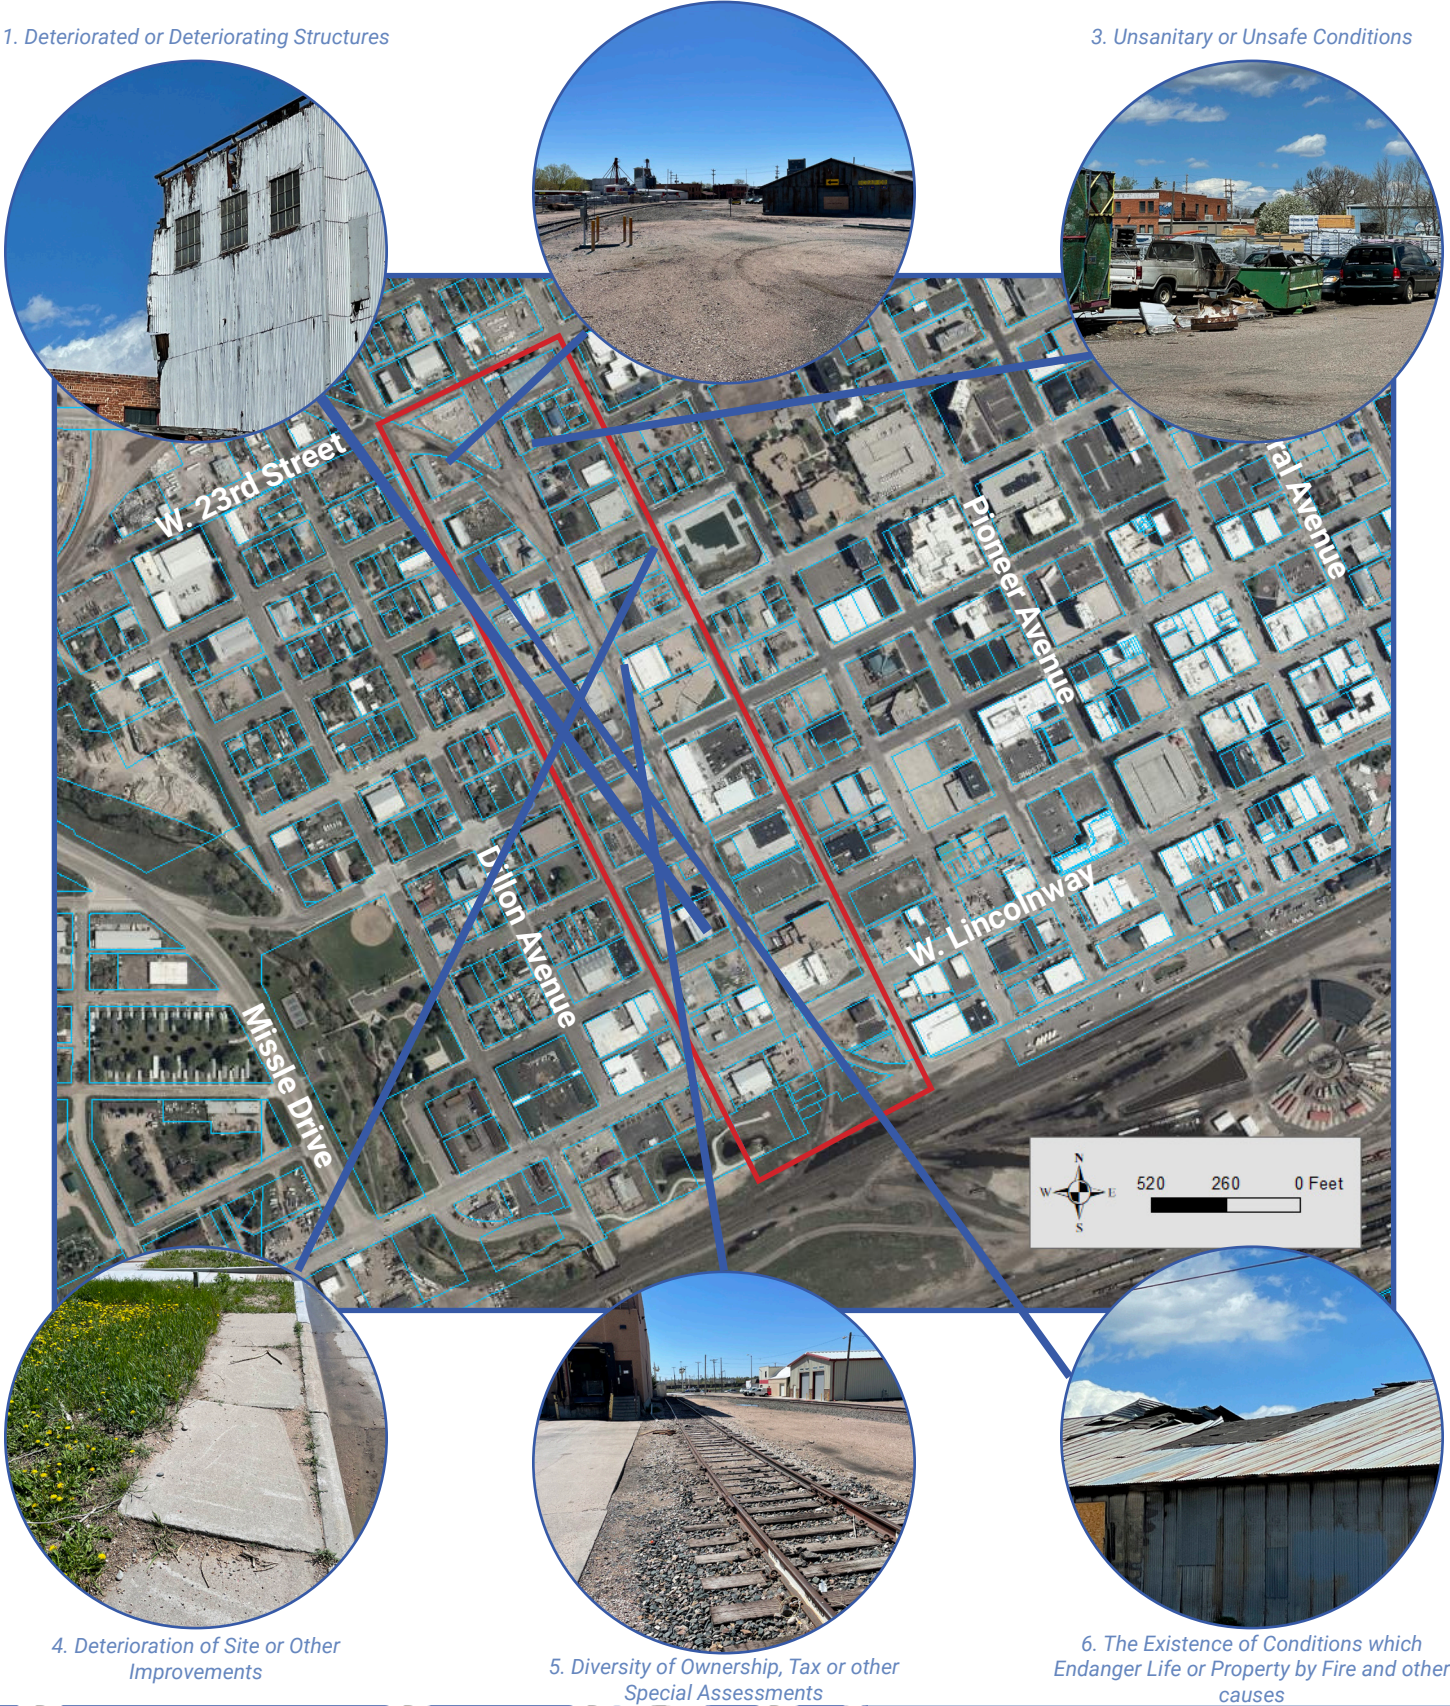
Figure 2: Reed Avenue Rail Corridor Study Area

2. Faulty Lot Layout in Relation to Size, Accessibility or Usefulness

1. Deteriorated or Deteriorating Structures

3. Unsanitary or Unsafe Conditions

The Reed Avenue Rail Corridor is shown in Figure 2. The study area includes the blocks between Bent Avenue and Snyder Avenue from east to west and between W 23rd Street and the Union Pacific Railroad from north to south. The study area included six (6) of the nine (9) conditions of blight identified in the survey, demonstrating a second area of blight in the community.

Staff noted several deteriorating buildings in the Reed Avenue Rail Corridor. Examples include 800 W 17th Street (Figure 2) and 820 W 22nd Street; though several other buildings appear to be deteriorating and may be more so on the interior. Indicators of deterioration witnessed include evidence of fire, boarded-up buildings, and faulty building siding. The photo on the previous page and those in Appendix B illustrate the study area meets this condition of blight.

Many blocks in the study area contain platted alleys while others have been vacated. This leads to confusion and lack of usable area for development purposes. Supplemental to this evidence of blight, many lots have not been platted since the Original City subdivision. Staff has difficulty interpreting the Original City subdivision and the legal descriptions are often a source of confusion. The inconsistency in alley vacation and age of the subdivision lead to faulty lot layout in relation to size, accessibility, and usefulness. The photo in Figure 2 for this criteria depicts a lot with a faulty layout.

The Reed Rail study area contained litter and a lack of connections over the rail tracks, meeting unsanitary conditions and unsafe conditions respectively. Furthermore, the prevalence of industrial businesses (Figure 2), and the age

The Reed Avenue Rail Corridor has deteriorated curb, gutter, and sidewalk in various locations (Figure 2). The deteriorated site conditions have exacerbated the pedestrian connections along the Reed Avenue Rail Corridor, which is a critical project for the City of Cheyenne. The photos in Appendix B show several locations of deteriorated site conditions and infrastructure.

The building located at 820 W 22nd Street shows evidence of fire damage (Figure 2). Furthermore, many of the vehicles adjacent to this site show evidence of fire. Again, the confirmed environmental contamination on some sites and probable contamination along the corridor yield another condition that may endanger life and property. The noted fire damage and environmental contamination fulfill this condition of blight.

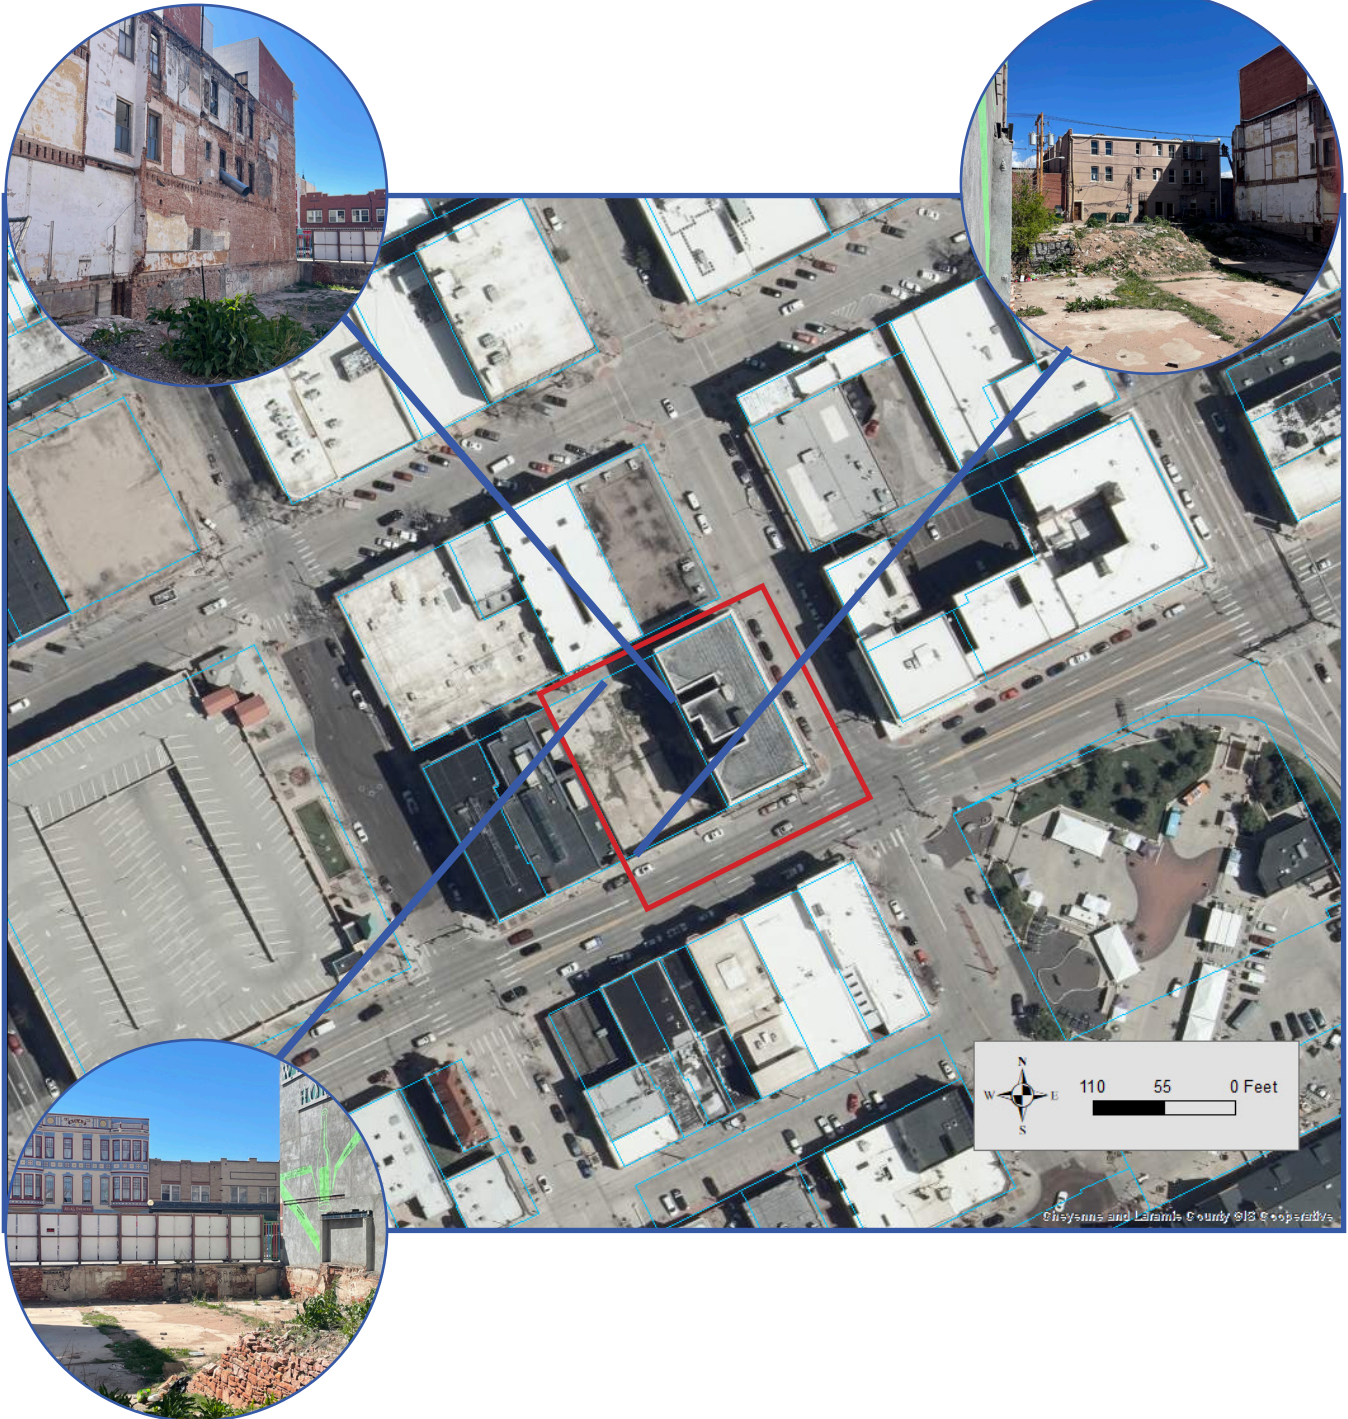
Figure 3: The Hynds and the Hole Study Area

1. Deteriorated or Deteriorating Structures

2. Unsanitary or Unsafe Conditions

3. The Existence of Conditions which Endanger Life or Property by Fire and other causes

The Hynds and the Hole study area is shown in Figure 3. The study area contains Lot 1, Block 1 of Cheyenne Leads Lincolnway Subdivision (the Hole) and Lot 8, Block 390 of the Original City Subdivision (the Hynds). The study area included three (3) of the nine (9) conditions of blight identified in the survey, demonstrating a third area of blight in the community.

The Hynds and Hole exhibit both a deteriorated and deteriorating structure (Figure 3). The building where the Hole is burned down in 2004 and the foundation that is still present shows evidence of deterioration. The Hynds building shows evidence of deterioration with rust and other loose and collapsing building materials.

The presence of the Hole represents an unsafe condition. Although the Hole is fenced off, if individuals are to enter over the fence or through the alley there is the possibility of injury.

The Hole was created by a fire that destroyed the building in 2004. The site has remained vacant ever since and represents a blighted area in the community (Figure 3).
