**RE: Cheyenne, Wyoming 15 UPRR Railcars
Hazardous Material Inspection Summary Letter Report
Earth Services & Abatement Project Number: DENP000352**

HAZARDOUS MATERIAL INSPECTION SUMMARY LETTER REPORT

15 UPRR RAILCARS CHEYENNE, WYOMING

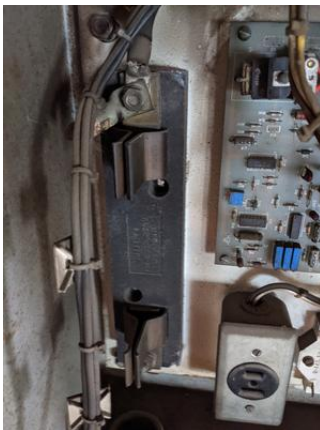
CHE-CNW11047-150721-007 thru 009, 15% Asbestos, Black bakelite

Asset Number	CNW 11047
Exposure Area	Breakers
Asbestos Containing Material	Black bakelite
Sample Number	CHE-CNW11047-150721-007 thru 009
Size	NA
Quantity	0.5 SF
MATERIAL CONDITION (MC)	0
0 =No damage, excellent condition 1 =Very minor damage, no visible debris 2 =Damage is evident, small area 3 =Damage is easily seen, some debris 4 =Damage is widespread, debris is common 5 =Most or all material is damaged, hanging, and / or found as debris throughout the area	
BUILDING AGE (BA)	1
1 =>30 years old 0 =15 - 30 years old -1 =<15 years old	
MATERIAL TYPE	
Pipe Covering (PC)	NA
1 =MAG/CAL Silicate -1 =Air Cell / paper	
Ceiling Plasters or Fireproofing (CP)	NA
-1 =Cementitious (Monocoat) 0 =Standard 1 ="Cotton Candy" texture	
WATER DAMAGE (WD)	0
0 =No water damage 1 =Small amount of damage can be seen; damage is localized rather than widespread 2 =Good deal of water damage; widespread	
ROOF CHARACTERISTICS (RC)	-0.5

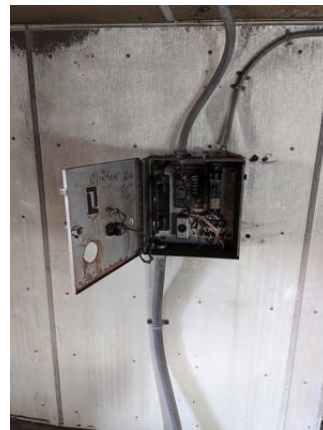
CHE-CNW11047-150721-007 thru 009, 15% Asbestos, Black bakelite

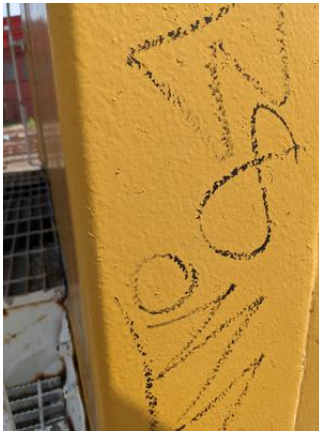
CHE-CNW11047-150721-002L, 0.45% Lead, Yellow

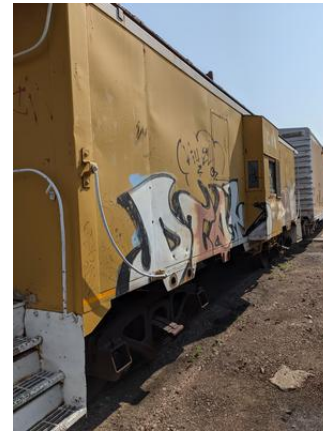
CHE-CNW11047-150721-002L, 0.45% Lead, Yellow

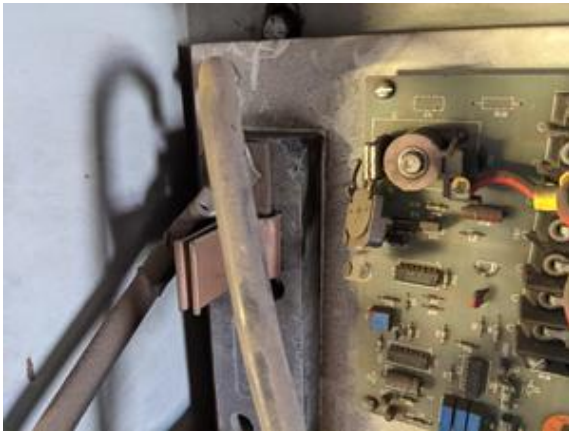
CHE-CNW11097-140721-001 thru 003, 6% Asbestos, Black bakelite

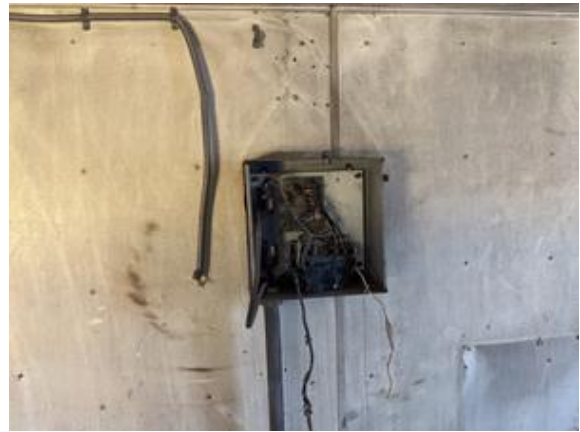
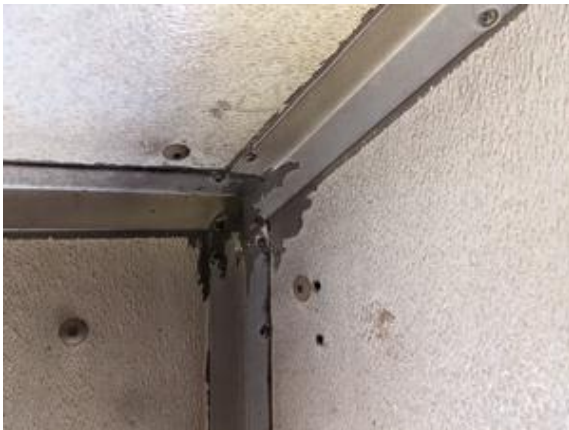
CHE-CNW11097-140721-001 thru 003, 6% Asbestos, Black bakelite

Asset Number	CNW 11097
Exposure Area	Breakers
Asbestos Containing Material	Black bakelite
Sample Number	CHE-CNW11097-140721-001 thru 003
Size	NA
Quantity	0.5 SF
MATERIAL CONDITION (MC)	0
0 =No damage, excellent condition 1 =Very minor damage, no visible debris 2 =Damage is evident, small area 3 =Damage is easily seen, some debris 4 =Damage is widespread, debris is common 5 =Most or all material is damaged, hanging, and / or found as debris throughout the area	
BUILDING AGE (BA)	1
1 =>30 years old 0 =15 - 30 years old -1 =<15 years old	
MATERIAL TYPE	
Pipe Covering (PC)	NA
1 =MAG/CAL Silicate -1 =Air Cell / paper	
Ceiling Plasters or Fireproofing (CP)	NA
-1 =Cementitious (Monocoat) 0 =Standard 1 ="Cotton Candy" texture	
WATER DAMAGE (WD)	0
0 =No water damage 1 =Small amount of damage can be seen; damage is localized rather than widespread 2 =Good deal of water damage; widespread	
ROOF CHARACTERISTICS (RC)	-0.5

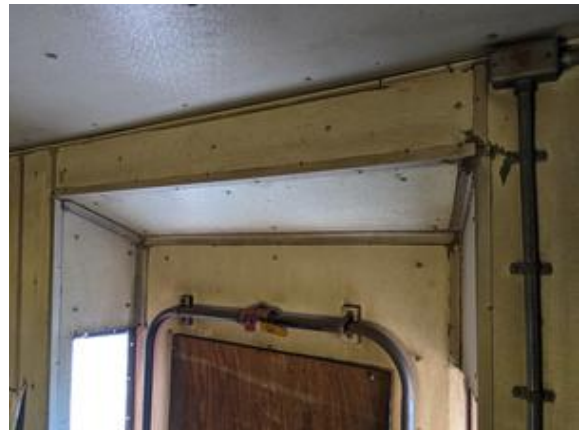
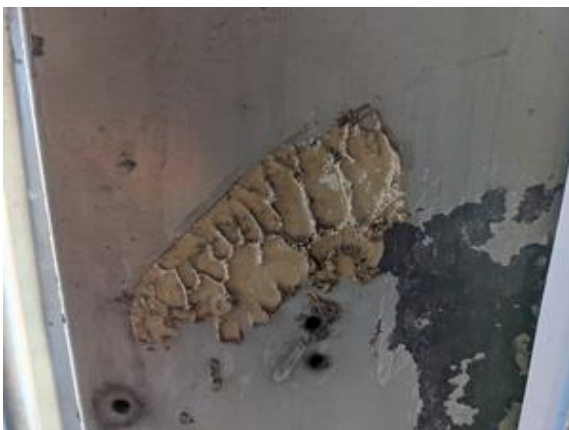
CHE-CNW11097-140721-004 thru 006, Asbestos Not Detected, White sealant

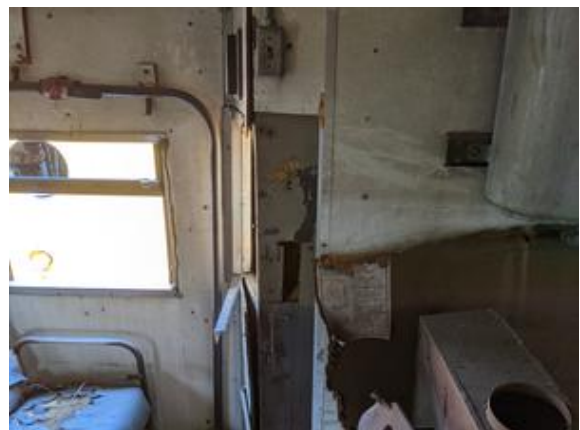
CHE-CNW11097-140721-007 thru 009, Asbestos Not Detected, Beige mastic

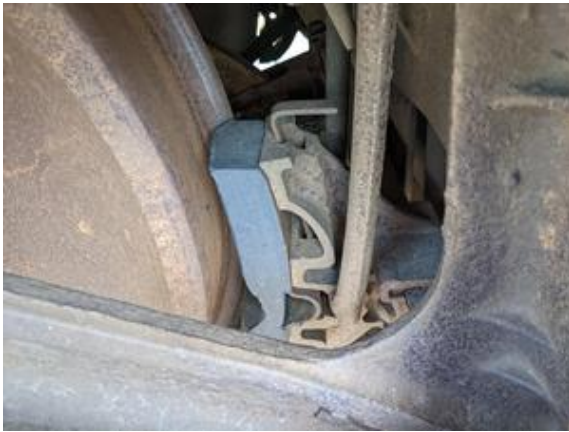
CHE-CN11097-140721-010 thru 012, Asbestos Not Detected, Black brake pads

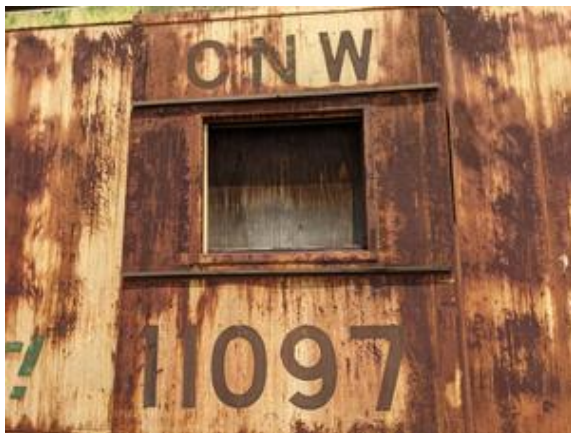
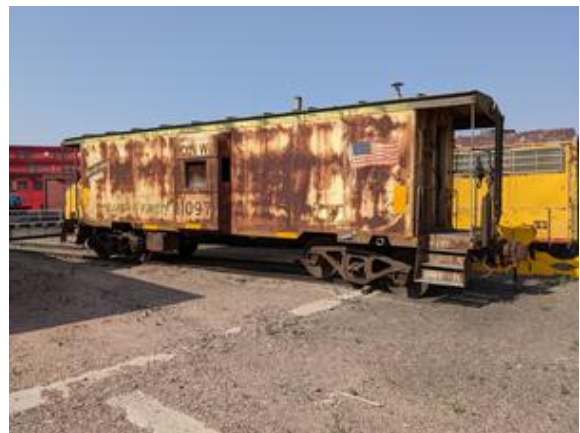
CHE-CNW11097-140721-002L, 0.014% Lead, Yellow

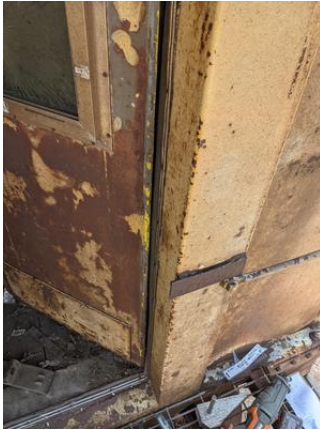
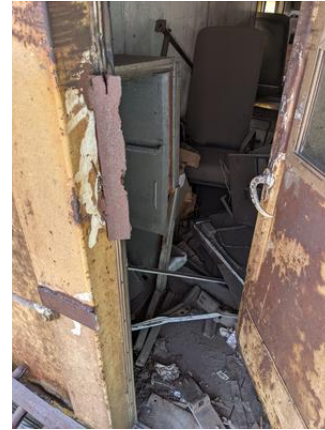
CHE-CNW11097-140721-001P, PCB Not Detected,
Black/brown caulk

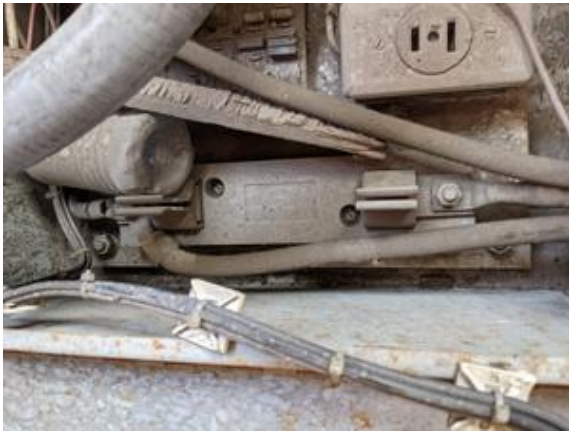
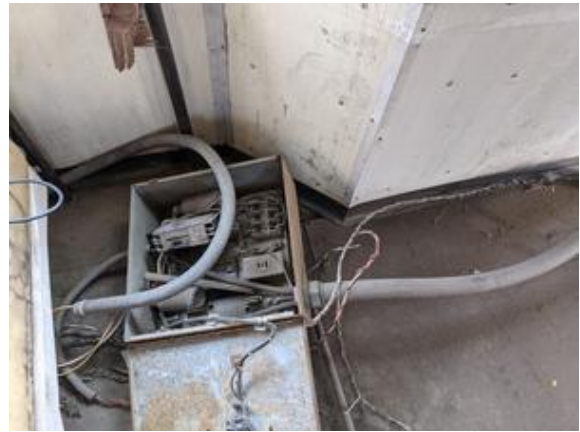
CHE-CNW11111-150721-001 thru 003, 6% Asbestos, Black bakelite

Asset Number	CNW 11111
Exposure Area	Breaker box
Asbestos Containing Material	Black bakelite
Sample Number	CHE-CNW11111-150721-001 thru 003
Size	NA
Quantity	0.5 SF
MATERIAL CONDITION (MC)	0
0 =No damage, excellent condition 1 =Very minor damage, no visible debris 2 =Damage is evident, small area 3 =Damage is easily seen, some debris 4 =Damage is widespread, debris is common 5 =Most or all material is damaged, hanging, and / or found as debris throughout the area	
BUILDING AGE (BA)	1
1 =>30 years old 0 =15 - 30 years old -1 =<15 years old	
MATERIAL TYPE	
Pipe Covering (PC)	NA
1 =MAG/CAL Silicate -1 =Air Cell / paper	
Ceiling Plasters or Fireproofing (CP)	NA
-1 =Cementitious (Monocoat) 0 =Standard 1 ="Cotton Candy" texture	
WATER DAMAGE (WD)	0
0 =No water damage 1 =Small amount of damage can be seen; damage is localized rather than widespread 2 =Good deal of water damage; widespread	
ROOF CHARACTERISTICS (RC)	-0.5

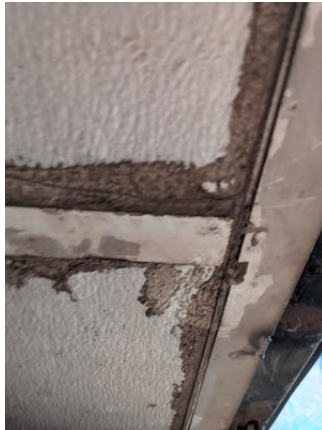
CHE-CNW11111-150721-004 thru 006, Asbestos Not Detected, White/gray sealant

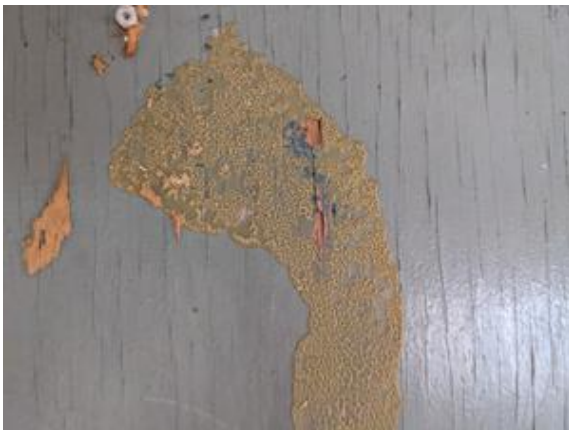
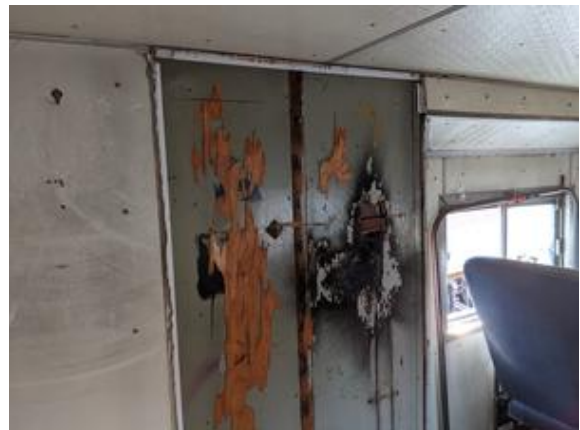
CHE-CNW11111-150721-007 thru 009, Asbestos Not Detected, Yellow mastic

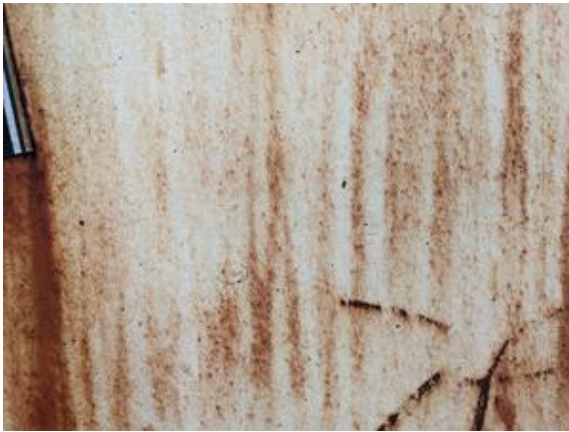
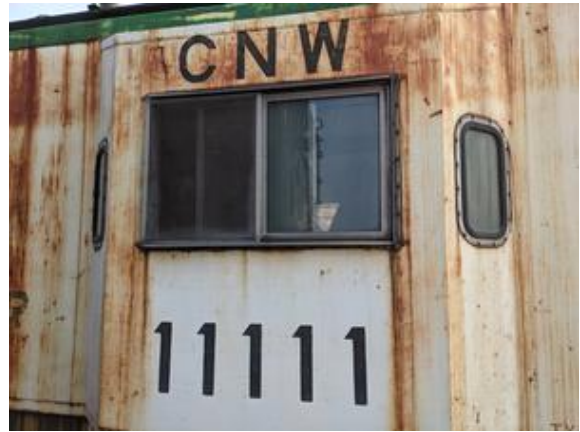
CHE-CNW11111-150721-002L, 5.1% Lead, Yellow

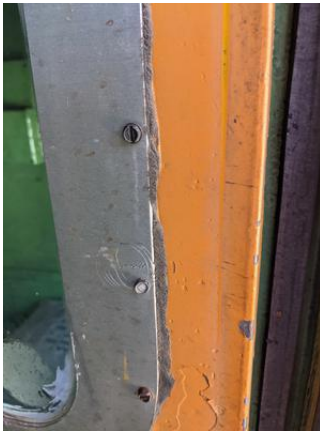
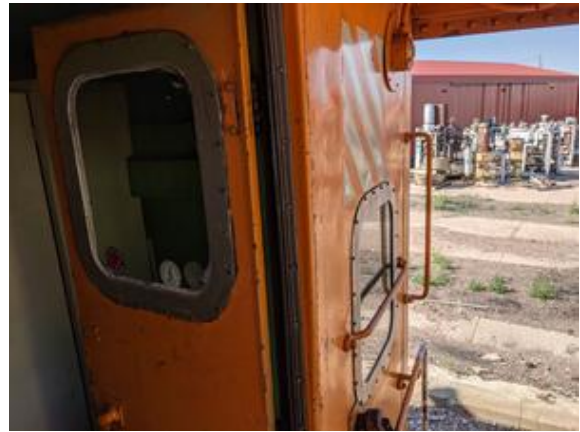
CHE-DRGW01476-170721-001 thru 003, 6% Asbestos, Gray/black window caulk

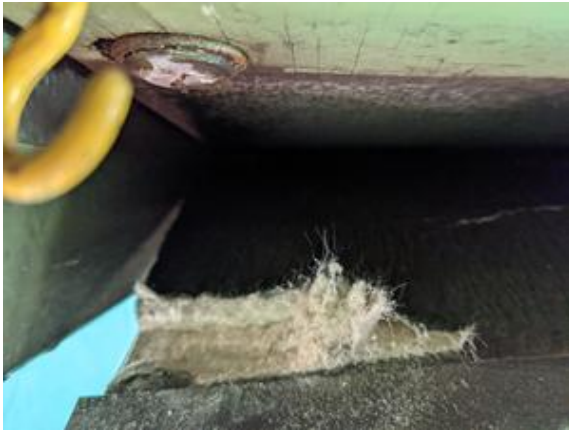
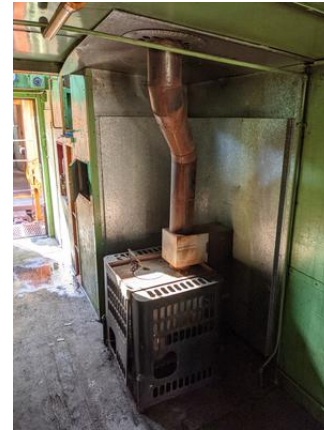
CHE-DRGW01476-170721-004 thru 006, Asbestos Not Detected, Brown fiberboard

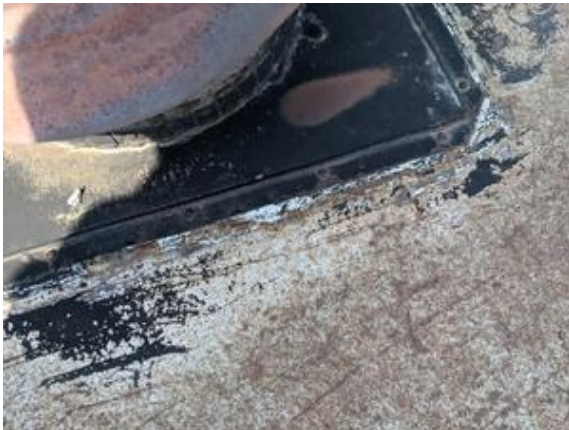
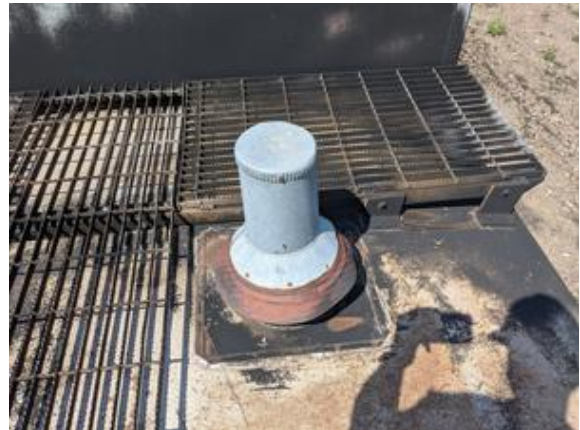
CHE-DRGW01481-160721-007 thru 009, 2.85% Asbestos, White/brown sealant

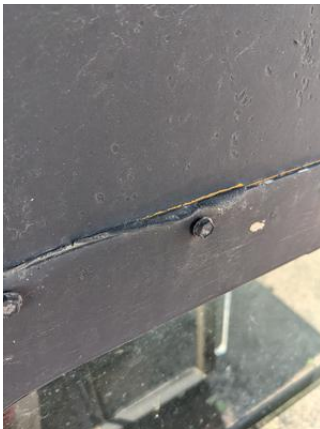
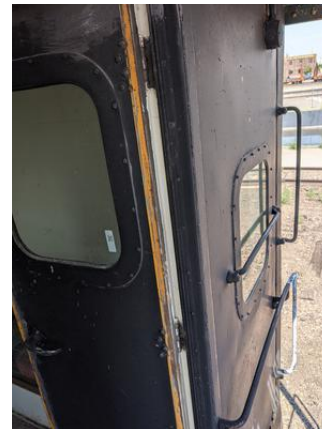
CHE-DRGW01481-160721-001P, PCB Not Detected,
Black/brown window caulk

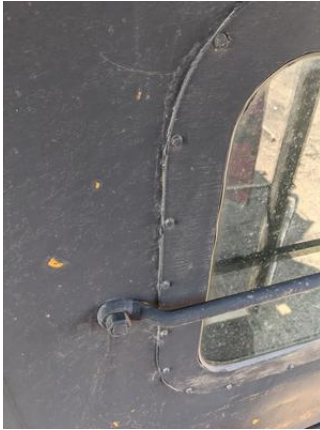
CHE-DRGW01486-160721-001 thru 003, Asbestos Not Detected, Black window caulk

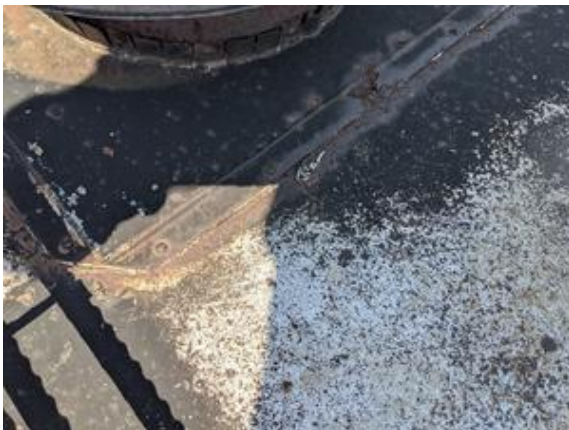
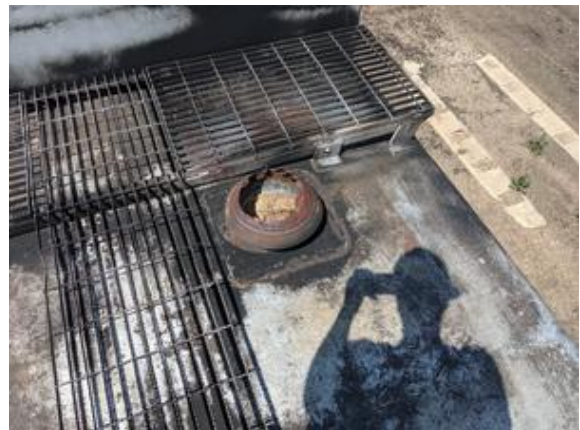
CHE-DRGW01486-160721-007 thru 009, 8% Asbestos, Brown/white sealant

Asset Number	D&RGW 01486
Exposure Area	Roof penetration
Asbestos Containing Material	Brown/white sealant
Sample Number	CHE-DRGW01486-160721-007 thru 009
Size	NA
Quantity	8 LF
MATERIAL CONDITION (MC)	2
0 =No damage, excellent condition 1 =Very minor damage, no visible debris 2 =Damage is evident, small area 3 =Damage is easily seen, some debris 4 =Damage is widespread, debris is common 5 =Most or all material is damaged, hanging, and / or found as debris throughout the area	
BUILDING AGE (BA)	1
1 =>30 years old 0 =15 - 30 years old -1 =<15 years old	
MATERIAL TYPE	
Pipe Covering (PC)	NA
1 =MAG/CAL Silicate -1 =Air Cell / paper	
Ceiling Plasters or Fireproofing (CP)	NA
-1 =Cementitious (Monocoat) 0 =Standard 1 ="Cotton Candy" texture	
WATER DAMAGE (WD)	0
0 =No water damage 1 =Small amount of damage can be seen; damage is localized rather than widespread 2 =Good deal of water damage; widespread	
ROOF CHARACTERISTICS (RC)	NA

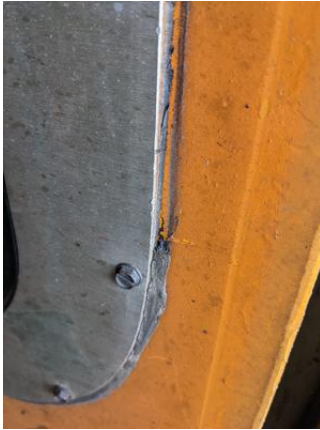
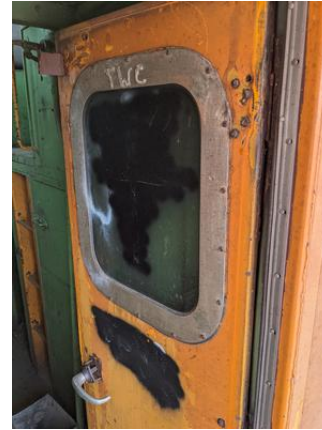
CHE-DRGW01489-150721-001 thru 003, 8% Asbestos,
Black window caulk

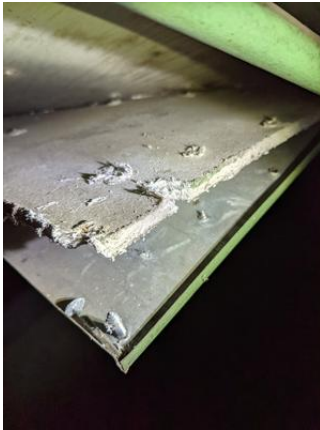
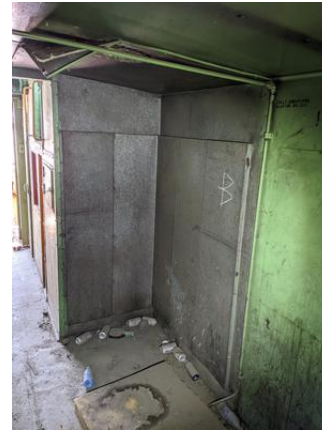
CHE-DRGW01489-150721-004 thru 006, 60% Asbestos,
White fiberboard

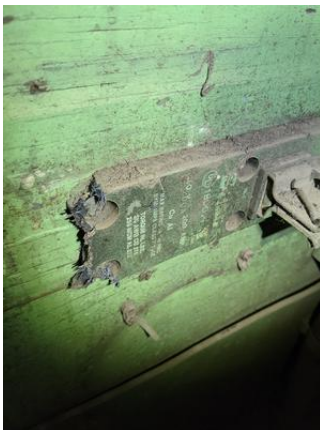
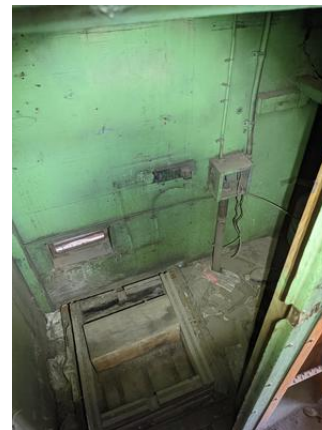
CHE-DRGW01489-150721-007 thru 009, Asbestos Not
Detected, Breakers

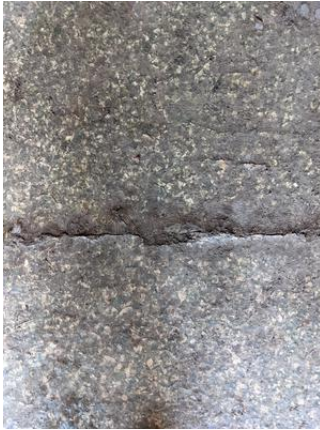
CHE-DRGW01524-170721-001 thru 003, Asbestos Not Detected, Beige flooring and gray mastic

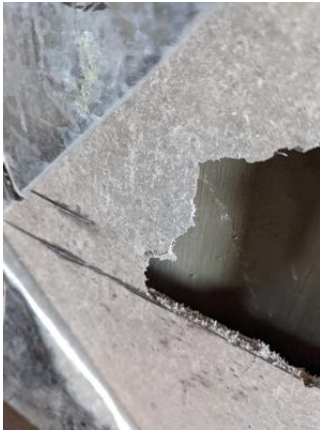
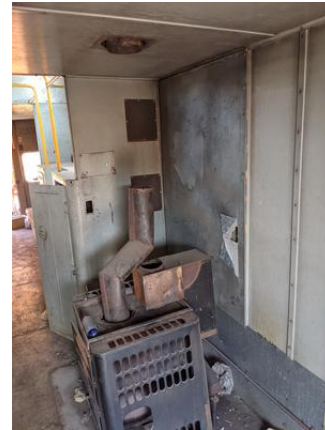
CHE-DRGW01524-170721-004 thru 006, 15% Asbestos, Gray transite boards

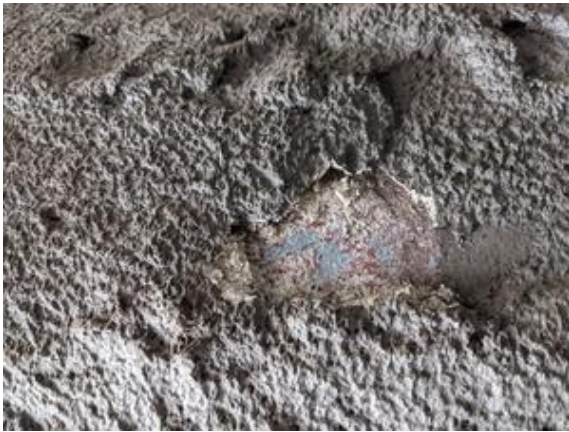
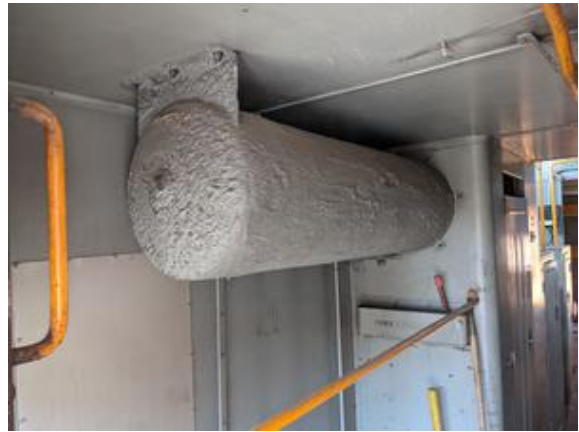
CHE-DRGW01524-170721-010 thru 012, 6.42% Asbestos, White coating

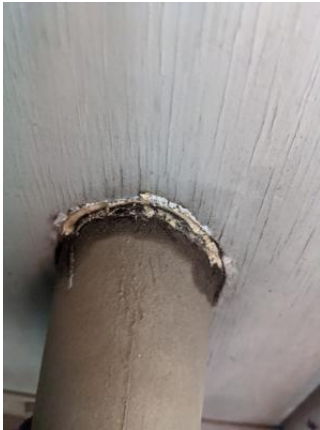
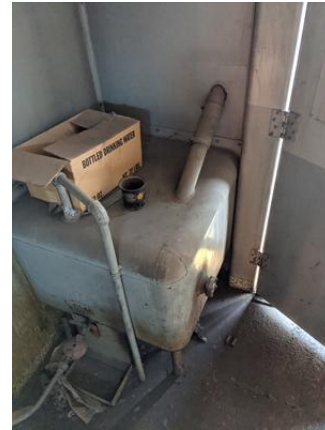
CHE-DRGW01524-170721-013 thru 015, 1.43% Asbestos, Tan sealant

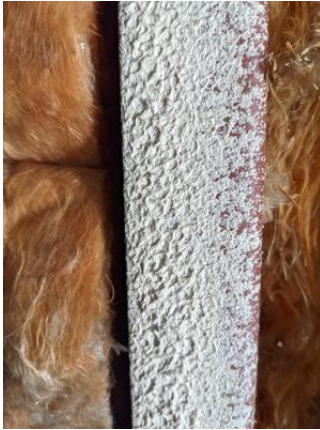
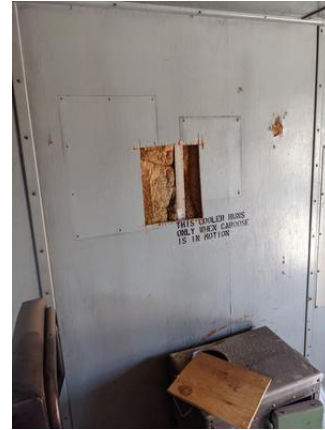
CHE-DRGW01524-170721-019 thru 021, 4.7% Asbestos, White coating

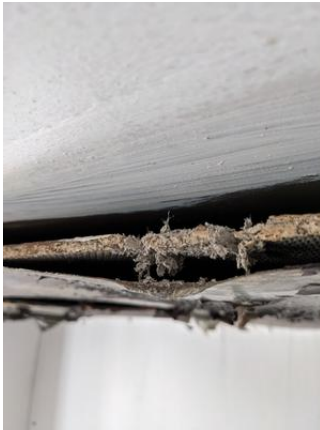
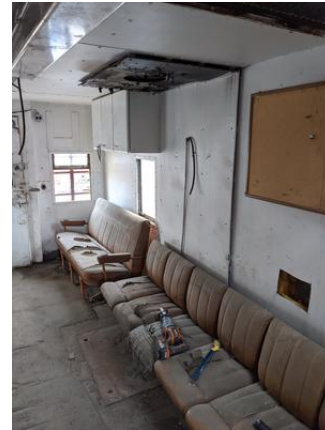
CHE-FTSX812-140721-004 thru 006, 15% Asbestos, Gray transite

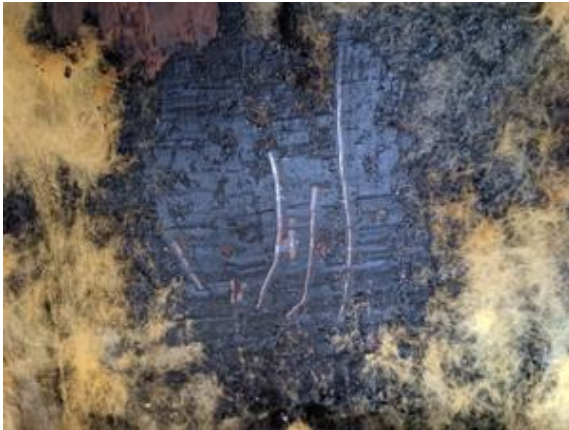
CHE-FTSX812-140721-013 thru 015, 0.42% Asbestos, Black coating

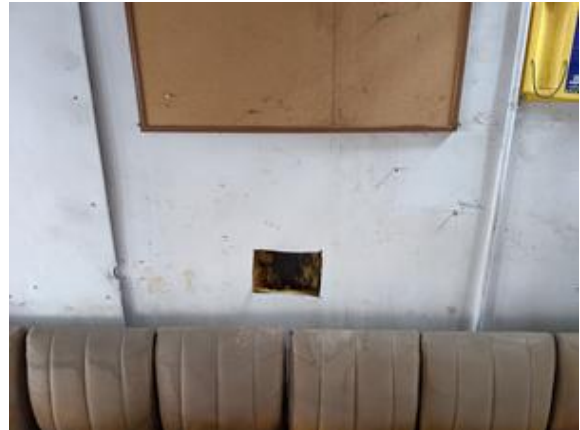
CHE-FTSX812-140721-013 thru 015, 0.42% Asbestos, Black coating

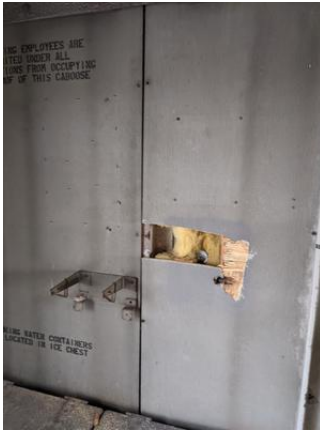
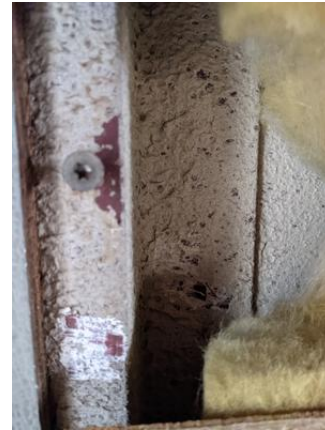
CHE-MP13835-130721-004 thru 006, 10% Asbestos, White coating

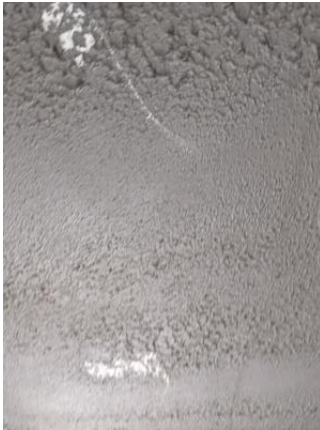
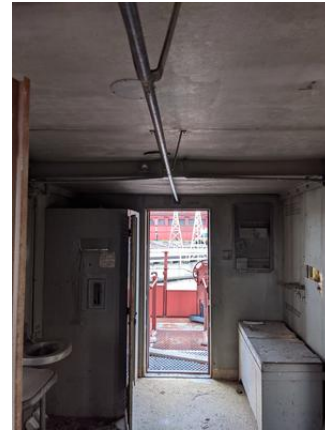
CHE-MP13835-130721-013 thru 015, 10% Asbestos, White coating

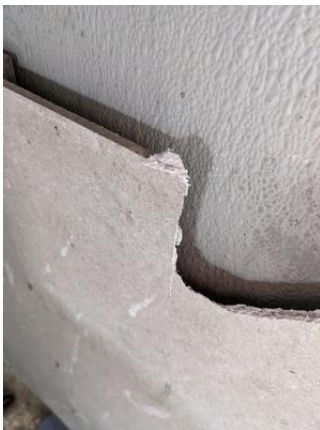
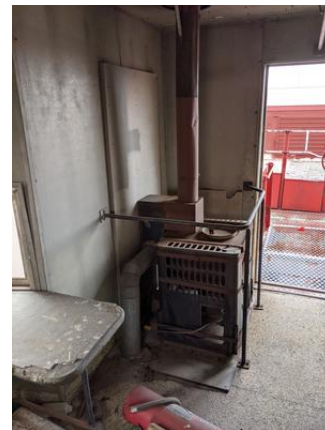
CHE-MP13835-130721-016 thru 018, 15% Asbestos, Gray transite boards

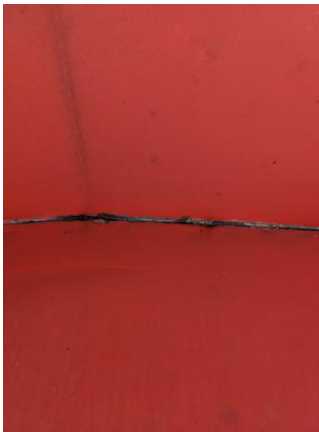
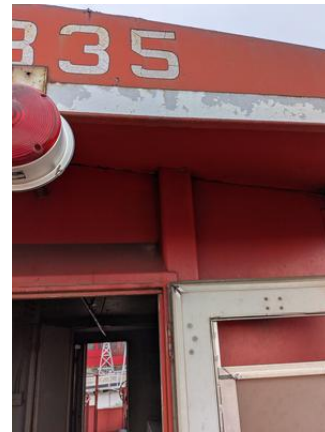
CHE-MP13835-130721-022 thru 024, 10% Asbestos, Gray roof seam sealant

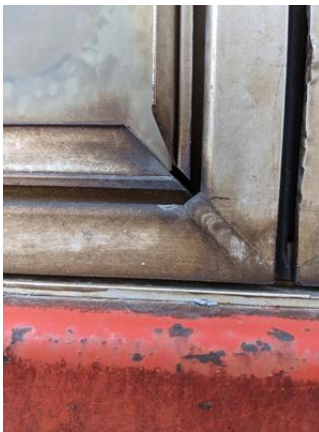
CHE-MP13835-130721-025 thru 027, 10% Asbestos, Gray window caulk

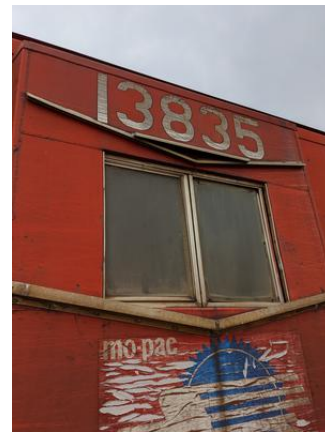
CHE-MP13835-130721-025 thru 027, 10% Asbestos, Gray window caulk

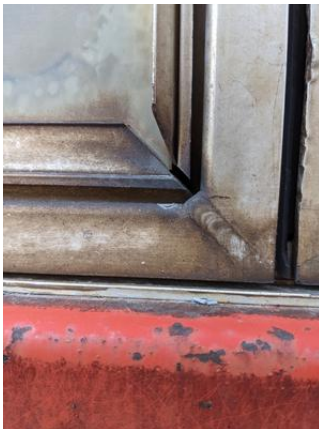
CHE-MP13835-130721-001P, PCB Not Detected, Gray window caulk

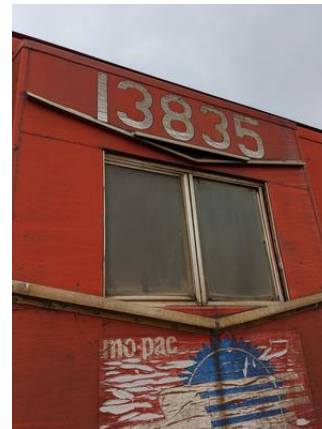
CHE-MP13835-130721-001P, PCB Not Detected, Gray window caulk

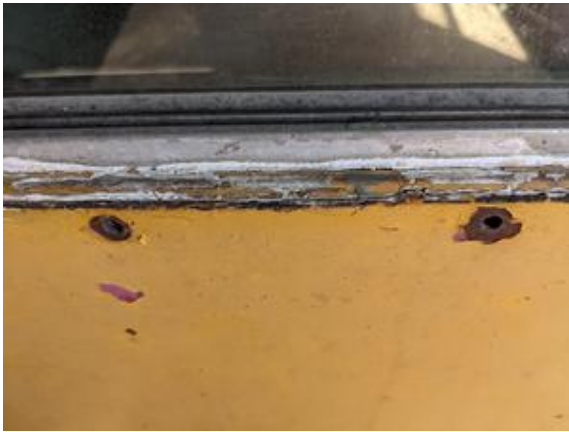
CHE-RI17017-150721-001 thru 003, 1.75% Asbestos, White window glazing

Asset Number	RI 17017	RI 17017
Exposure Area	Exterior windows ☐	Railcar undercarriage ☐
Asbestos Containing Material	White window glazing ☐	Black fire proofing ☐
Sample Number	CHE-RI17017-150721-001 thru 003 ☐	CHE-RI17017-150721-004 thru 006 ☐
Size	NA	NA
Quantity	24 LF	340 SF
MATERIAL CONDITION (MC) 0 =No damage, excellent condition 1 =Very minor damage, no visible debris 2 =Damage is evident, small area 3 =Damage is easily seen, some debris 4 =Damage is widespread, debris is common 5 =Most or all material is damaged, hanging, and / or found as debris throughout the area	3	2
BUILDING AGE (BA) 1 =>30 years old 0 =15 - 30 years old -1 =<15 years old	1	1
MATERIAL TYPE		
Pipe Covering (PC) 1 =MAG/CAL Silicate -1 =Air Cell / paper	NA	NA
Ceiling Plasters or Fireproofing (CP) -1 =Cementitious (Monocoat) 0 =Standard 1 ="Cotton Candy" texture	NA	NA
WATER DAMAGE (WD) 0 =No water damage 1 =Small amount of damage can be seen; damage is localized rather than widespread 2 =Good deal of water damage; widespread	0	0

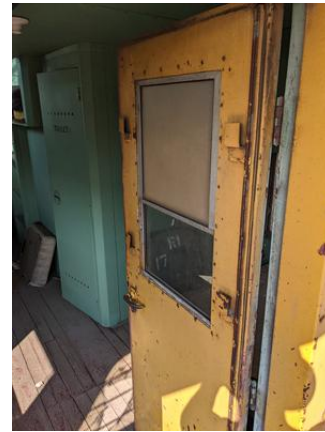
CHE-RI17017-150721-001 thru 003, 1.75% Asbestos, White window glazing

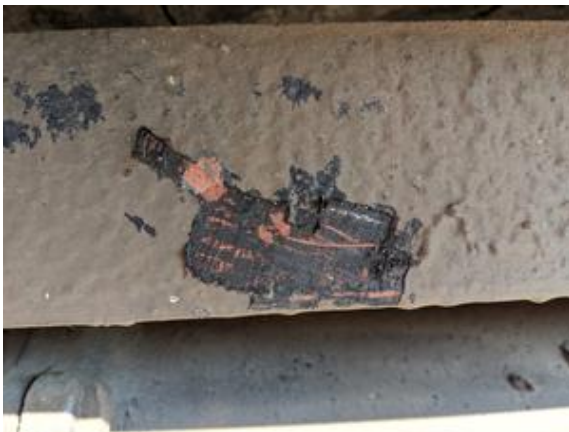
CHE-RI17017-150721-004 thru 006, 15% Asbestos, Black fire proofing

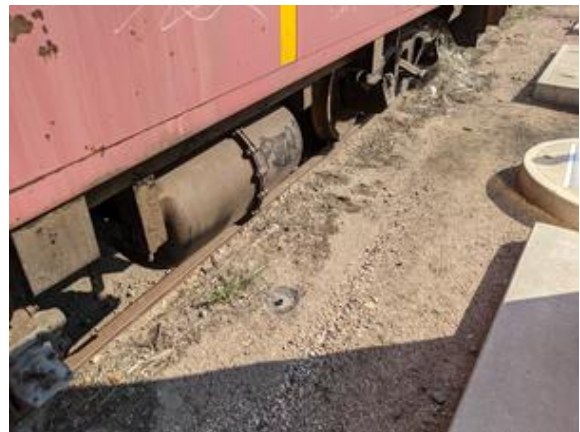
CHE-RI17017-150721-004 thru 006, 15% Asbestos, Black fire proofing

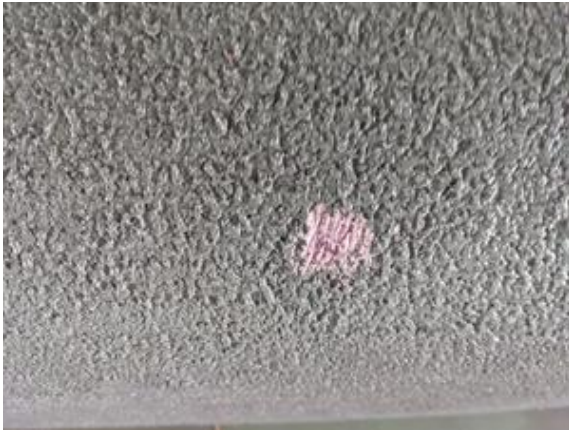
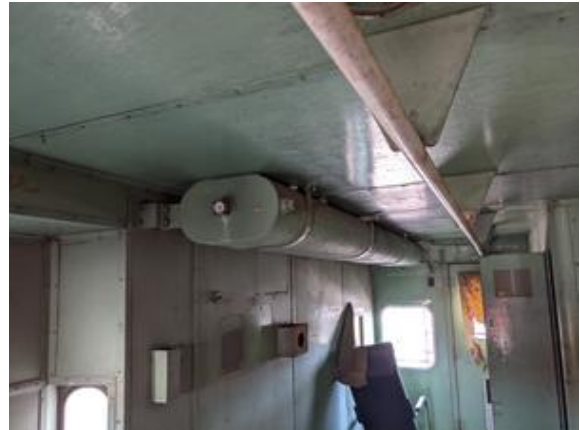
CHE-SP4641-130721-004 thru 006, 10% Asbestos, White/Green Coating

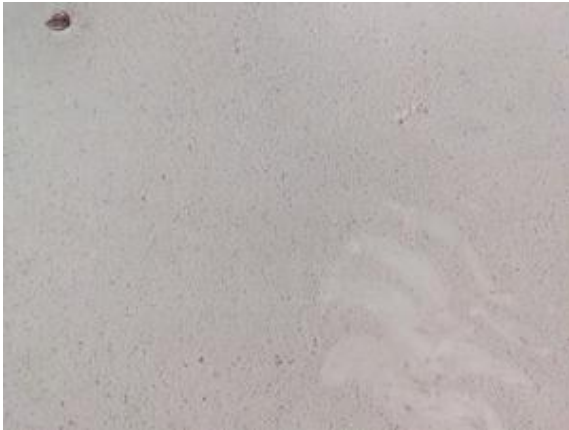
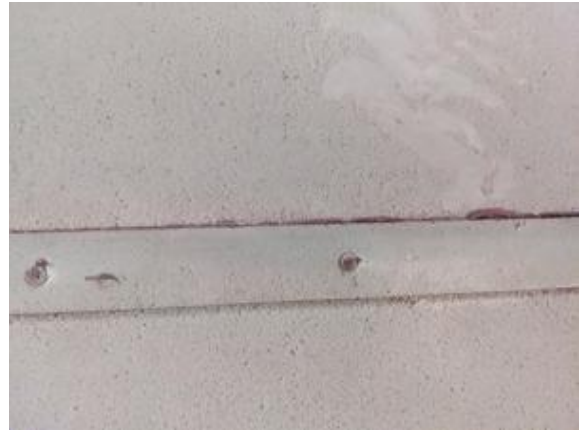
CHE-SP4641-130721-013 thru 015, 10% Asbestos, White wall coating

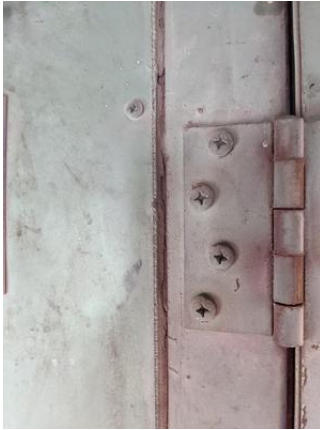
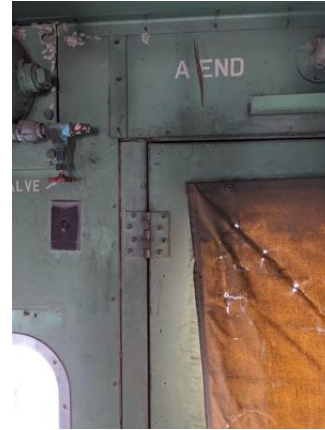
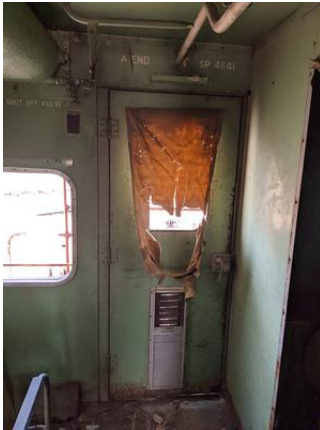
CHE-SP4641-130721-019 thru 021, 10% Asbestos, Gray door sealant

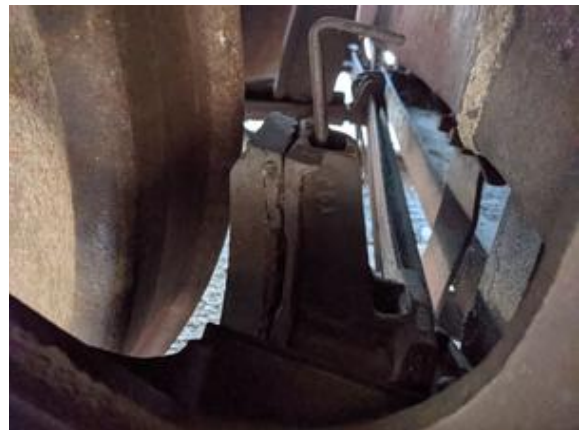
CHE-SP4641-130721-025 thru 027, Asbestos Not Detected, Black Brake Pads

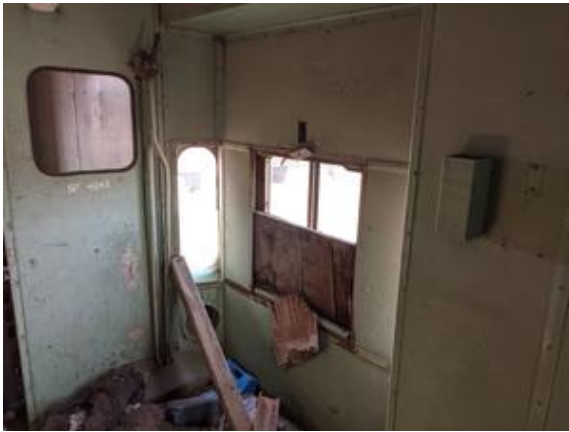
CHE-SP4641-130721-001P, PCB Not Detected, White window caulk

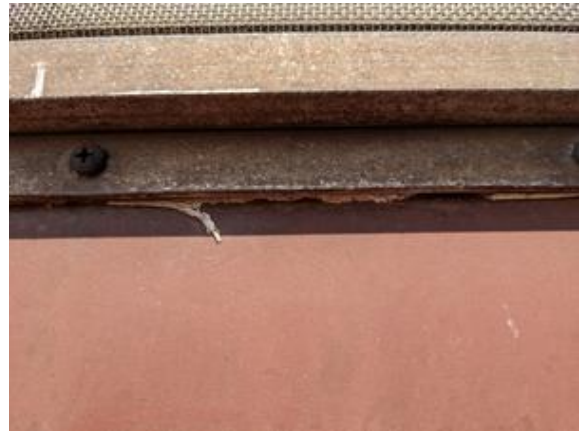
CHE-SP4641-130721-002P, PCB Not Detected, White window caulk

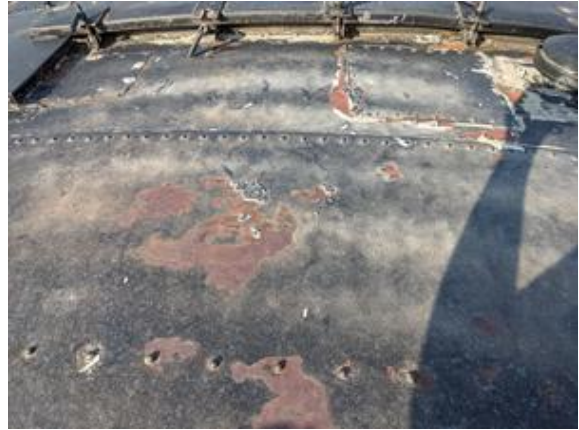
CHE-SP7077-170821-001 thru 003, 6% Asbestos, Silver/black coating

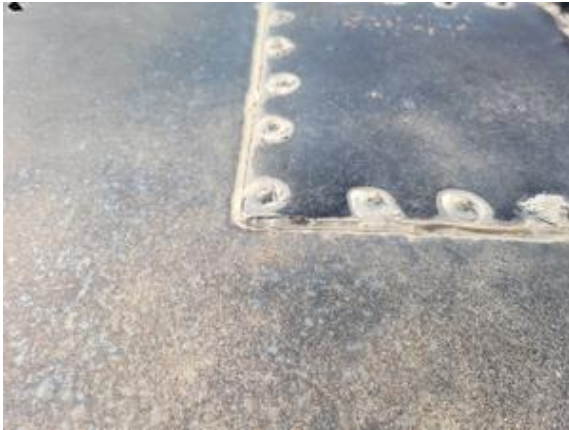
CHE-SP7077-170821-004 thru 005, 8% Asbestos, Black tar

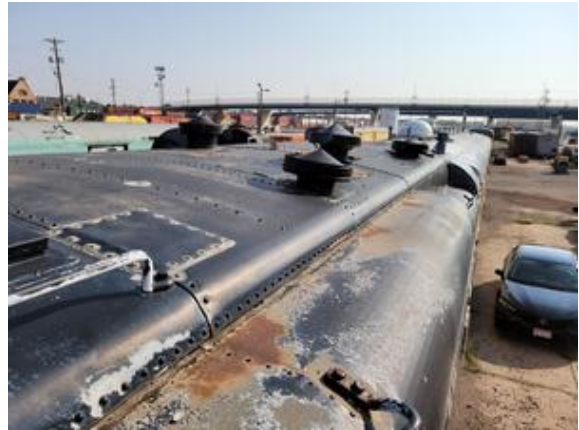
CHE-SP7077-170821-004 thru 005, 8% Asbestos, Black tar

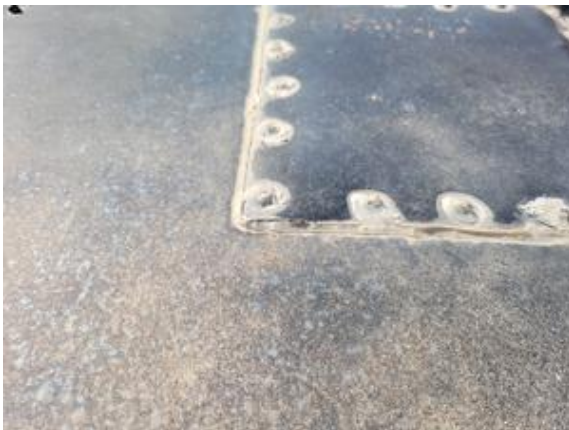
CHE-SP7077-170821-004 thru 006, Asbestos Not Detected, Clear silicone caulk

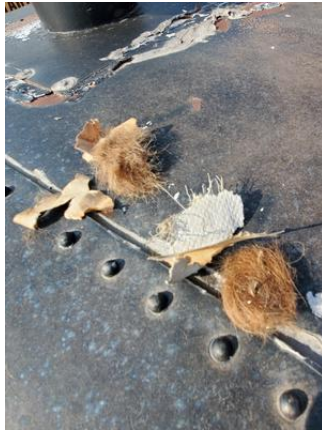
CHE-SP7077-170821-010 thru 012, 40% Asbestos, Gray Insulation

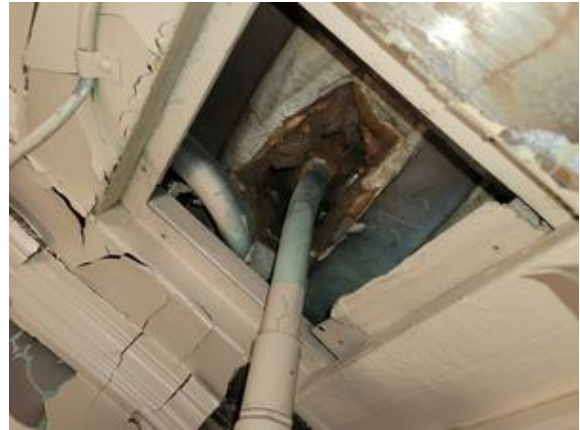
CHE-SP7077-170821-010 thru 012, 40% Asbestos, Gray Insulation

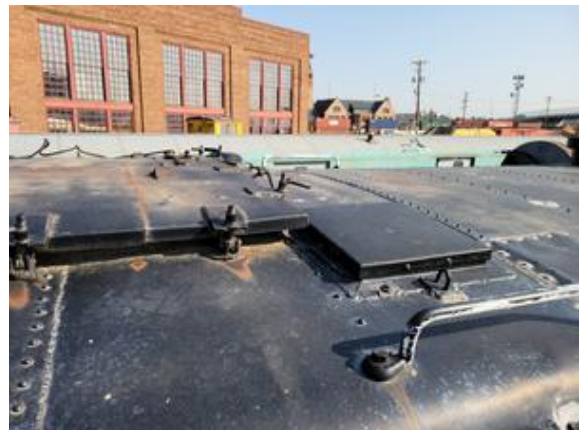
CHE-SP7077-170821-013 thru 015, Asbestos Not Detected, Thin black/gray coating

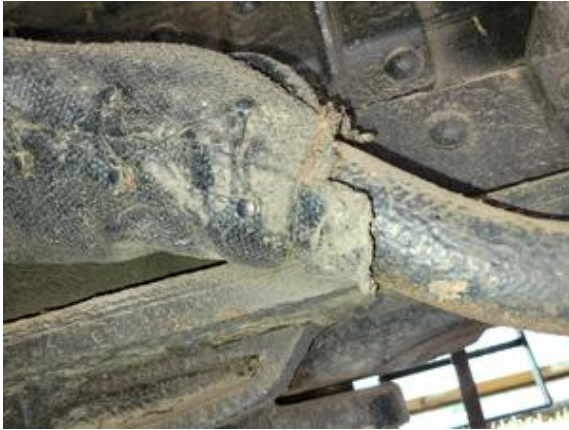
CHE-SP7077-170821-016 thru 018, 30% Asbestos, White pipe wrap

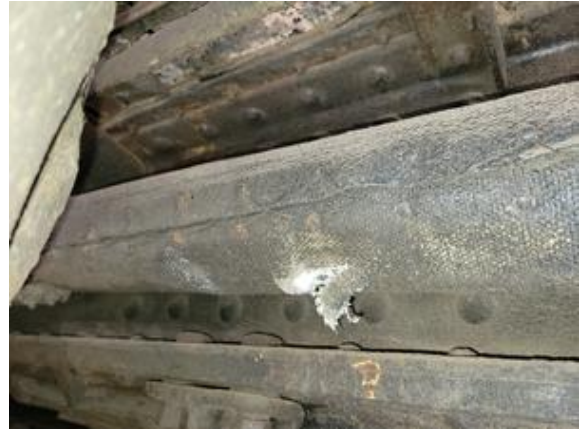
CHE-SP7077-170821-016 thru 018, 30% Asbestos, White pipe wrap

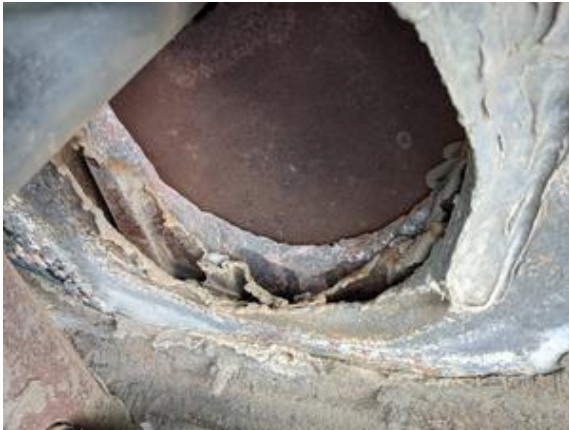
CHE-SP7077-170821-019 thru 021, 2.2% Asbestos, Gray sealant

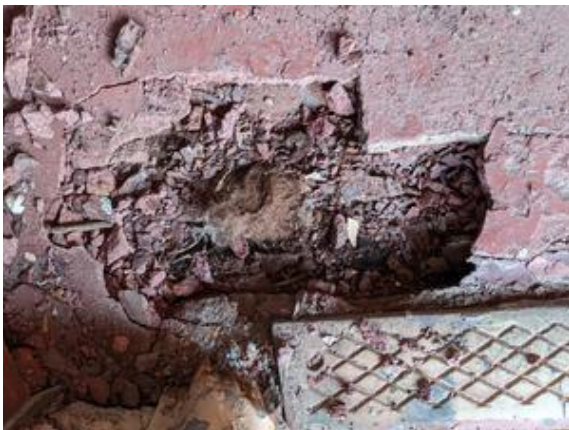
CHE-SP7077-170821-022 thru 024, 0.75% Asbestos, Red cementitious material

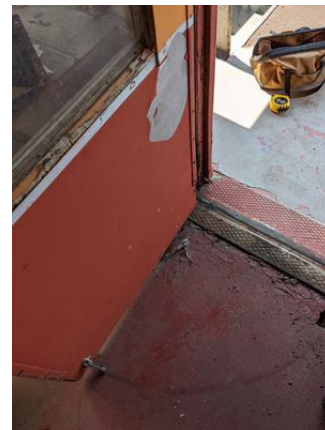
CHE-SP7077-170821-022 thru 024, 0.75% Asbestos, Red cementitious material

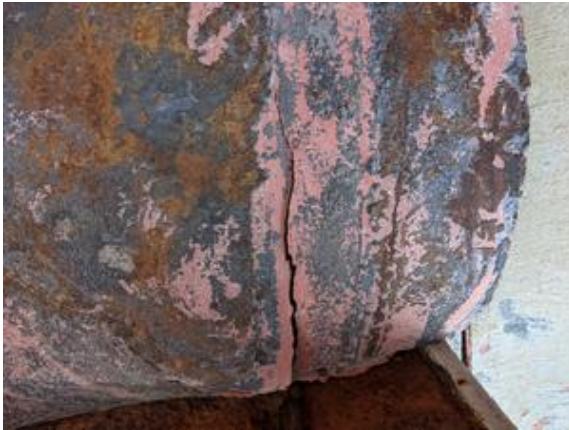
CHE-SP7077-170821-028 thru 030, 2.41% Asbestos, Red Vinyl flooring

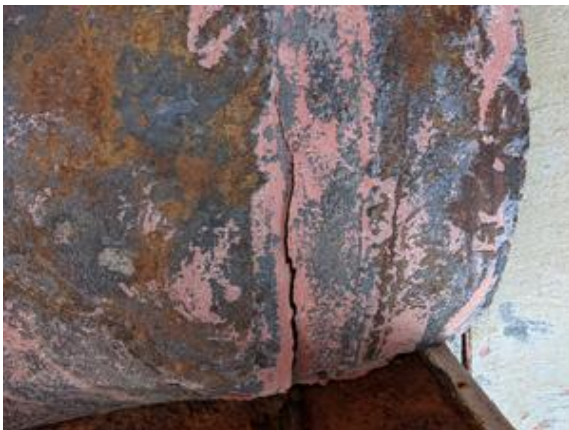
CHE-SP7077-170821-028 thru 030, Asbestos Not Detected, Yellow mastic, associated with red flooring

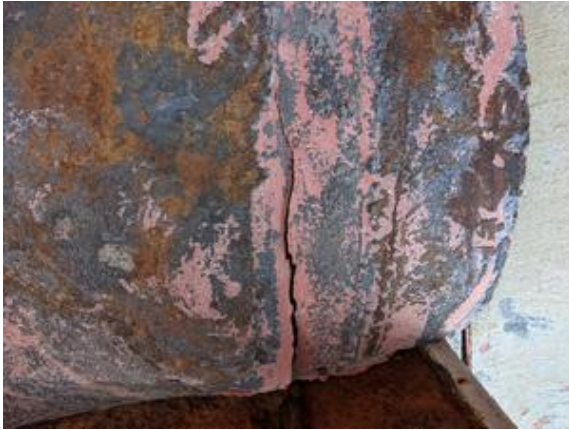
CHE-SP7077-170821-028 thru 030, 1.75% Asbestos, Black/gray subflooring

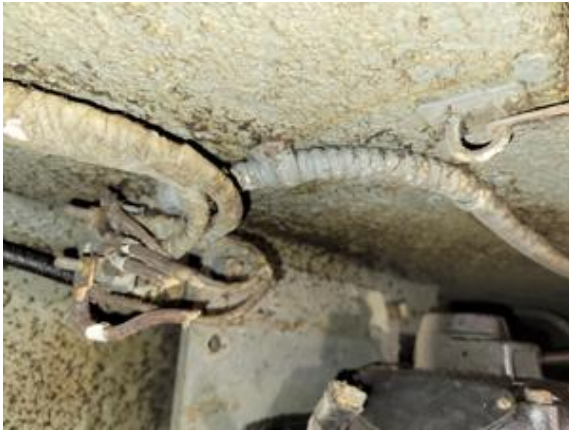
CHE-SP7077-170821-031 thru 033, 6% Asbestos, Black wall coating

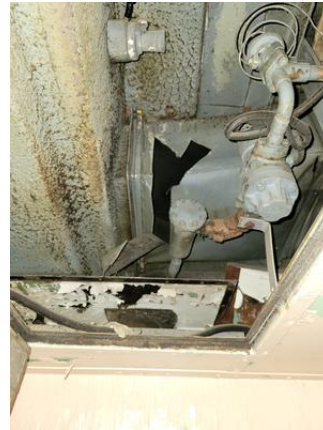
CHE-SP7077-170821-031 thru 033, 6% Asbestos, Black wall coating

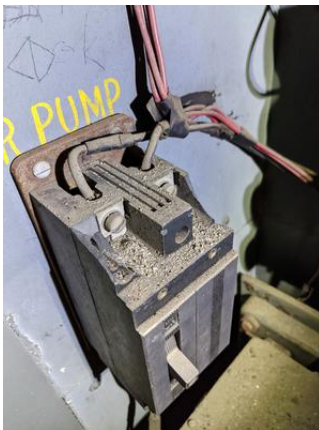
CHE-SP7077-170821-034 thru 036, 1.59% Asbestos, Black bakelite

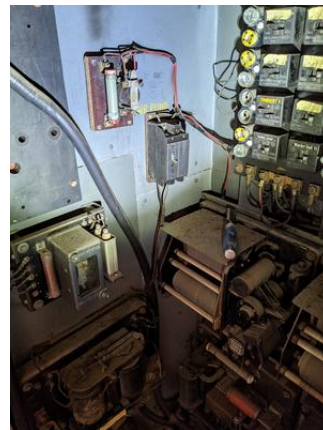
CHE-SP7077-170821-034 thru 036, 1.59% Asbestos, Black bakelite

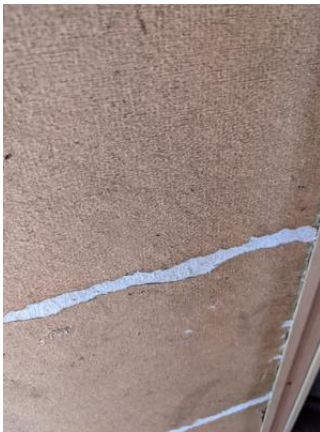
CHE-SP7077-170821-040 thru 042, 65% Asbestos, White Insulation

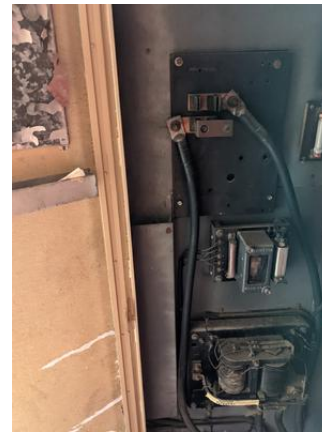
CHE-SP7077-170821-040 thru 042, 65% Asbestos, White Insulation

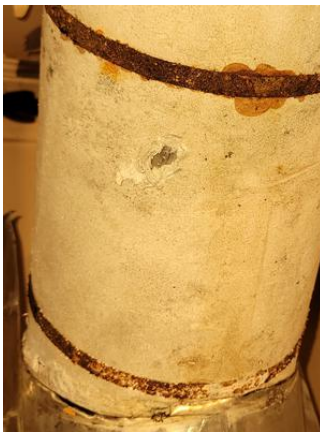
CHE-SP7077-170821-043 thru 045, 30% Asbestos, White exhaust pipe wrap

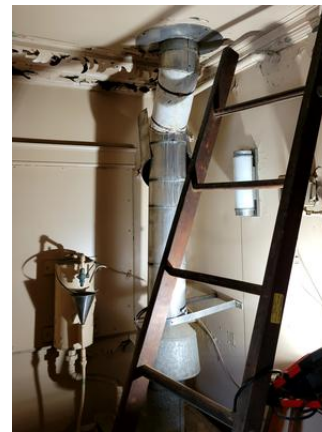
CHE-SP7077-170821-043 thru 045, 30% Asbestos, White exhaust pipe wrap

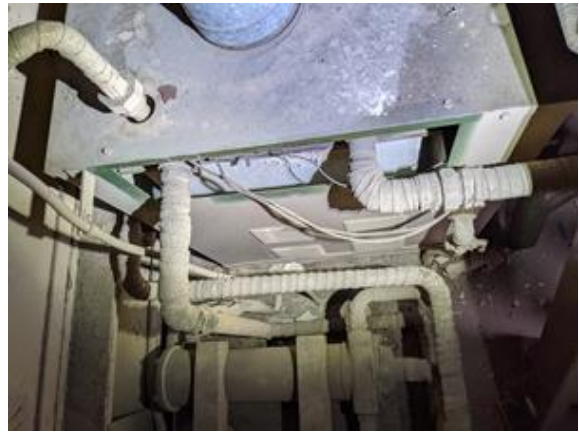
CHE-SP7077-170821-046 thru 048, 10% Asbestos, Gray heater block

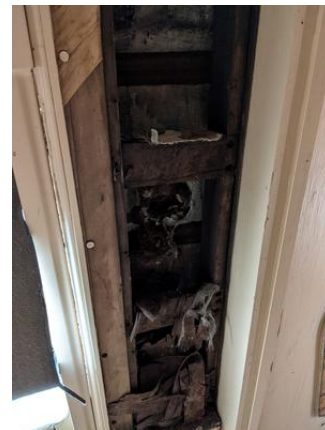
CHE-SP7078-180821-007 thru 009, 15% Asbestos, White/brown paper insulation

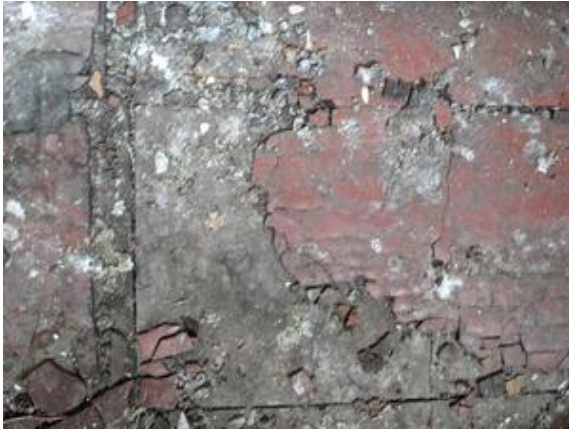
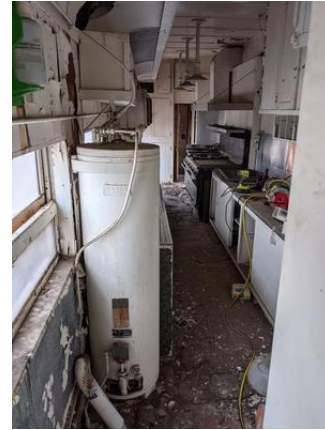
CHE-SP7078-180821-010 thru 012, Asbestos Not Detected, Red vinyl floor and brown mesh tape
