**RE: Cheyenne, Wyoming 15 UPRR Railcars
Hazardous Material Inspection Summary Letter Report
Earth Services & Abatement Project Number: DENP000352**

HAZARDOUS MATERIAL INSPECTION SUMMARY LETTER REPORT

15 UPRR RAILCARS CHEYENNE, WYOMING

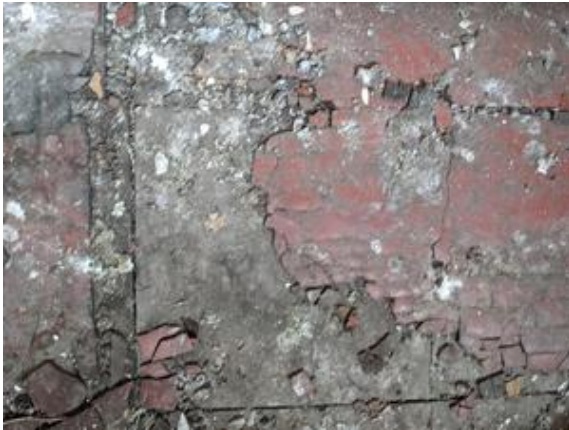
CHE-SP7078-180821-013 thru 015, 6% Asbestos, Gray 9"x9" floor tile and gray leveling compound

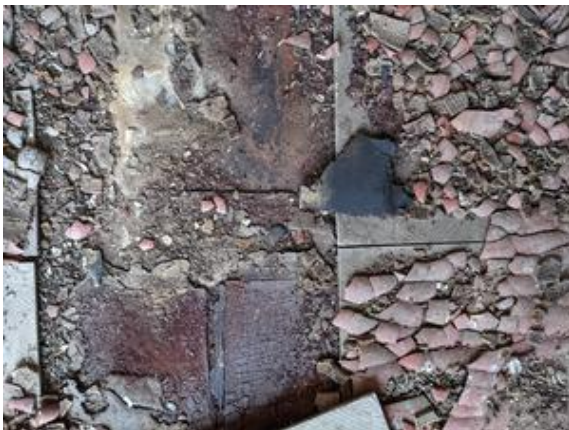
CHE-SP7078-180821-013 thru 015, Asbestos Not Detected, Yellow mastic associated with gray 9"x9" floor tile

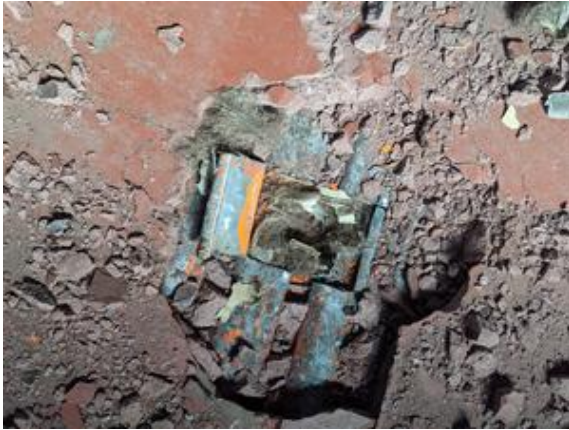
CHE-SP7078-180821-016 thru 018, 1.75% Asbestos, Red cementitious flooring

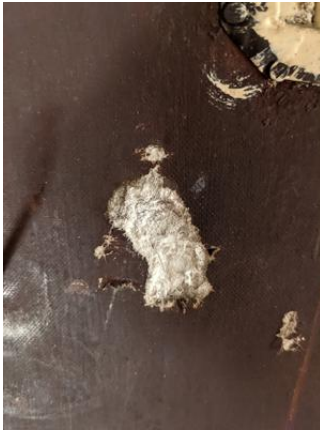
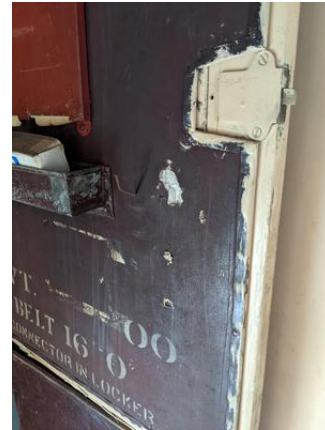
CHE-SP7078-180821-019 thru 021, 65% Asbestos, White fiberboard

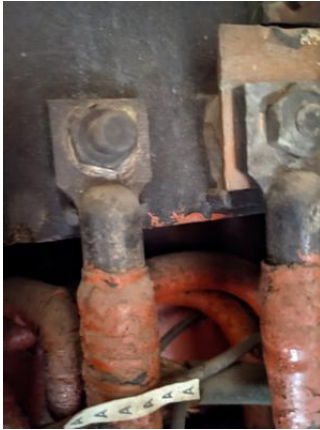
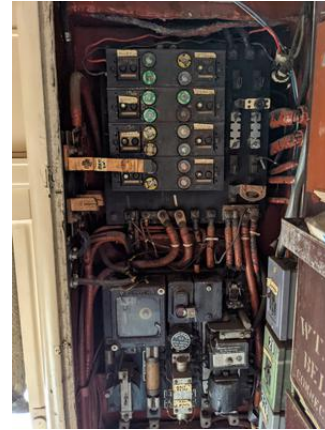
CHE-SP7078-180821-025 thru 027, 6% Asbestos, Black fiberboard

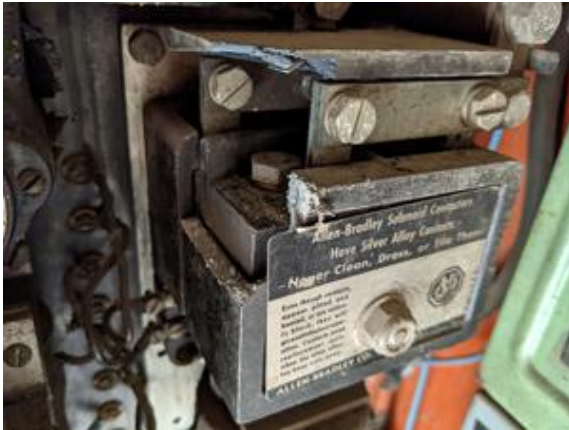
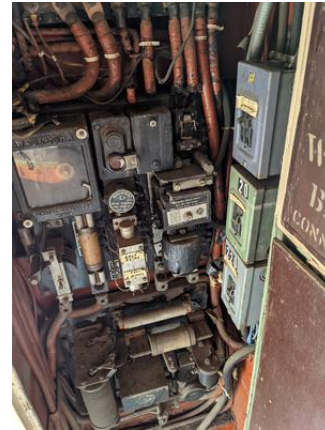
CHE-SP7078-180821-028 thru 030, 15% Asbestos, Black bakelite

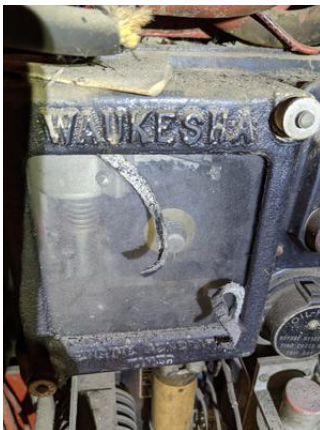
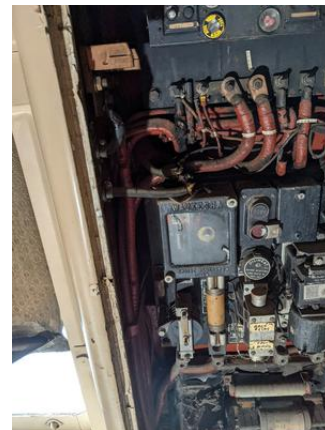
CHE-SP7078-180821-031 thru 033, Asbestos Not Detected, Gasket (layered silver coating and black felt)

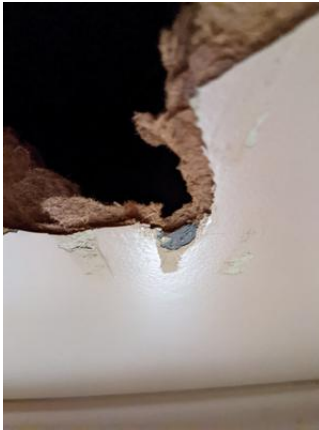
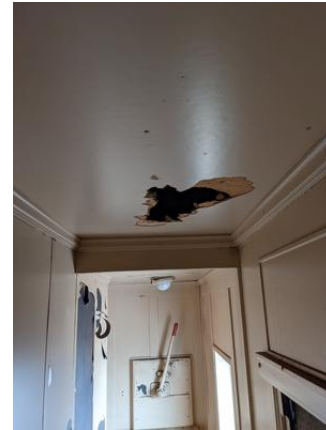
CHE-SP7078-180821-037 thru 039, Asbestos Not Detected, Masonite board (layered compound, mastic and fiberboard)

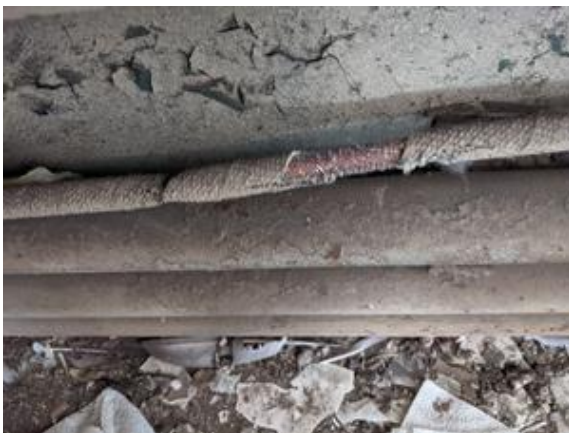
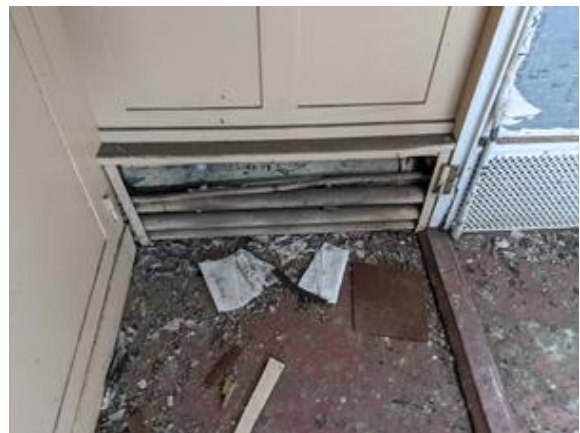
CHE-SP7078-180821-040 thru 042, 55% Asbestos, Beige pipe wrap

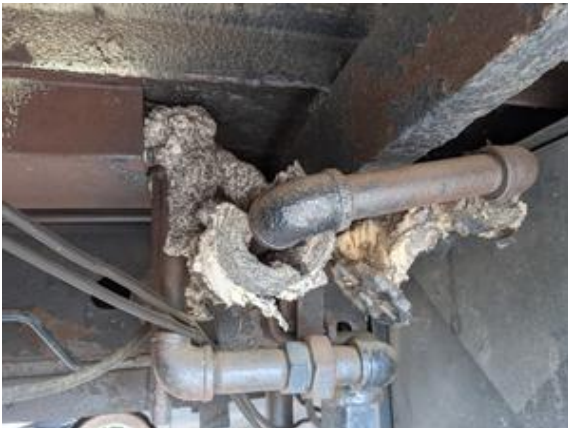
CHE-SP7078-180821-046 thru 048, Asbestos Not Detected, Vibration dampener and mastic

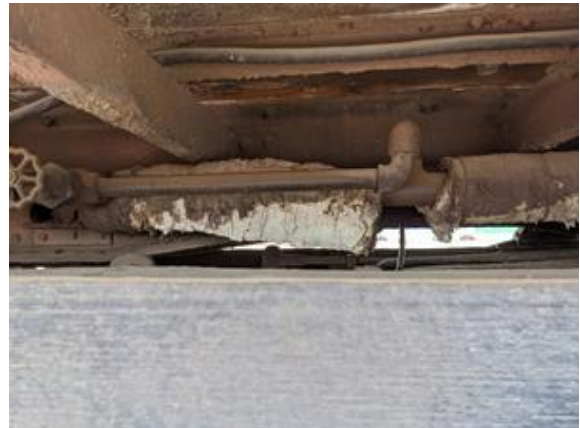
CHE-SP7078-180821-049 thru 051, 15% Asbestos, White pipe wrap

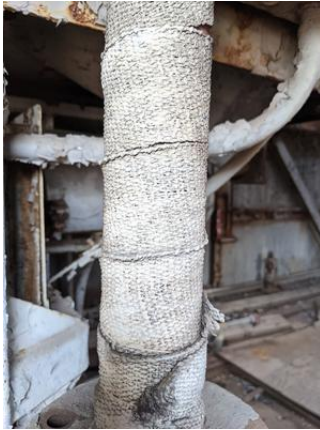
CHE-UP928-160821-001 thru 003, 90% Asbestos, White pipe wrap

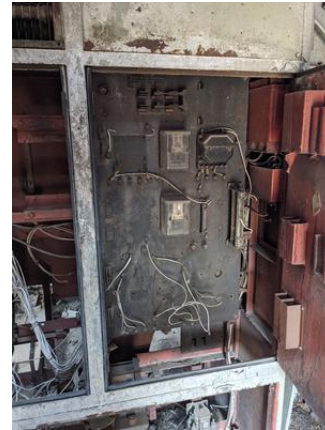
CHE-UP928-160821-004 thru 006, Asbestos Not Detected, White/black electrical wire wrap

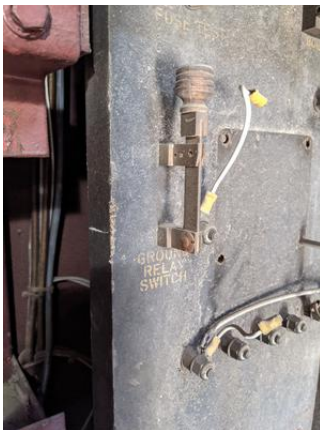
CHE-UP928-160821-007 thru 009, 40% Asbestos, Black Fireboard

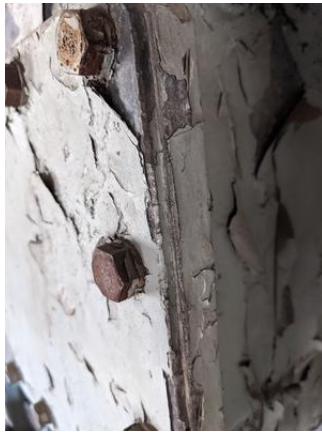
CHE-UP928-160821-010 thru 012, Asbestos Not Detected, Gray/Brown Gaskets

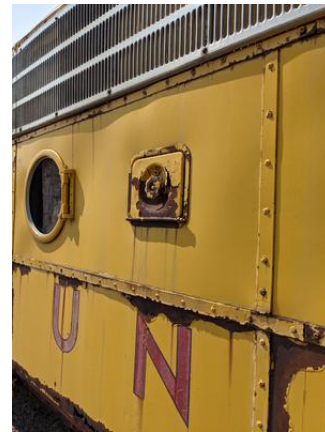
CHE-UP928-160821-013 thru 015, Asbestos Not Detected, Yellow/Black Penetration Gaskets

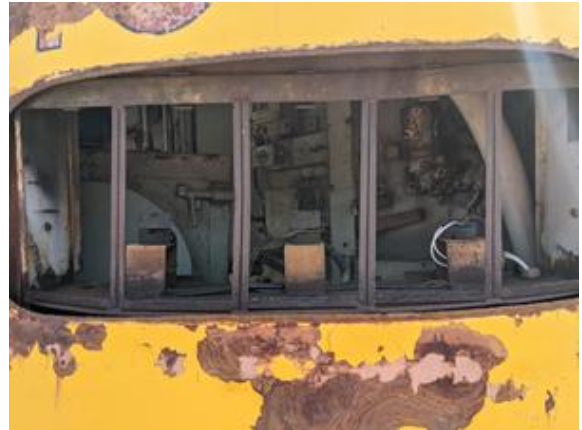
CHE-UP928-160821-022 thru 024, Asbestos Not Detected, Black Headlight Bulb Insulators

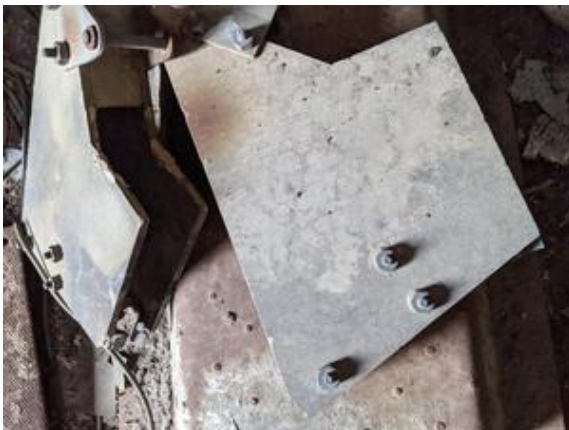
CHE-UP928-160821-025 thru 027, 20% Asbestos, Gray transite

Asset Number	UP 928	UP 928
Exposure Area	Interior loose bracing pieces	Interior pipe connections
Asbestos Containing Material	Gray transite	Black gasket
Sample Number	CHE-UP928-160821-025 thru 027	CHE-UP928-160821-028 thru 030
Size	NA	NA
Quantity	3 SF	1 LF
MATERIAL CONDITION (MC)	1	1
0 =No damage, excellent condition 1 =Very minor damage, no visible debris 2 =Damage is evident, small area 3 =Damage is easily seen, some debris 4 =Damage is widespread, debris is common 5 =Most or all material is damaged, hanging, and / or found as debris throughout the area		
BUILDING AGE (BA)	1	1
1 =>30 years old 0 =15 - 30 years old -1 =<15 years old		
MATERIAL TYPE		
Pipe Covering (PC)	NA	NA
1 =MAG/CAL Silicate -1 =Air Cell / paper		
Ceiling Plasters or Fireproofing (CP)	NA	NA
-1 =Cementitious (Monocoat) 0 =Standard 1 ="Cotton Candy" texture		
WATER DAMAGE (WD)	0	0
0 =No water damage 1 =Small amount of damage can be seen; damage is localized rather than widespread 2 =Good deal of water damage; widespread

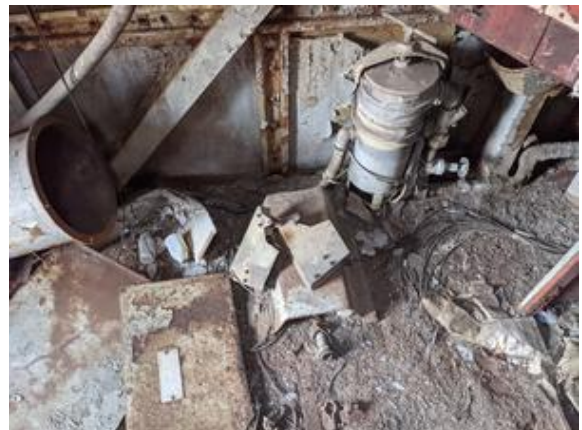
CHE-UP928-160821-025 thru 027, 20% Asbestos, Gray transite

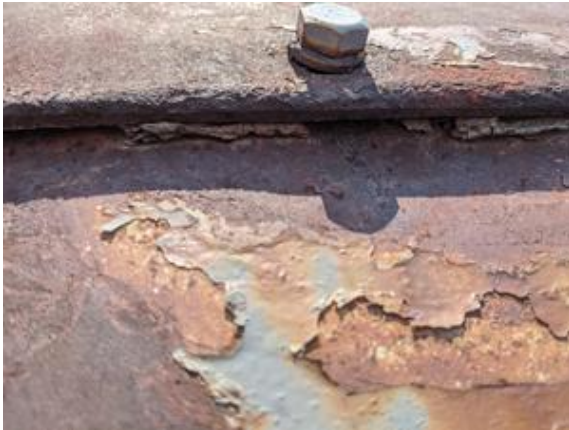
CHE-UP928-160821-031 thru 033, 10% Asbestos, Gray Coating

Asset Number	UP 928
Exposure Area	Roof
Asbestos Containing Material	Gray Coating
Sample Number	CHE-UP928-160821-031 thru 033
Size	NA
Quantity	620 SF
MATERIAL CONDITION (MC)	1
0 =No damage, excellent condition 1 =Very minor damage, no visible debris 2 =Damage is evident, small area 3 =Damage is easily seen, some debris 4 =Damage is widespread, debris is common 5 =Most or all material is damaged, hanging, and / or found as debris throughout the area	
BUILDING AGE (BA)	1
1 =>30 years old 0 =15 - 30 years old -1 =<15 years old	
MATERIAL TYPE	
Pipe Covering (PC)	NA
1 =MAG/CAL Silicate -1 =Air Cell / paper	
Ceiling Plasters or Fireproofing (CP)	NA
-1 =Cementitious (Monocoat) 0 =Standard 1 ="Cotton Candy" texture	
WATER DAMAGE (WD)	0
0 =No water damage 1 =Small amount of damage can be seen; damage is localized rather than widespread 2 =Good deal of water damage; widespread	
ROOF CHARACTERISTICS (RC)	-0.5
-0.5 =Sloped or Hipped -0.5 =Metal or Concrete 0.5 =Flat or Built-up

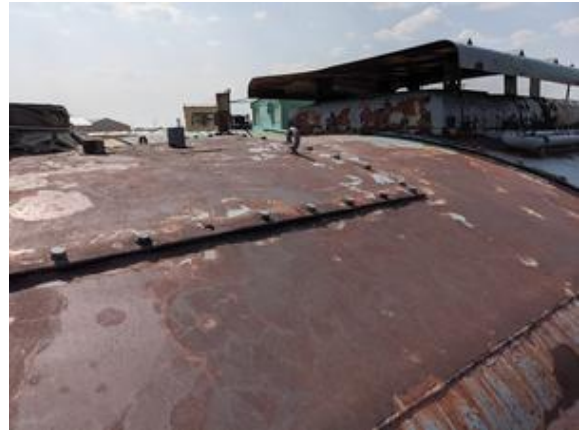
CHE-UP928-160821-031 thru 033, 10% Asbestos, Gray Coating
