**RE: Cheyenne, Wyoming 15 UPRR Railcars
Hazardous Material Inspection Summary Letter Report
Earth Services & Abatement Project Number: DENP000352**

HAZARDOUS MATERIAL INSPECTION SUMMARY LETTER REPORT

15 UPRR RAILCARS CHEYENNE, WYOMING

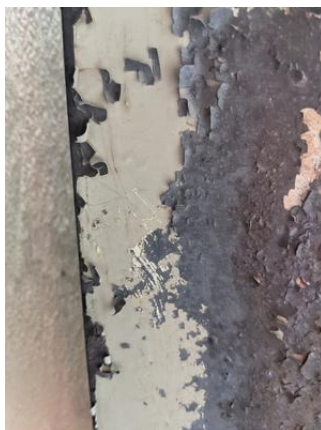
CHE-CNW11047-150721-001L, 0.42% Lead, Gray

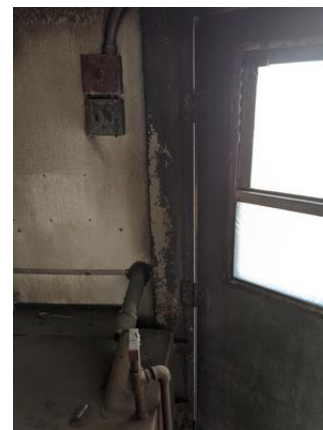
CHE-CNW11047-150721-001L, 0.42% Lead, Gray

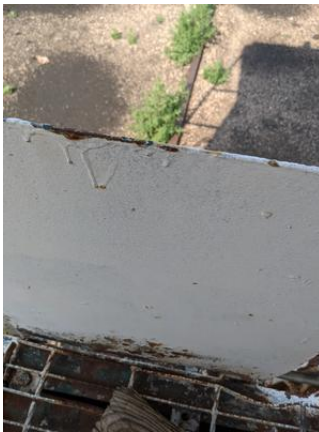
CHE-CNW11047-150721-003L, 0.38% Lead, White

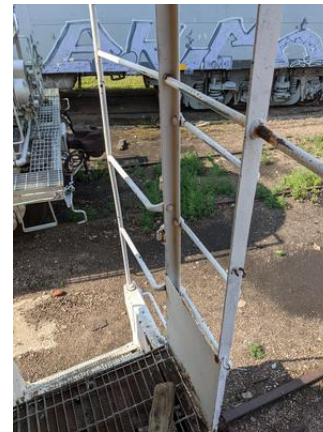
CHE-CNW11047-150721-003L, 0.38% Lead, White

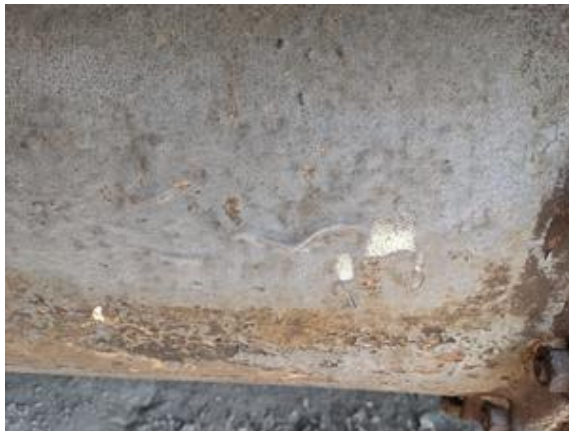
CHE-CNW11047-150721-004L, 1% Lead, Black

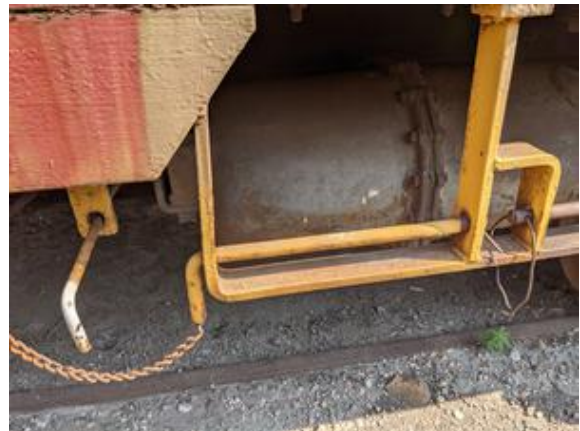
CHE-CNW11047-150721-004L, 1% Lead, Black

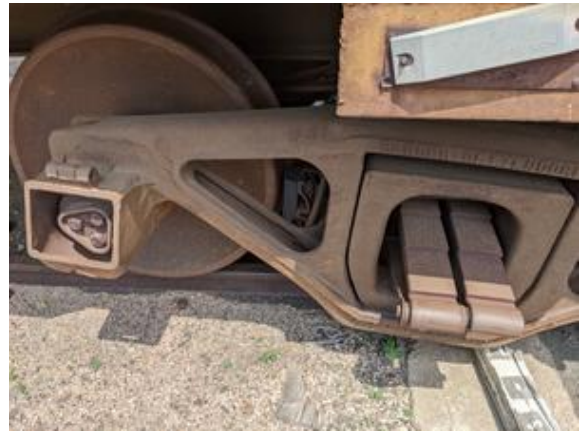
CHE-CN11097-140721-010 thru 012, Asbestos Not Detected, Black brake pads

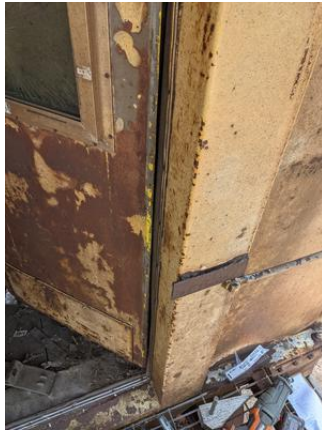
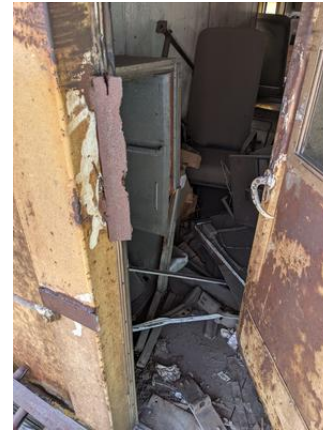
CHE-CN11097-140721-013 thru 015, Asbestos Not Detected, Black/brown caulk

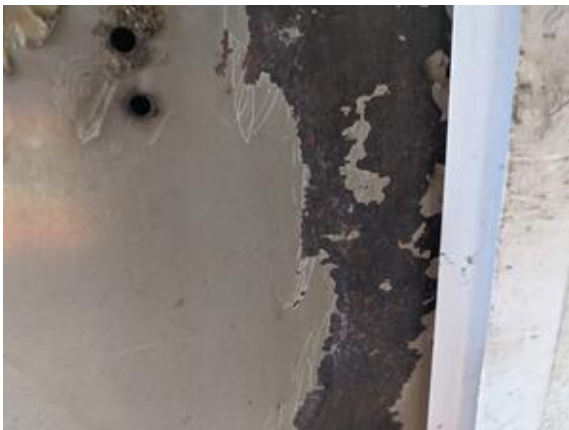
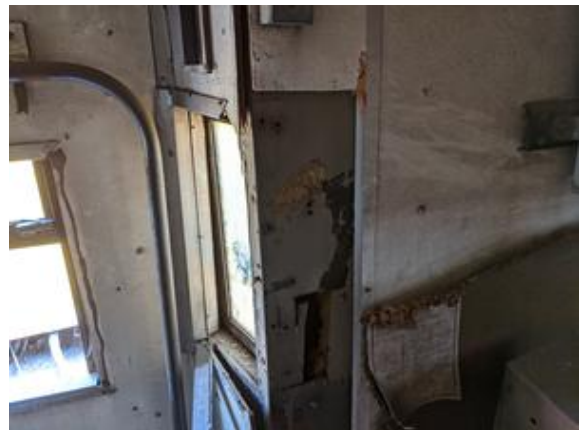
CHE-CN11097-140721-001L, 1.2% Lead, Gray

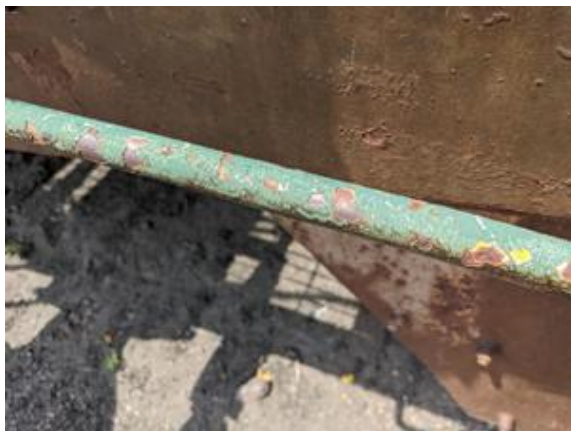
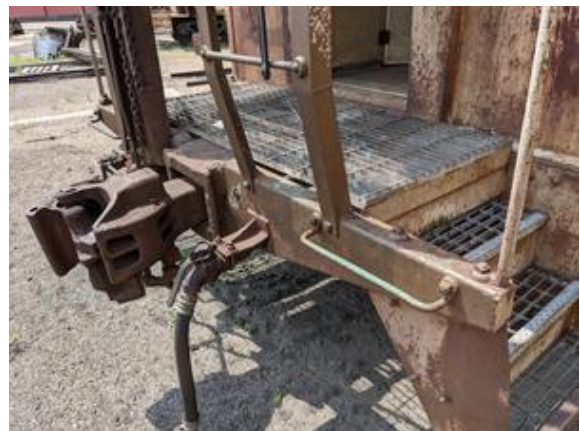
CHE-CNW11097-140721-003L, 3.9% Lead, Green/White/Black

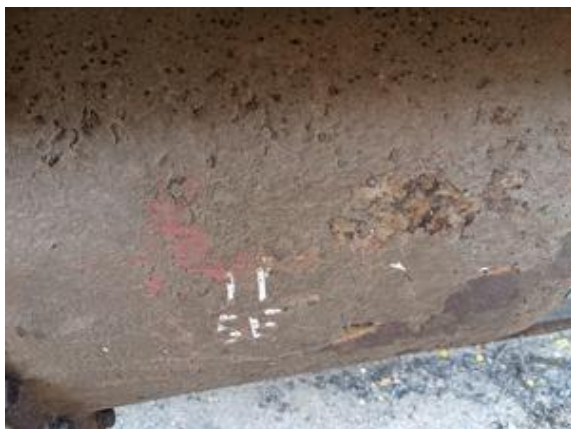
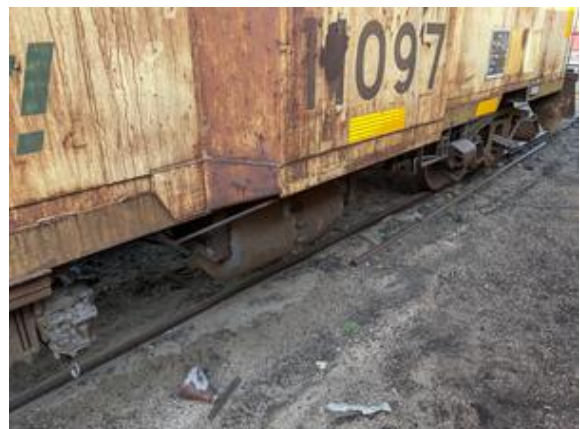
CHE-CNW11097-140721-004L, 2.1% Lead, Black

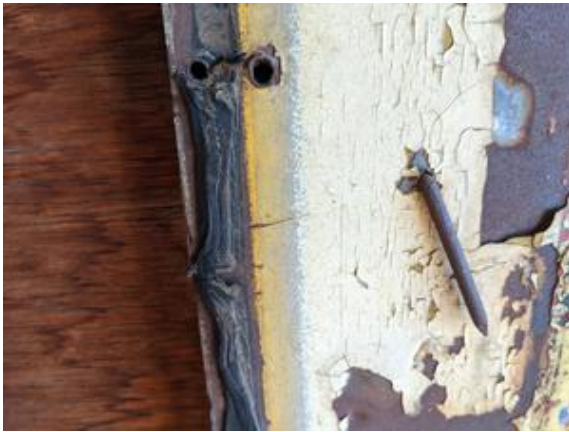
CHE-CNW11111-150721-010 thru 012, Asbestos Not Detected, Gray caulk

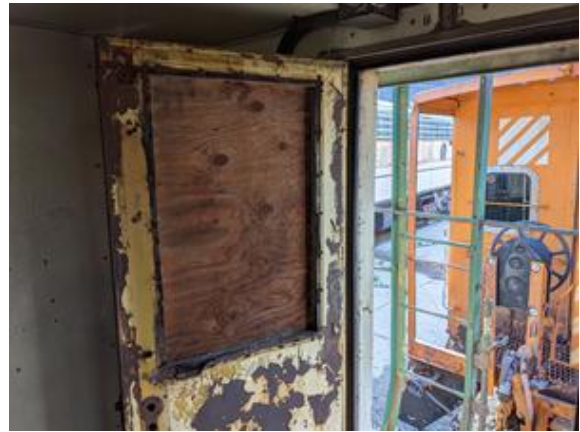
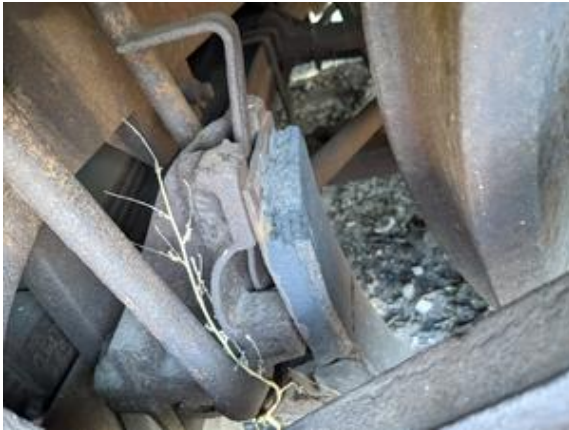
CHE-CNW11111-150721-010 thru 012, Asbestos Not Detected, Gray caulk

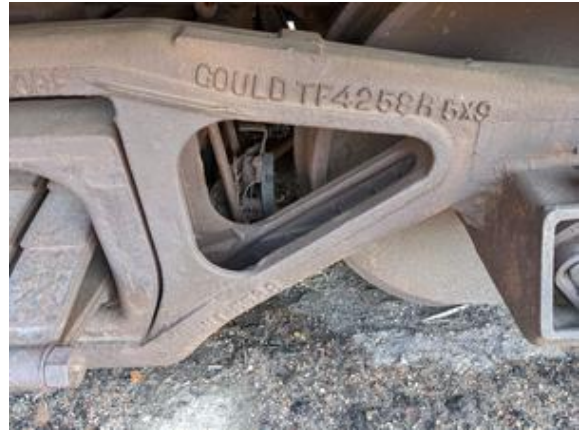
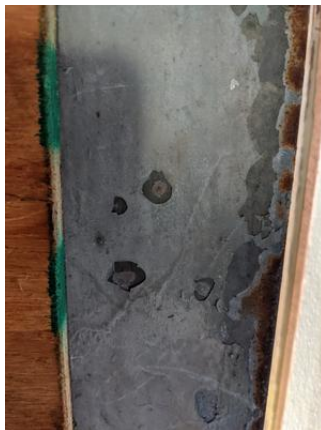
CHE-CNW11111-150721-013 thru 015, Asbestos Not Detected, Black brake pads

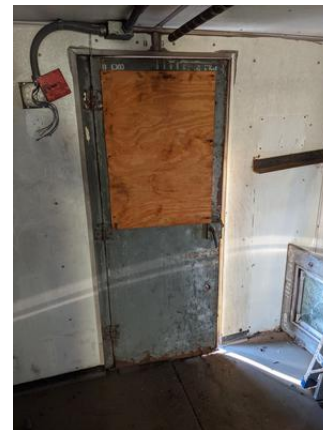
CHE-CNW11111-150721-001L, 0.51% Lead, Gray

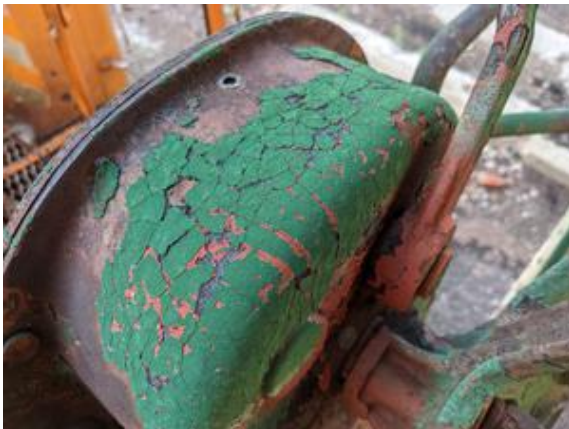
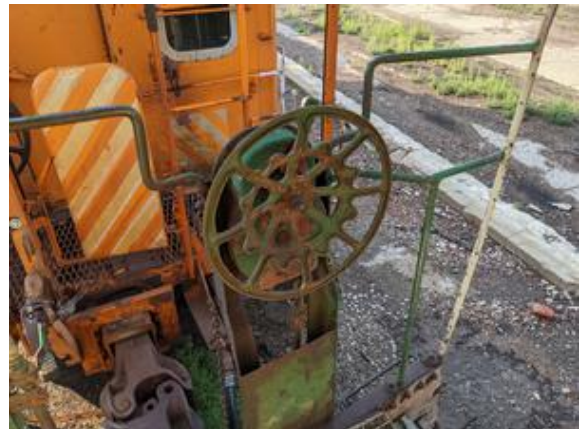
CHE-CNW11111-150721-003L, 0.27% Lead, Green

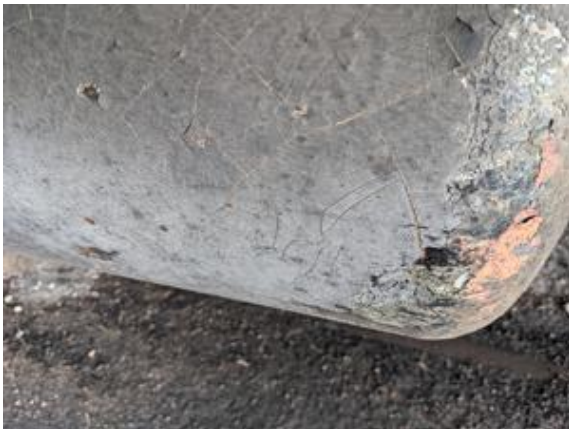
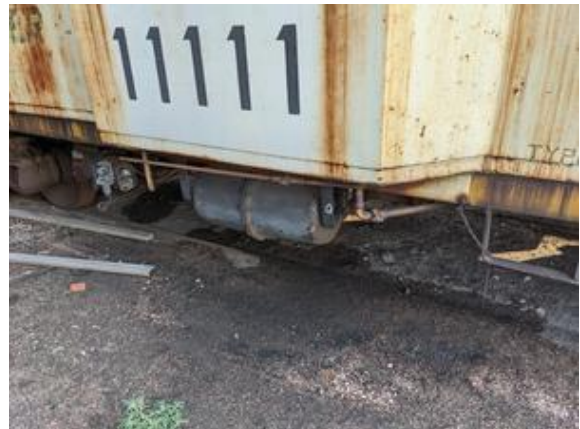
CHE-CNW11111-150721-004L, 0.54% Lead, Black

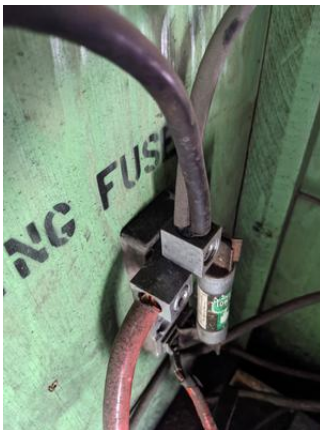
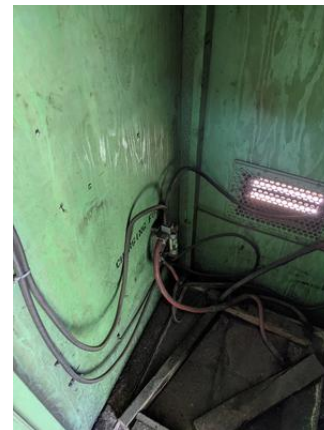
CHE-DRGW01476-170721-007 thru 009, Asbestos Not Detected, Gray bakelite

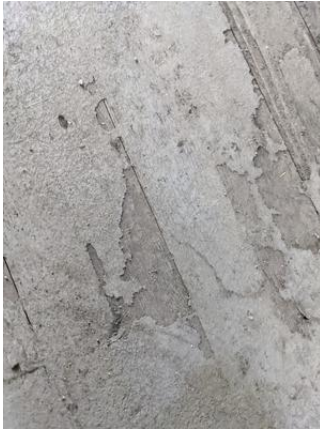
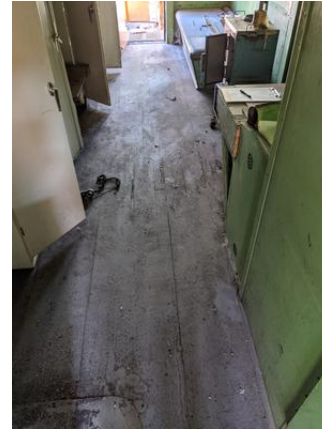
CHE-DRGW01476-170721-010 thru 012, Asbestos Not Detected, Black flooring and gray mastic

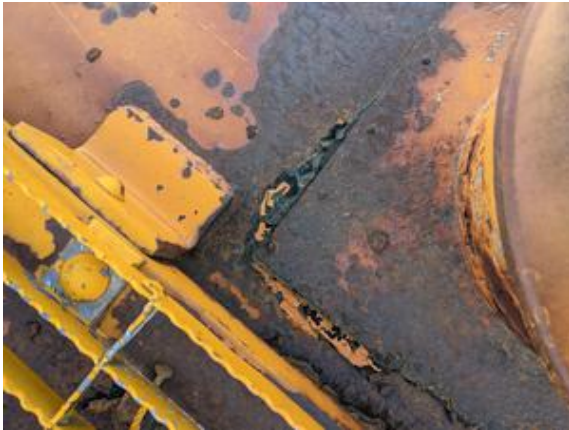
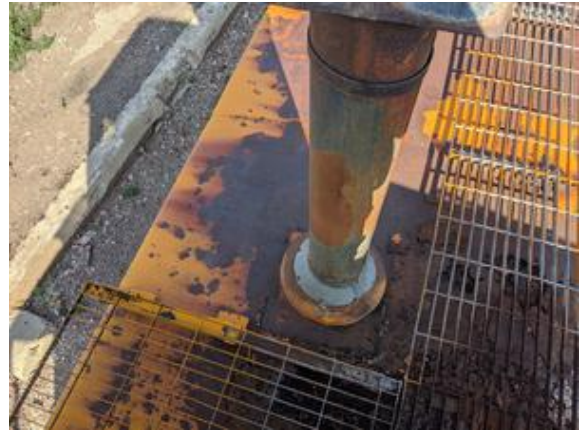
CHE-DRGW01476-170721-013 thru 015, 6% Asbestos, Black tar

Asset Number	D&RGW 01476	D&RGW 01476
Exposure Area	Exterior window frames☐	Roof penetrations☐
Asbestos Containing Material	Gray/black window caulk☐	Black tar☐
Sample Number	CHE-DRGW01476-170721-001 thru 003☐	CHE-DRGW01476-170721-013 thru 015☐
Size	NA	NA
Quantity	30 LF	2 SF
	2	2
MATERIAL CONDITION (MC) 0 =No damage, excellent condition 1 =Very minor damage, no visible debris 2 =Damage is evident, small area 3 =Damage is easily seen, some debris 4 =Damage is widespread, debris is common 5 =Most or all material is damaged, hanging, and / or found as debris throughout the area	1	1
BUILDING AGE (BA) 1 =>30 years old 0 =15 - 30 years old -1 =<15 years old		
MATERIAL TYPE Pipe Covering (PC) 1 =MAG/CAL Silicate -1 =Air Cell / paper Ceiling Plasters or Fireproofing (CP) -1 =Cementitious (Monocoat) 0 =Standard 1 ="Cotton Candy" texture	NA	NA
WATER DAMAGE (WD) 0 =No water damage 1 =Small amount of damage can be seen; damage is localized rather than widespread 2 =Good deal of water damage; widespread	0	0

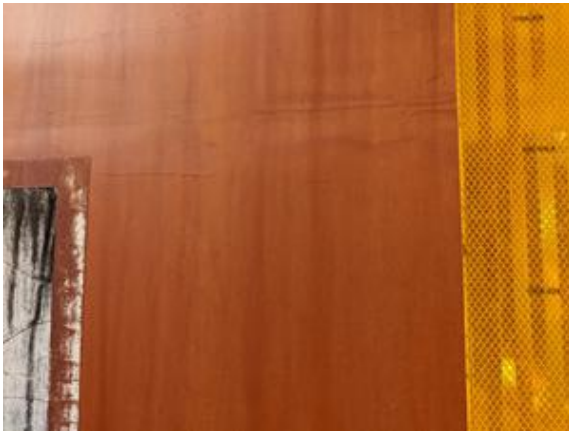
CHE-DRGW01476-170721-002L, 6.4% Lead, Orange

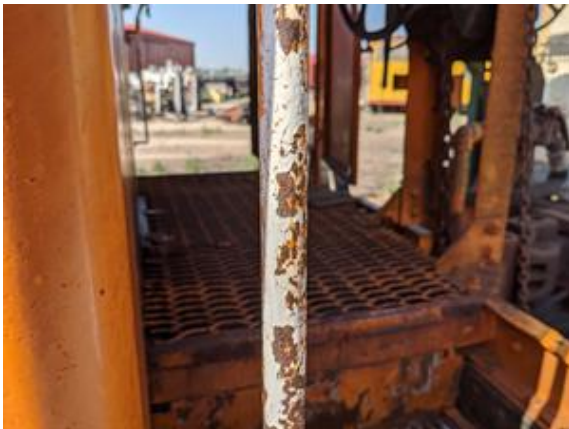
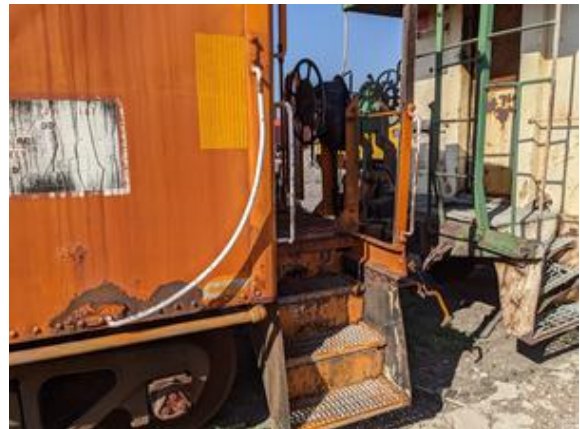
CHE-DRGW01476-170721-003L, 3% Lead, White

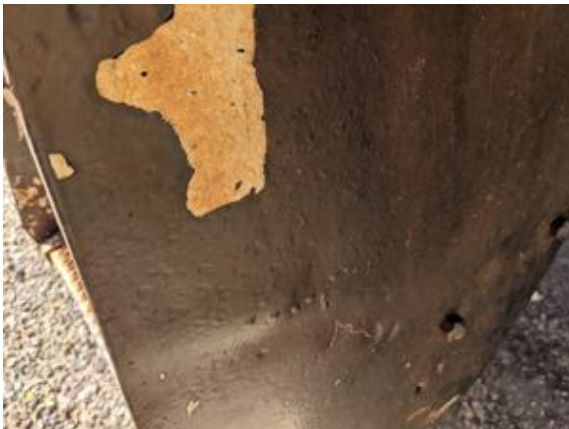
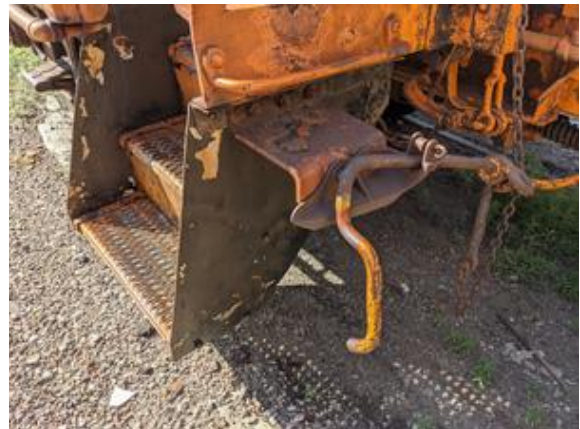
CHE-DRGW01476-170721-004L, 0.098% Lead, Black

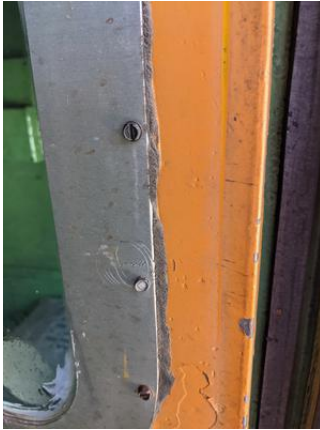
CHE-DRGW01476-170721-001P, PCB Not Detected,
Gray/black window caulk

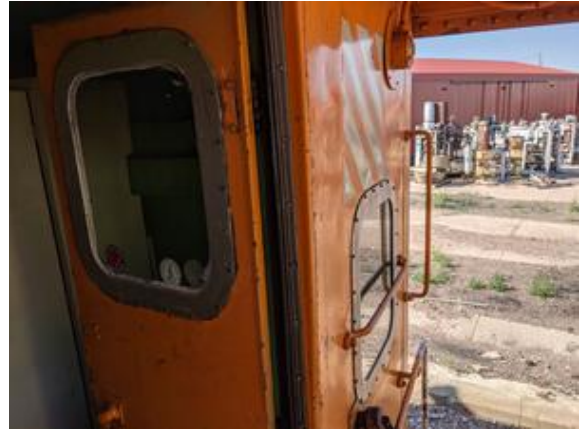
CHE-DRGW01476-170721-001P, PCB Not Detected,
Gray/black window caulk

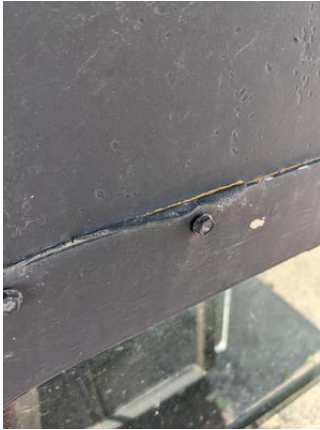
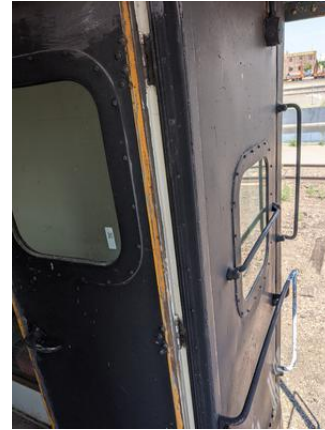
CHE-DRGW01481-160721-001 thru 003, Asbestos Not Detected, Black/brown window caulk

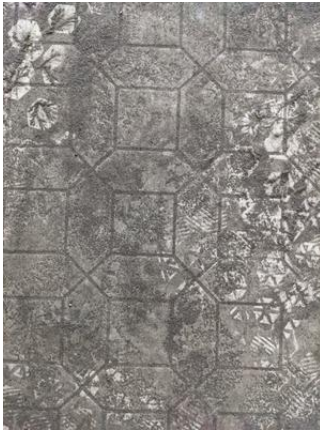
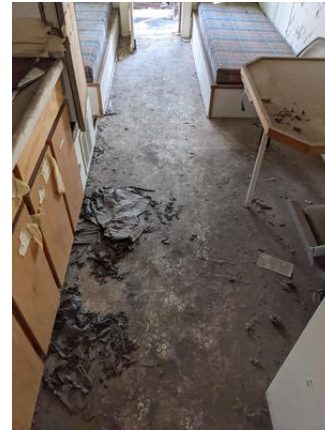
CHE-DRGW01481-160721-004 thru 006, Asbestos Not Detected, White sheet flooring and yellow mastic

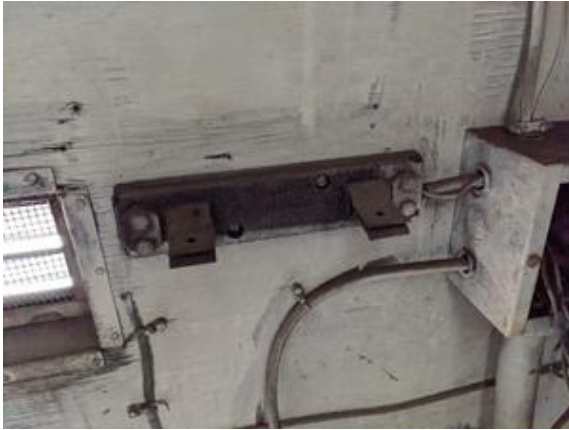
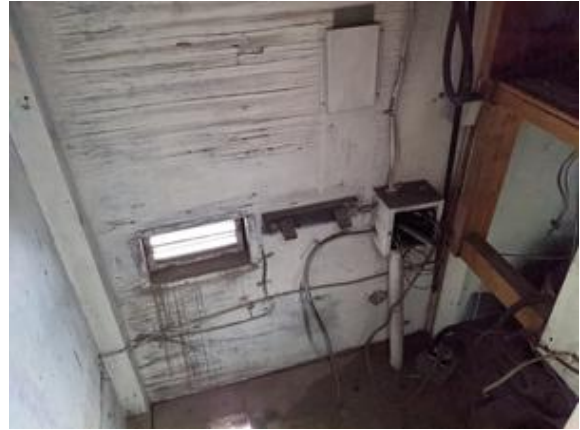
CHE-DRGW01481-160721-010 thru 012, 6% Asbestos, Black Bakelite

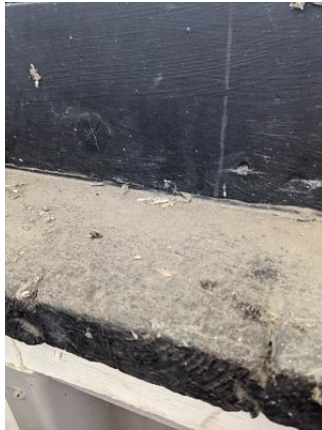
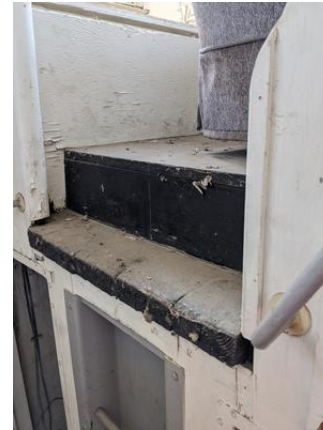
CHE-DRGW01481-160721-013 thru 015, Asbestos Not Detected, Black mastic

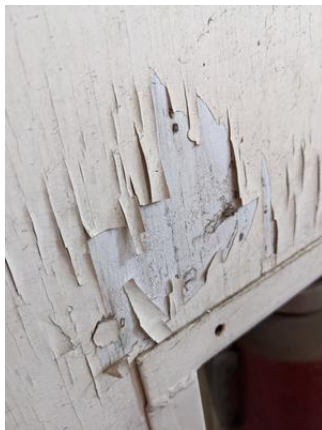
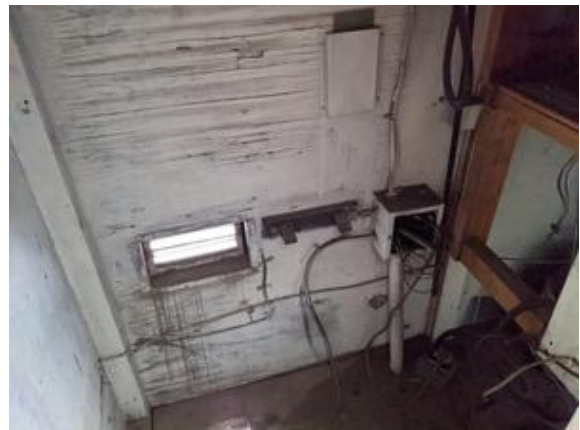
CHE-DRGW01481-160721-001L, <0.005% Lead, White

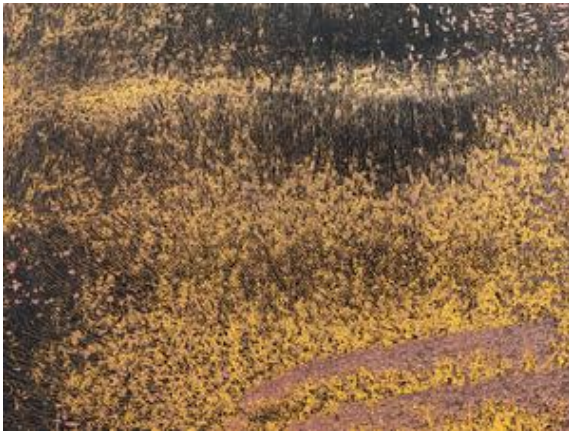
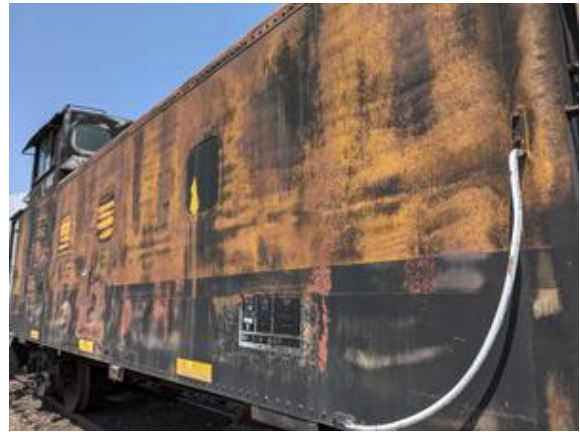
CHE-DRGW01481-160721-002L, 7.9% Lead, Yellow

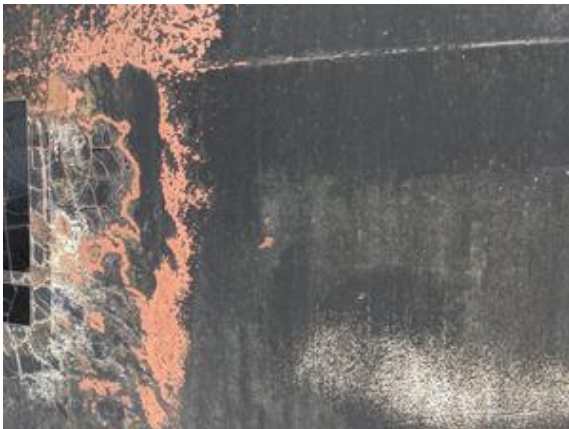
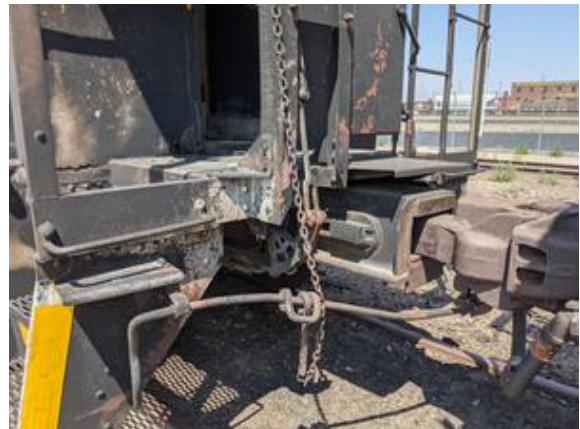
CHE-DRGW01481-160721-003L, 0.067% Lead, Black

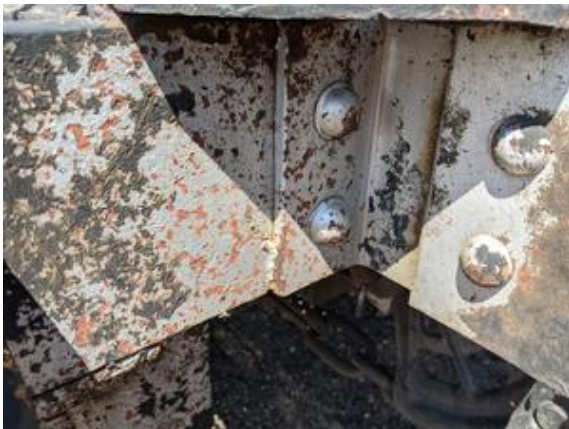
CHE-DRGW01481-160721-004L, 3.9% Lead, Silver

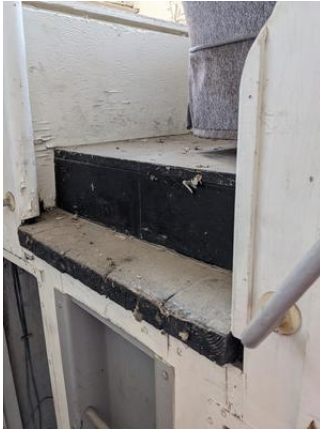
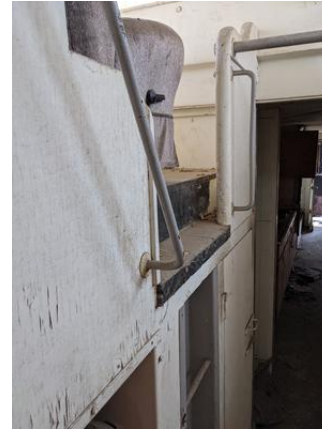
CHE-DRGW01481-160721-005L, 0.19% Lead, Gray

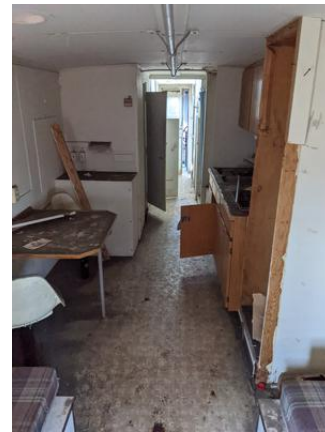
View of interior

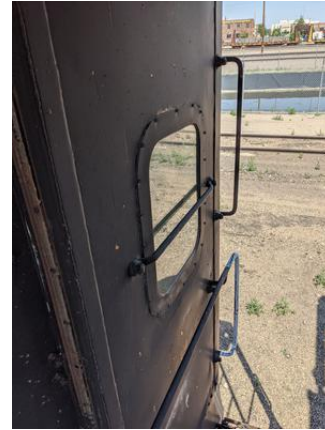
CHE-DRGW01486-160721-001 thru 003, Asbestos Not Detected, Black window caulk

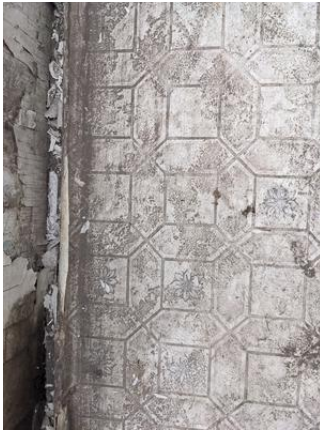
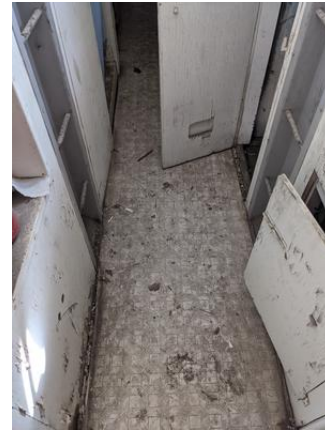
CHE-DRGW01486-160721-004 thru 006, Asbestos Not Detected, White sheet flooring and yellow mastic

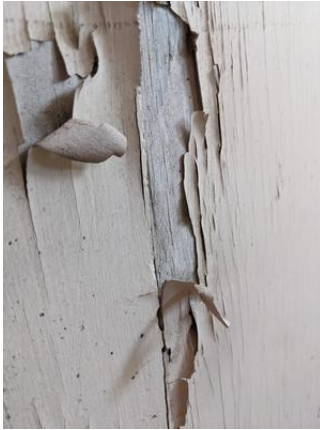
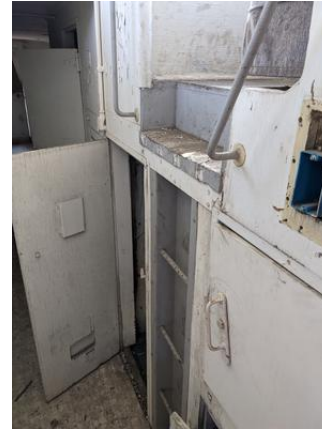
CHE-DRGW01486-160721-001L, <0.005% Lead, White

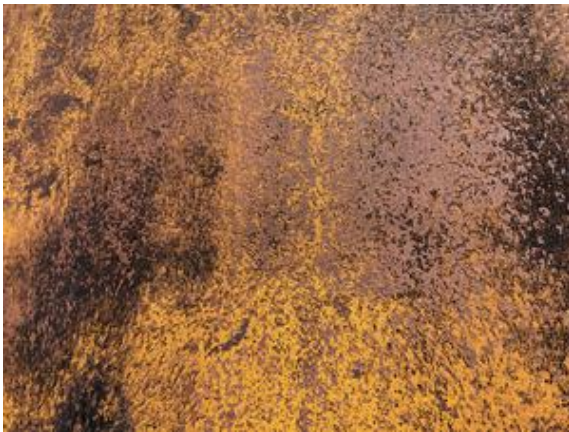
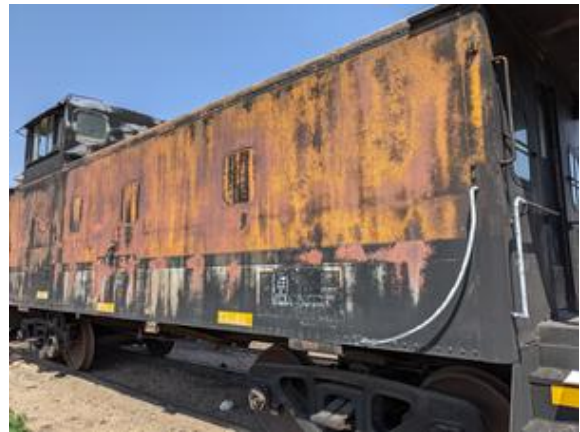
CHE-DRGW01486-160721-002L, 5.7% Lead, Yellow

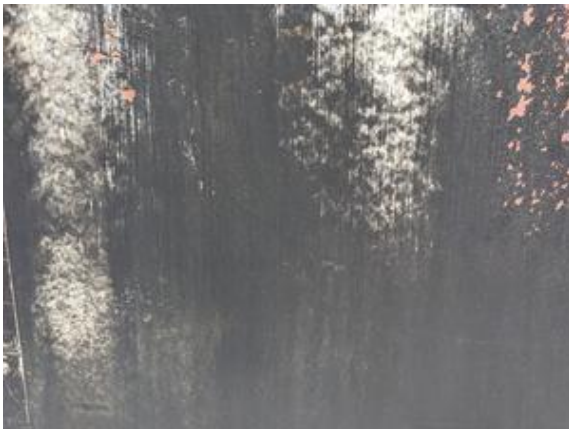
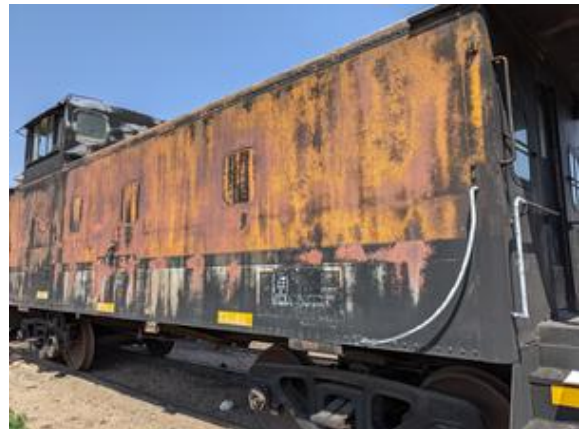
CHE-DRGW01486-160721-003L, 1.9% Lead, Black

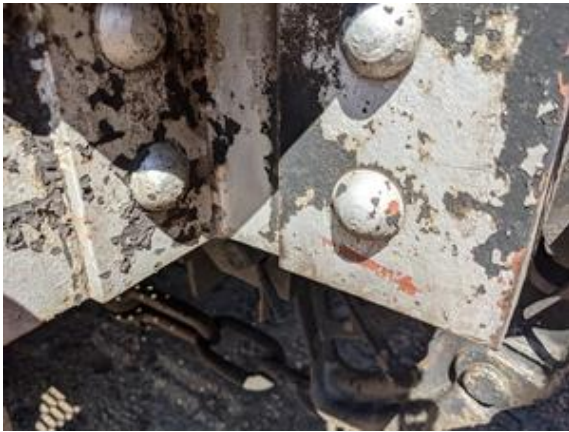
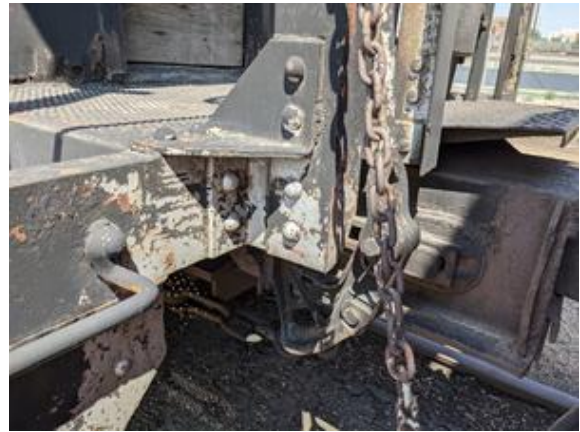
CHE-DRGW01486-160721-004L, 0.17% Lead, Silver

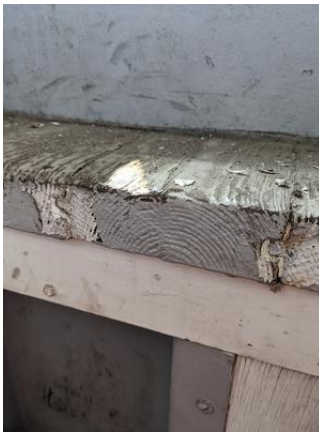
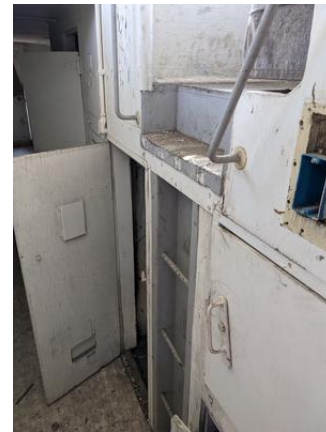
CHE-DRGW01486-160721-005L, 0.0086% Lead, Gray

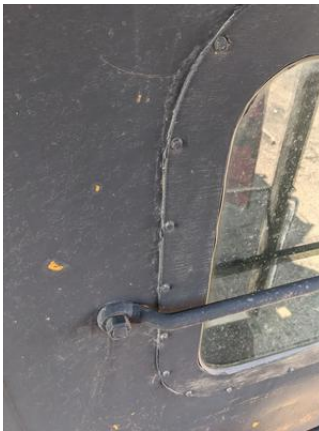
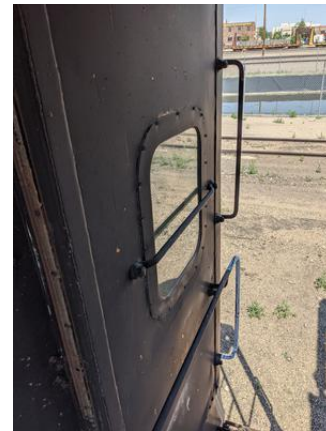
CHE-DRGW01486-160721-001P, PCB Not Detected,
Black window caulk

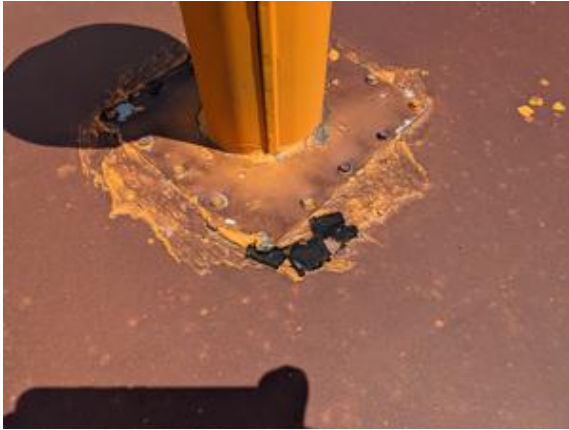
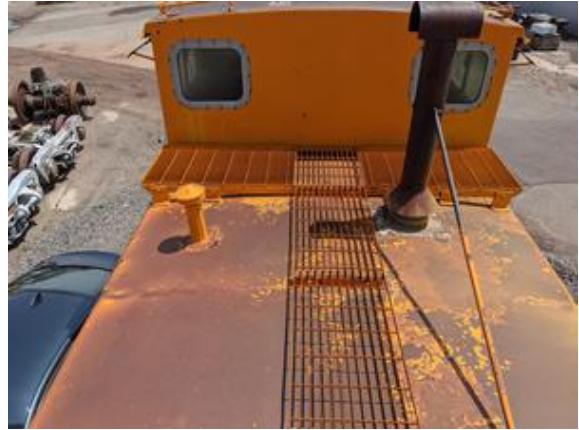
CHE-DRGW01489-150721-010 thru 012, Asbestos Not Detected, Black tar

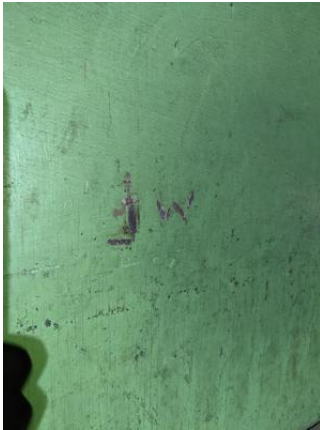
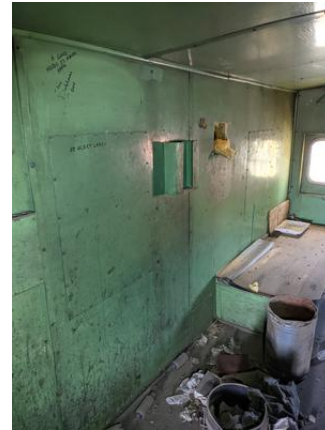
CHE-DRGW01489-150721-001L, 7% Lead, Green

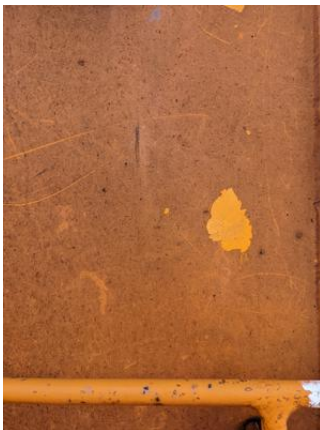
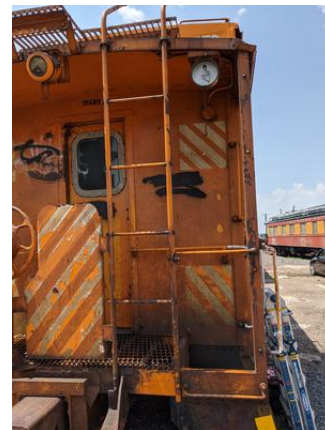
CHE-DRGW01489-150721-002L, 13% Lead, "Old" Orange

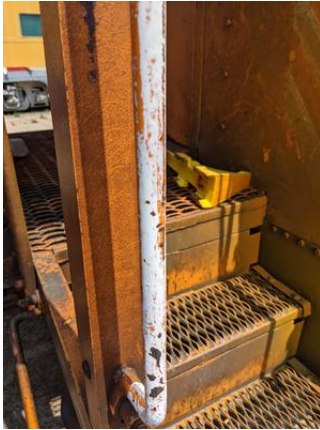
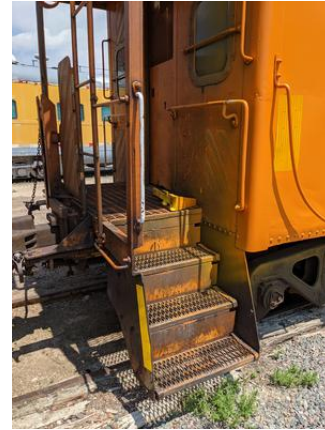
CHE-DRGW01489-150721-003L, 7.6% Lead, White

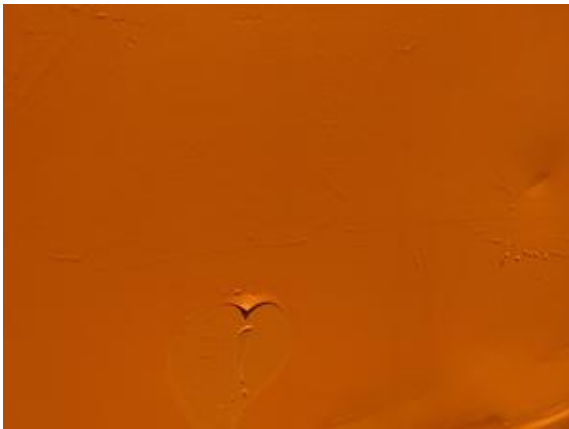
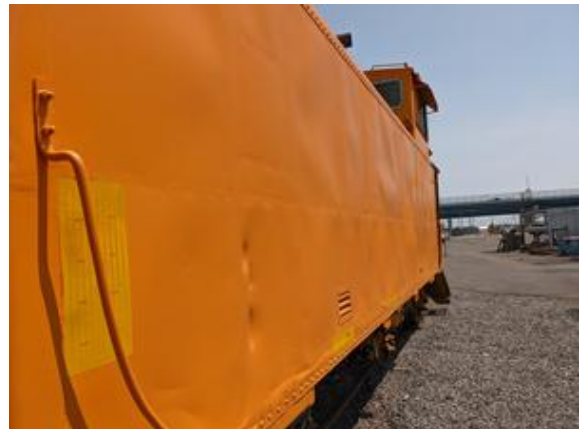
CHE-DRGW01489-150721-004L, <0.005% Lead, "New" Orange

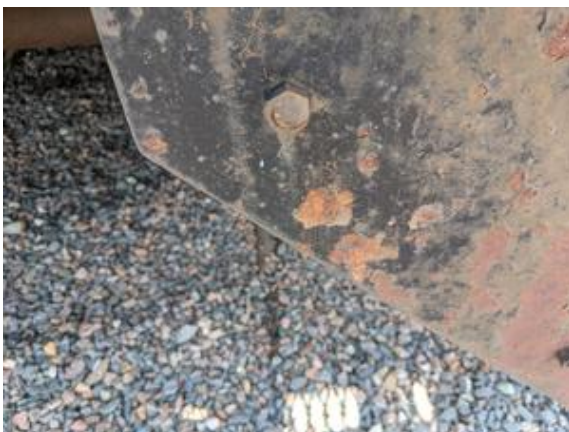
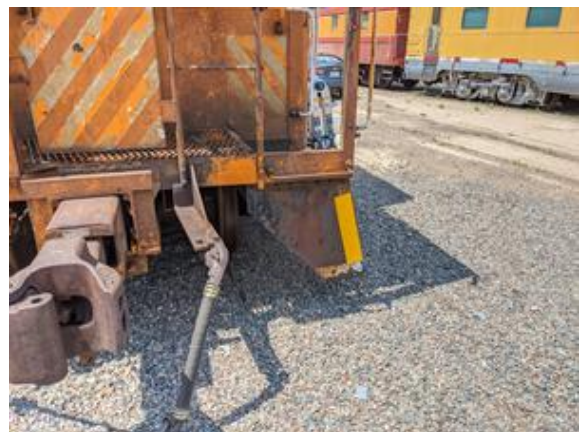
CHE-DRGW01489-150721-005L, 6.6% Lead, Black

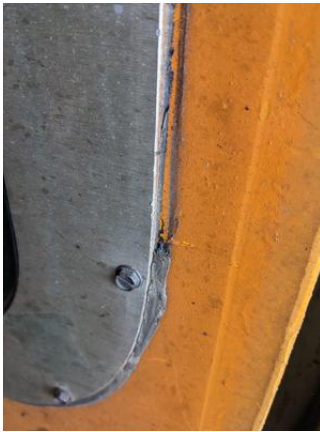
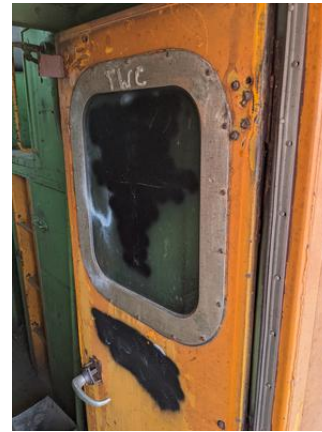
CHE-DRGW01489-150721-001P, PCB Not Detected,
Black window caulk

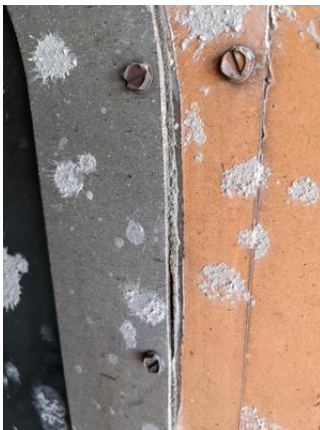
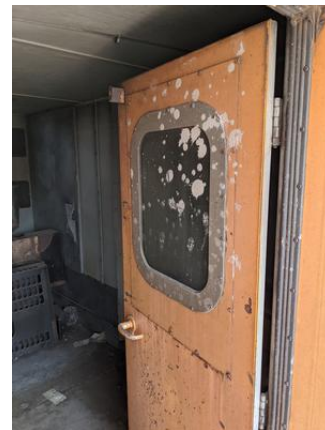
CHE-DRGW01524-170721-007 thru 009, 2% Asbestos, Black caulk

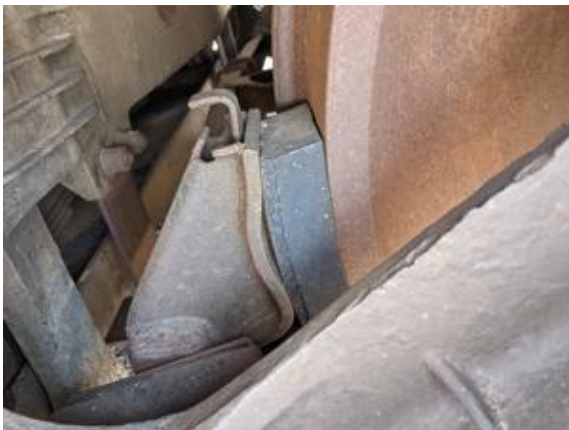
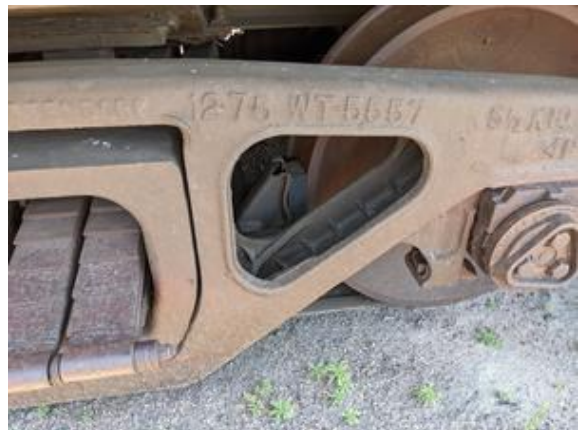
CHE-DRGW01524-170721-016 thru 018, Asbestos Not Detected, Black brake pads

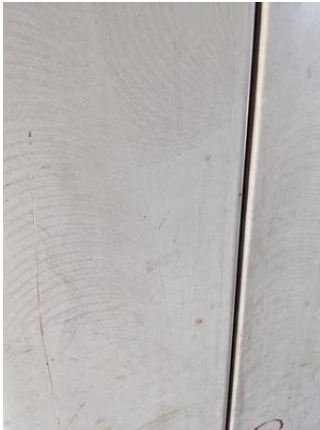
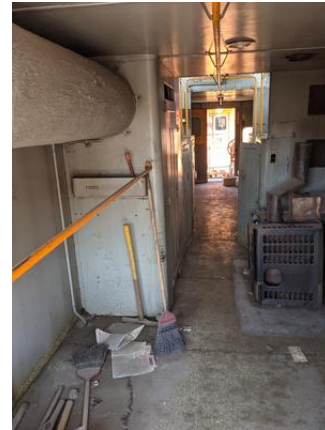
CHE-DRGW01524-170721-001L, 0.13% Lead, Gray

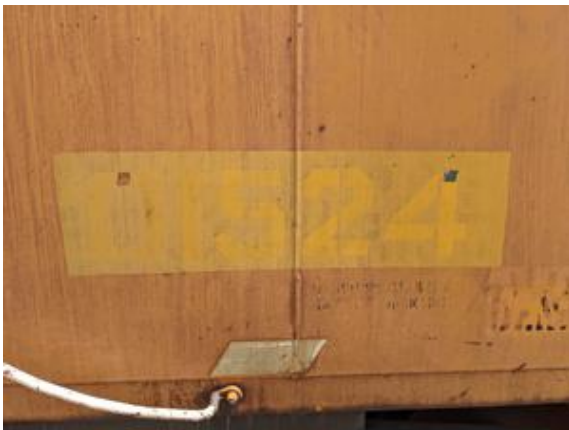
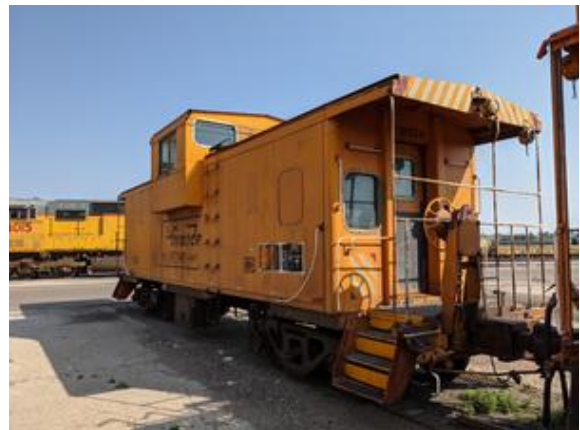
CHE-DRGW01524-170721-002L, 12% Lead, Yellow

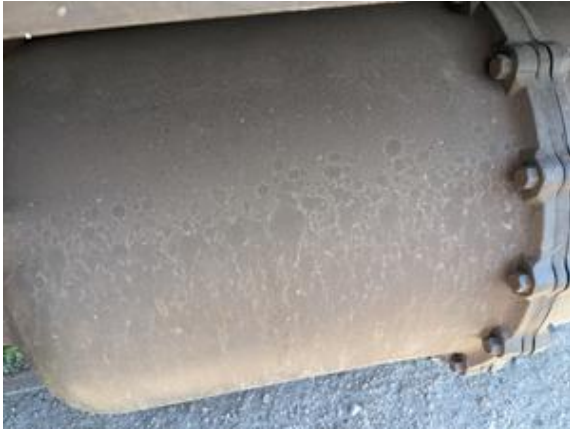
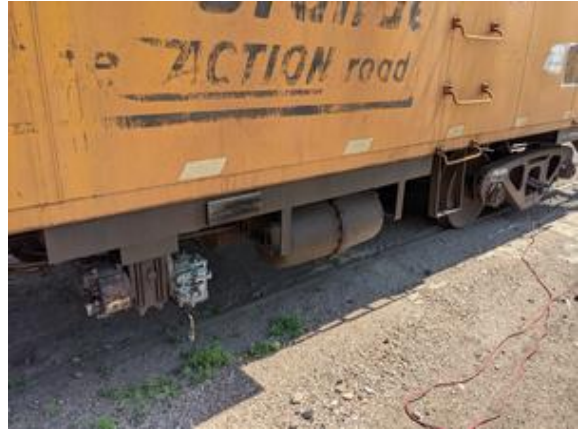
CHE-DRGW01524-170721-003L, 0.083% Lead, Black

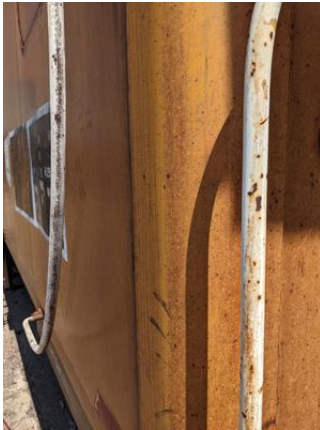
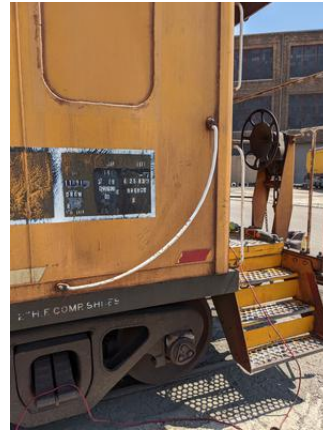
CHE-DRGW01524-170721-004L, 0.25% Lead, White

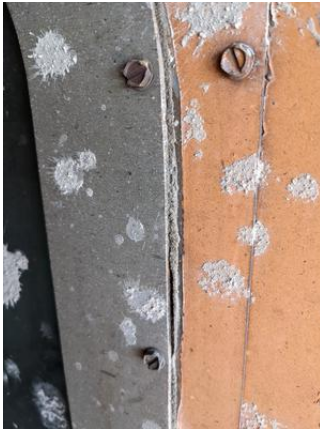
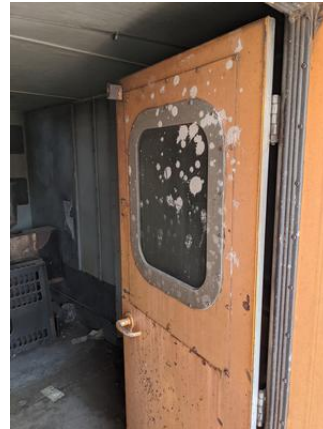
CHE-DRGW01524-170721-001P, PCB Not Detected,
Black caulk

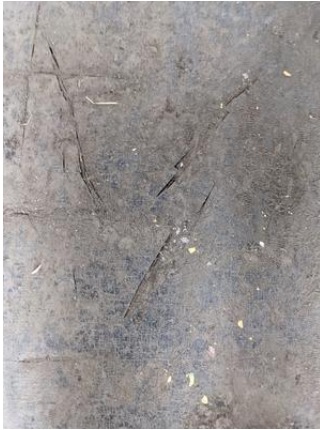
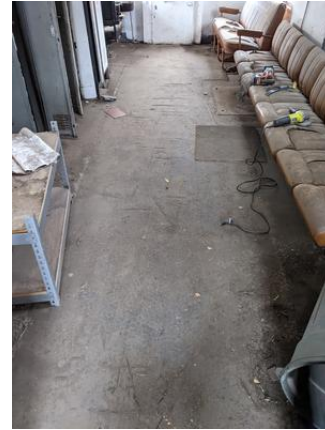
CHE-FTSX812-140721-001 thru 003, Asbestos Not Detected, Black rubberized flooring and clear mastic

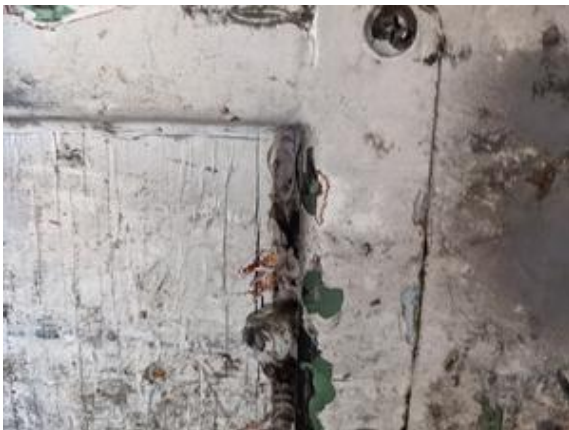
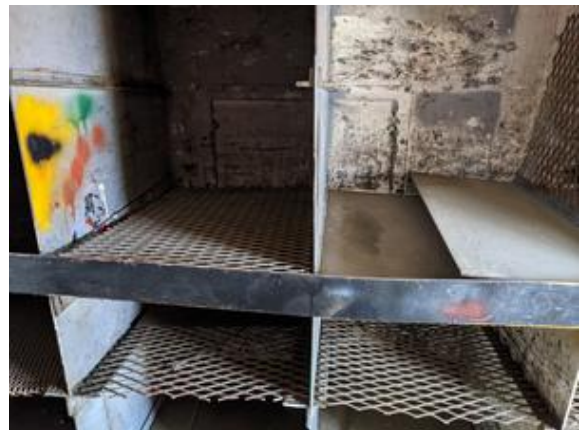
CHE-FTSX812-140721-007 thru 009, Asbestos Not Detected, White sealant

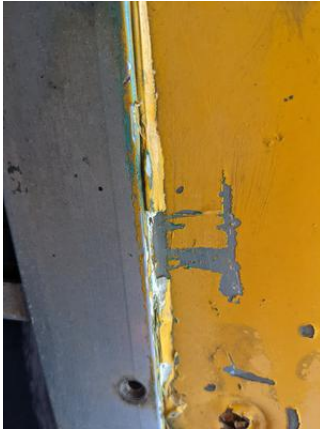
CHE-FTSX812-140721-010 thru 012, Asbestos Not Detected, White sealant

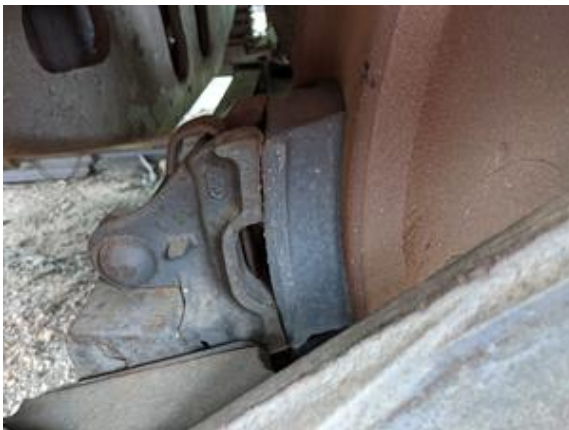
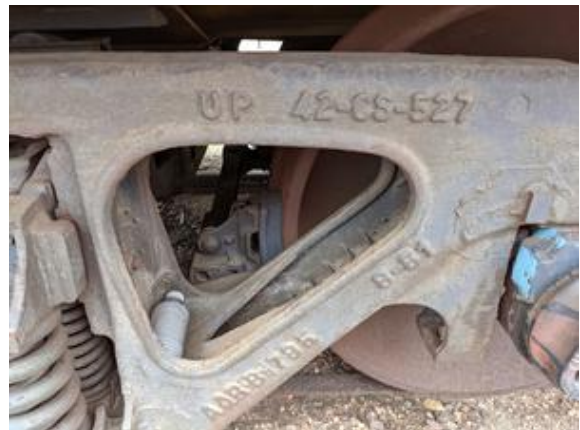
CHE-FTSX812-140721-016 thru 018, Asbestos Not Detected, Black break pads

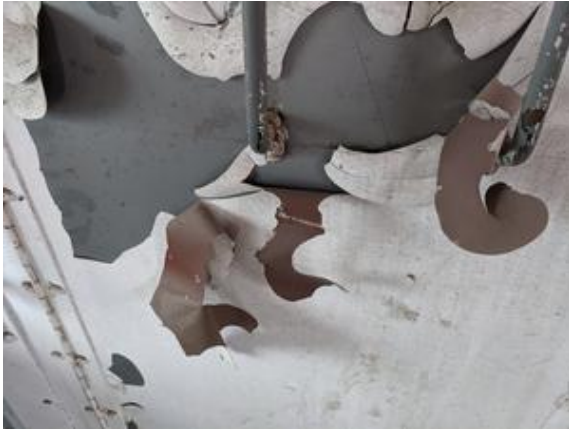
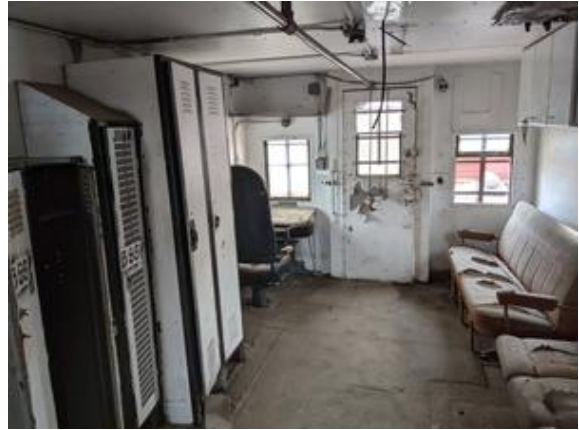
CHE-FTSX812-140721-001L, 1.6% Lead, White

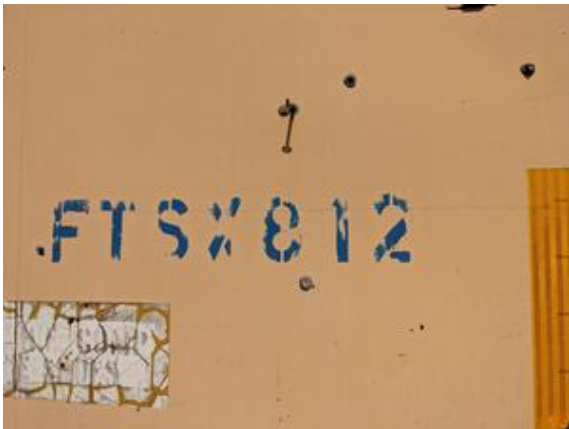
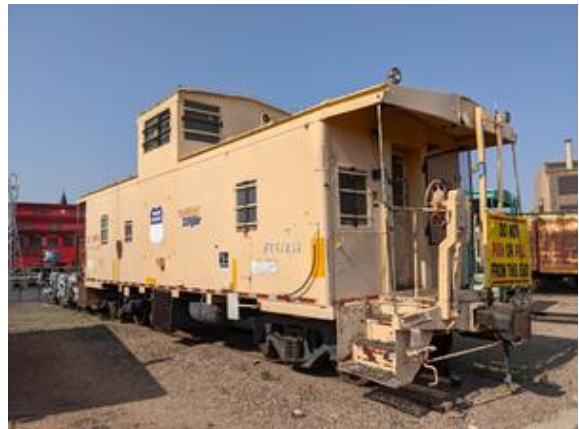
CHE-FTSX812-140721-002L, 6.8% Lead, Yellow
