**RE: Cheyenne, Wyoming 15 UPRR Railcars
Hazardous Material Inspection Summary Letter Report
Earth Services & Abatement Project Number: DENP000352**

HAZARDOUS MATERIAL INSPECTION SUMMARY LETTER REPORT

15 UPRR RAILCARS CHEYENNE, WYOMING

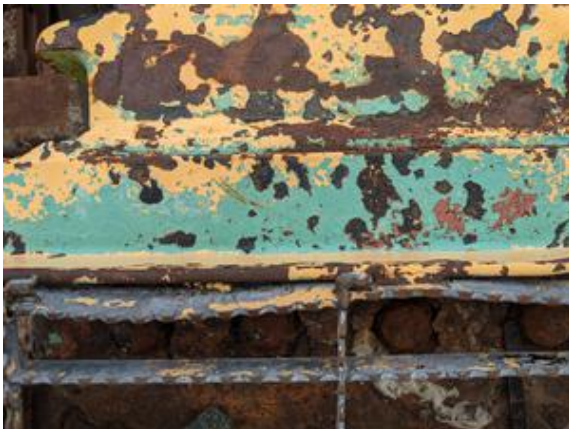
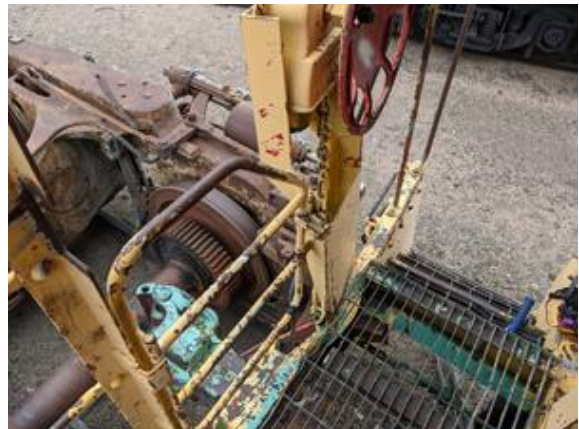
CHE-FTSX812-140721-003L, 0.63% Lead, Green/Red/Black (layered)

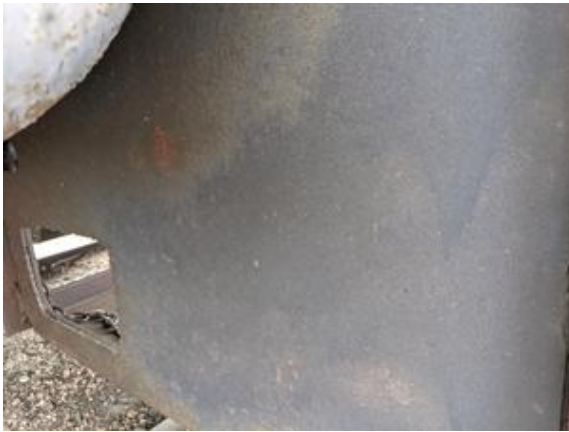
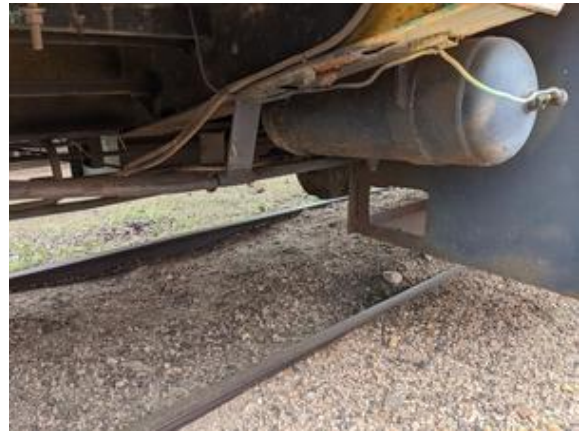
CHE-FTSX812-140721-004L, 0.29% Lead, Black

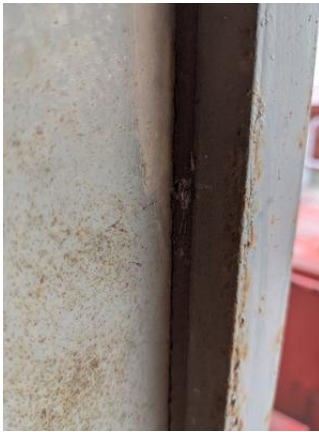
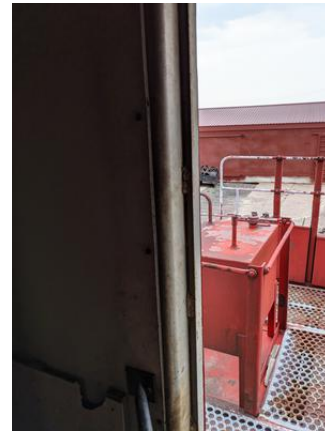
CHE-MP13835-130721-019 thru 021, 4.8% Asbestos, Gray door sealant

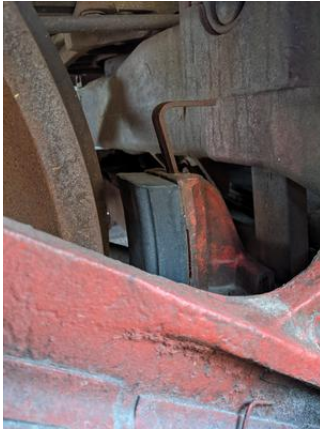
CHE-MP13835-130721-028 thru 030, Asbestos Not Detected, Black brake pads

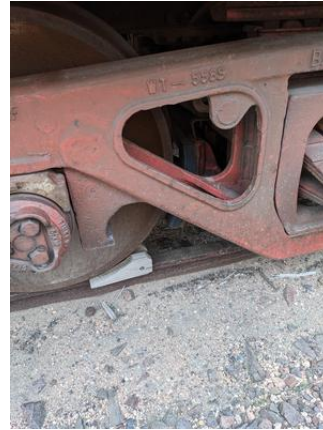
CHE-MP13835-130721-028 thru 030, Asbestos Not Detected, Black brake pads

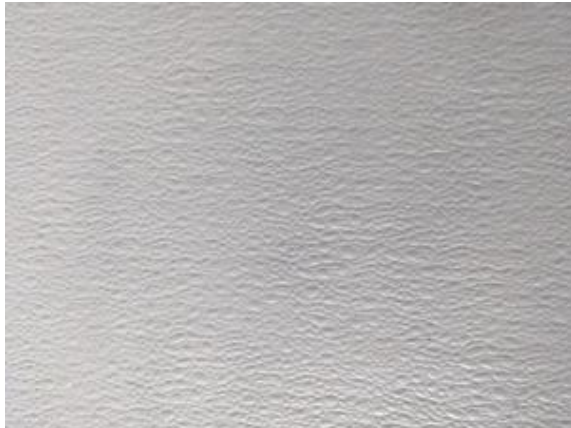
CHE-MP13835-130721-001L, 0.036% Lead, Gray

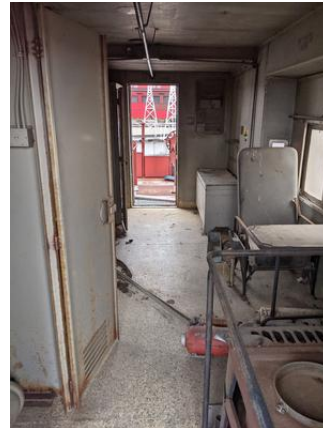
CHE-MP13835-130721-001L, 0.036% Lead, Gray

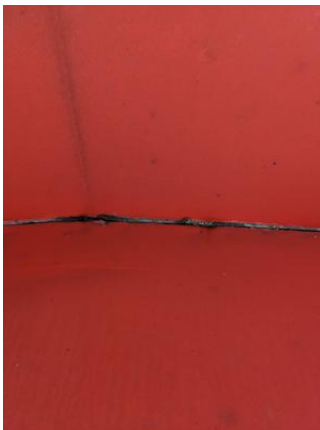
CHE-MP13835-130721-002L, 3.8% Lead, Red

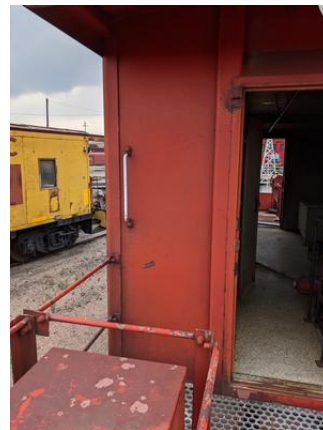
CHE-MP13835-130721-002L, 3.8% Lead, Red

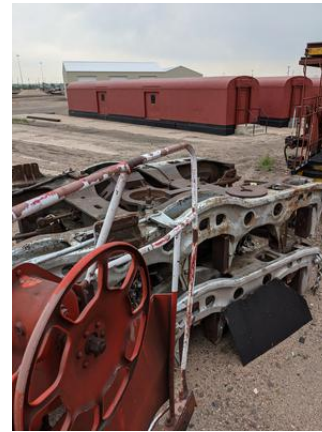
CHE-MP13835-130721-003L, 2.9% Lead, White

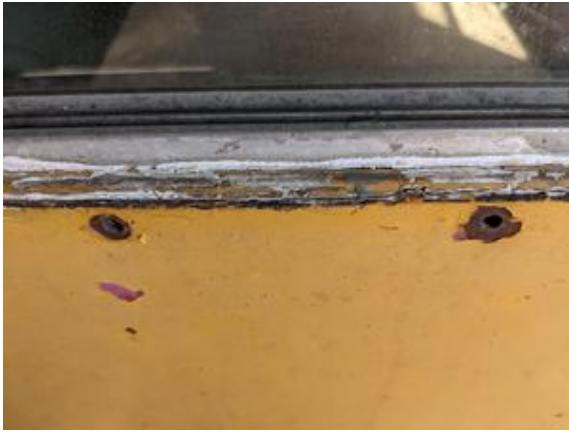
CHE-RI17017-150721-001 thru 003, Asbestos Not Detected, Silver coating

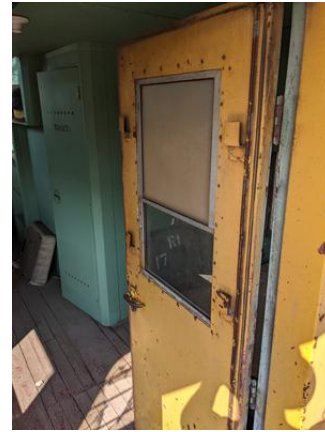
CHE-RI17017-150721-001 thru 003, Asbestos Not Detected, Silver coating

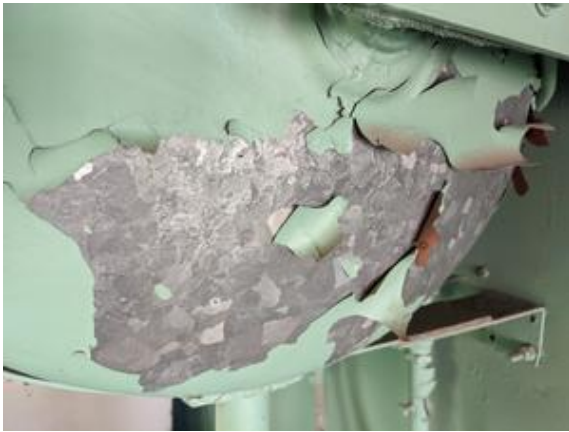
CHE-RI17017-150721-001L, 1.4% Lead, Green

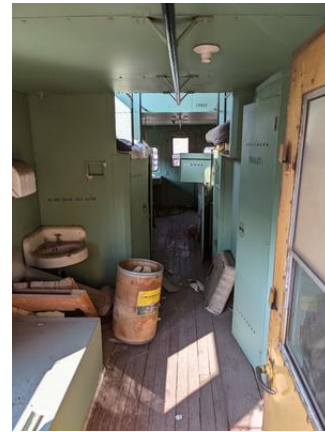
CHE-RI17017-150721-001L, 1.4% Lead, Green

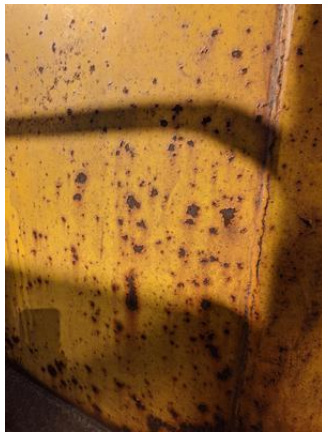
CHE-RI17017-150721-002L, 15% Lead, Yellow

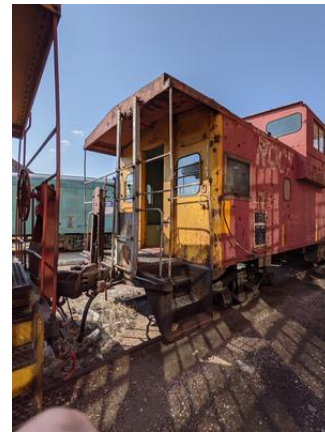
CHE-RI17017-150721-002L, 15% Lead, Yellow

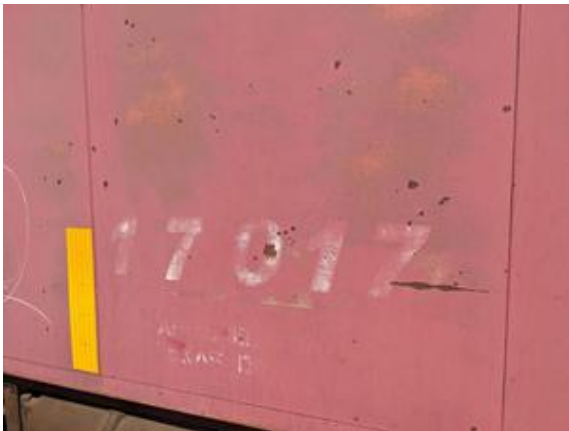
CHE-RI17017-150721-003L, 0.42% Lead, Red

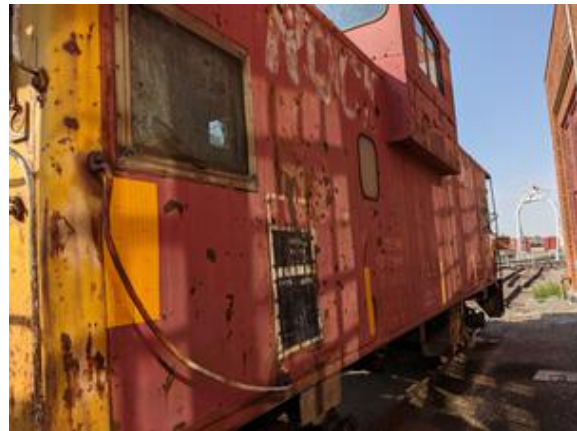
CHE-RI17017-150721-003L, 0.42% Lead, Red

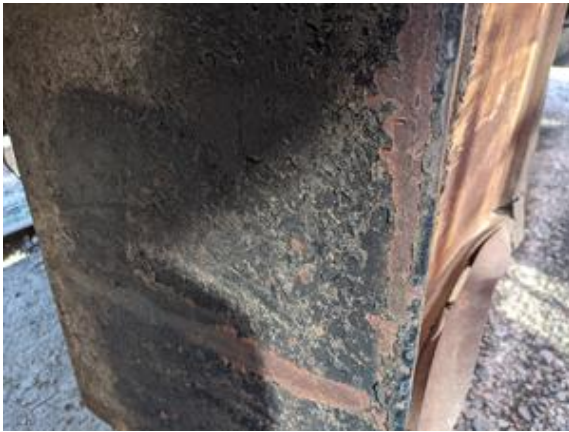
CHE-RI17017-150721-004L, 3.7% Lead, Black

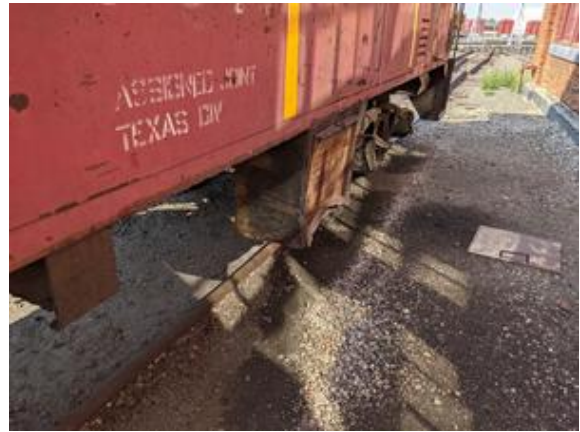
CHE-RI17017-150721-004L, 3.7% Lead, Black

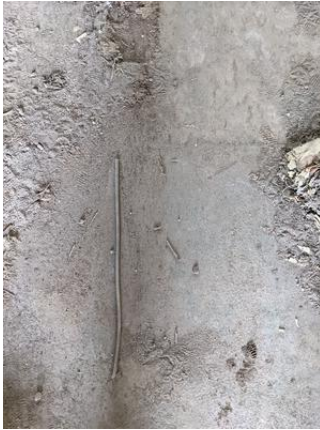
CHE-SP4641-130721-001 thru 003, Asbestos Not Detected, Green rubber flooring (no mastic)

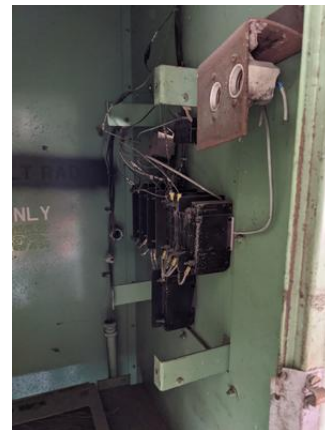
CHE-SP4641-130721-007 thru 009, Asbestos Not Detected, Black bakelite

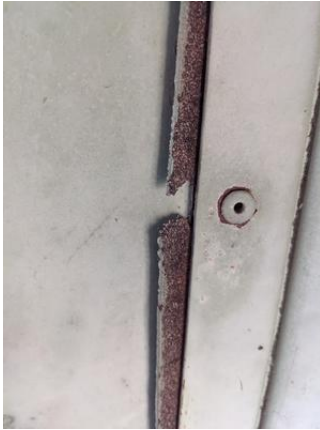
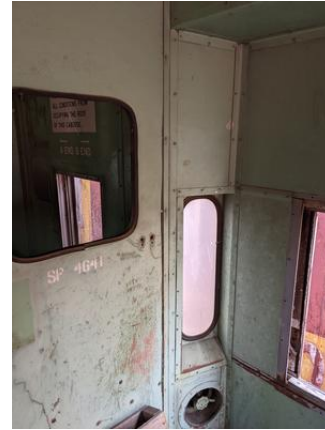
CHE-SP4641-130721-010 thru 012, Asbestos Not Detected, Black/Brown, Vibration Dampener

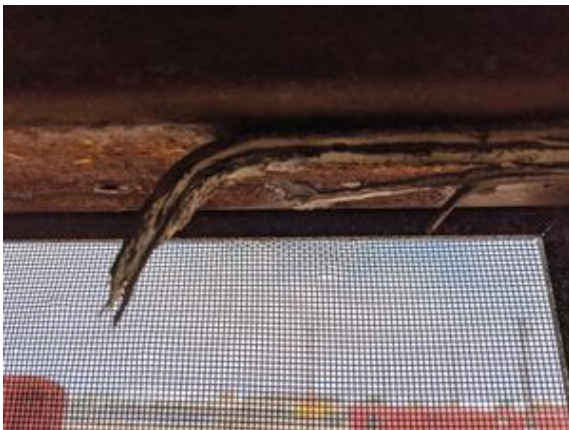
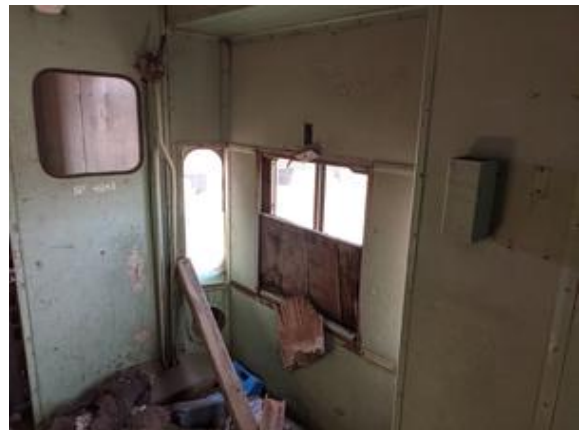
CHE-SP4641-130721-016 thru 018, 10% Asbestos, White window caulk

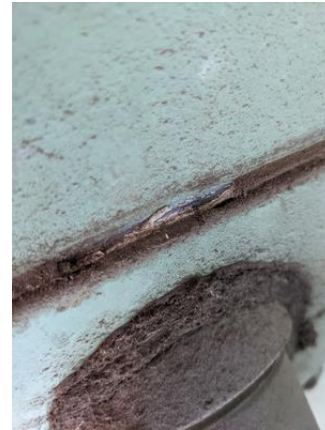
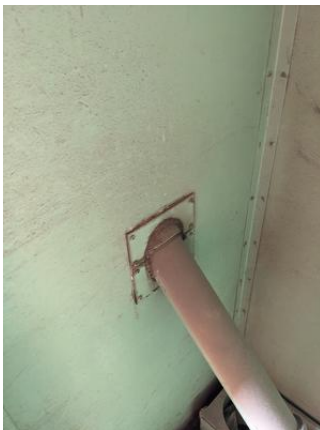
CHE-SP4641-130721-022 thru 024, 10% Asbestos, Gray oil tank sealant

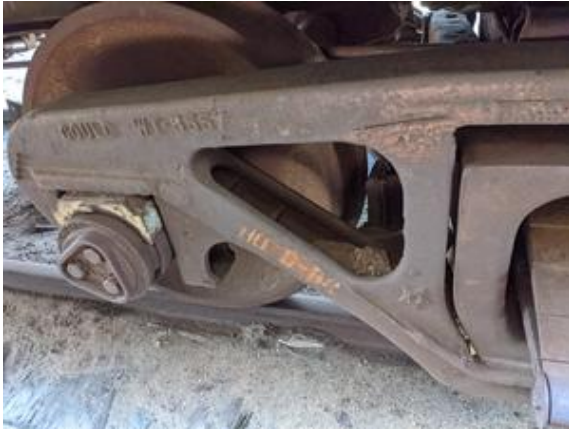
CHE-SP4641-130721-025 thru 027, Asbestos Not Detected, Black Brake Pads

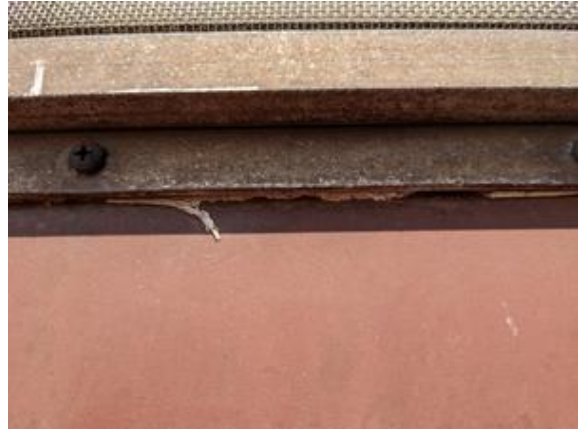
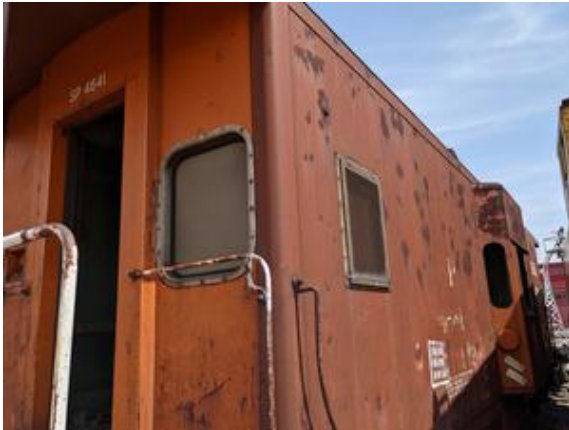
CHE-SP4641-130721-028 thru 030, 10% Asbestos, White window caulk

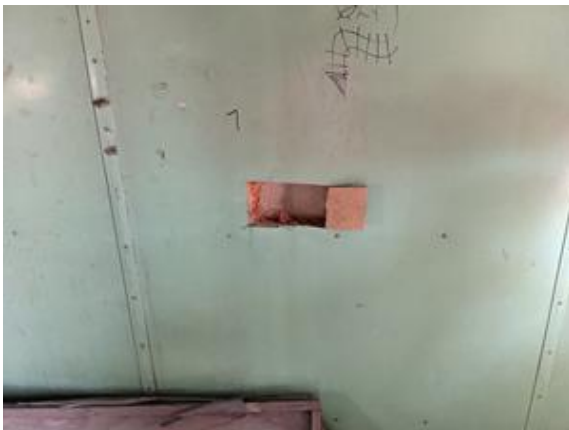
CHE-SP4641-130721-001L, 0.37% Lead, Green

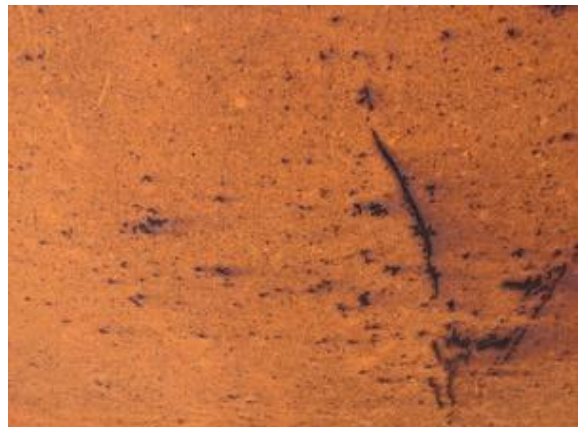
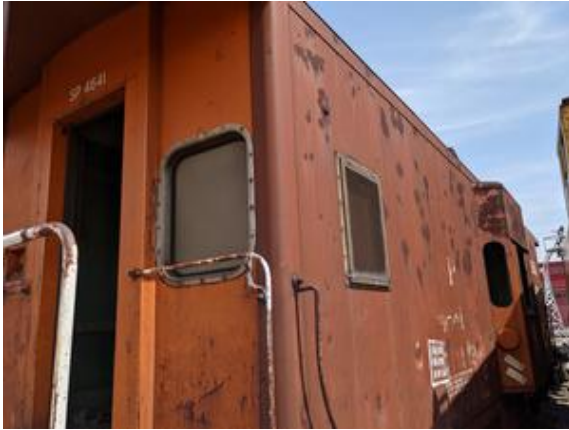
CHE-SP4641-130721-002L, 6.2% Lead, Orange

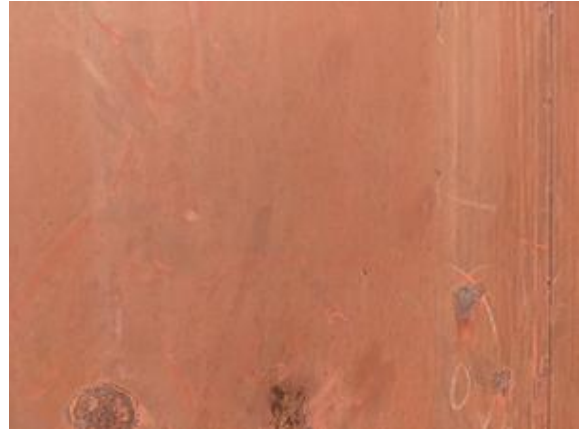
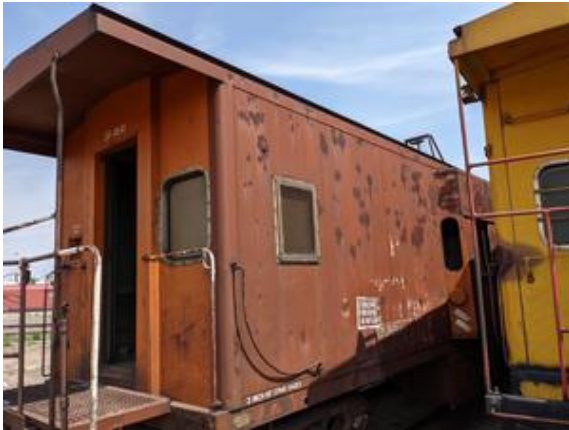
CHE-SP4641-130721-003L, 1.6% Lead, Dark Red

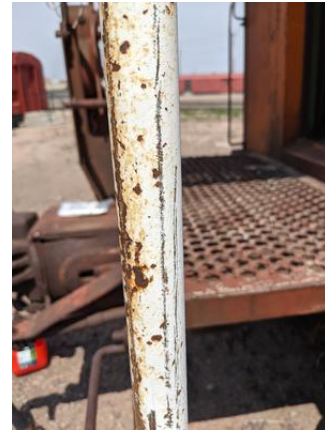
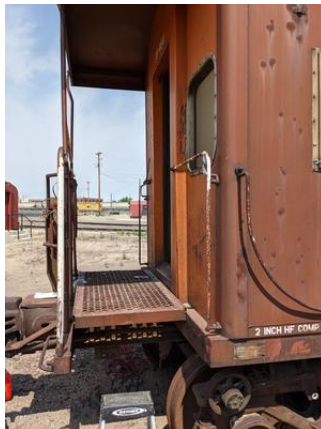
CHE-SP4641-130721-004L, 0.024% Lead, White

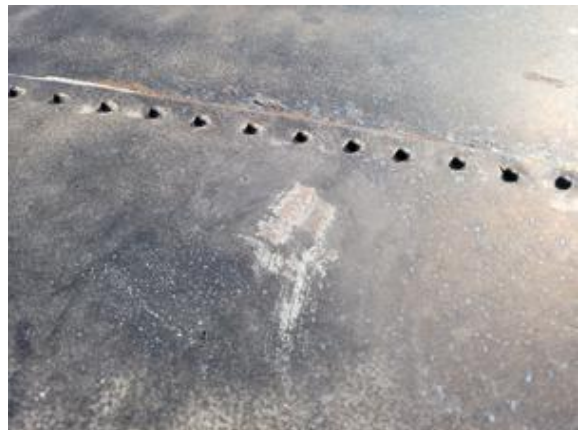
CHE-SP7077-170821-004 thru 006, Asbestos Not Detected, Clear silicone caulk

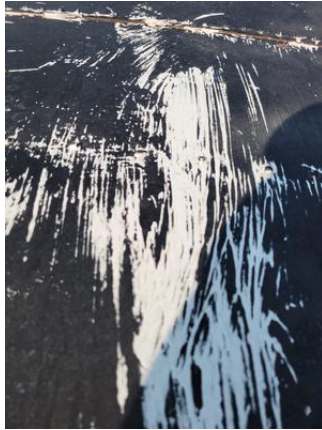
CHE-SP7077-170821-007 thru 009, Asbestos Not Detected, White sealant

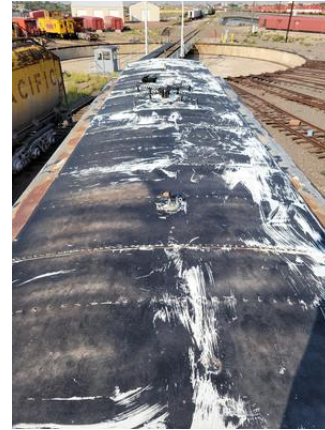
CHE-SP7077-170821-007 thru 009, Asbestos Not Detected, White sealant

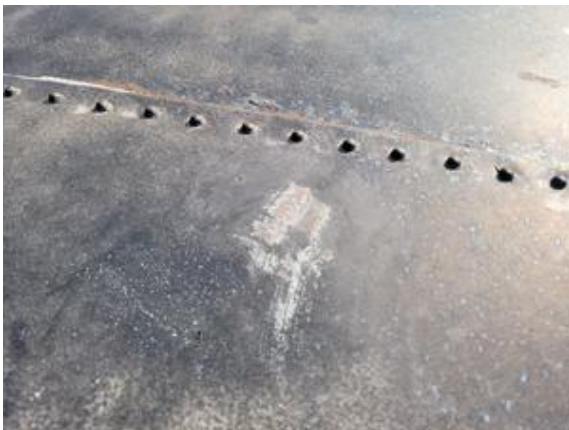
CHE-SP7077-170821-013 thru 015, Asbestos Not Detected, Thin black/gray coating

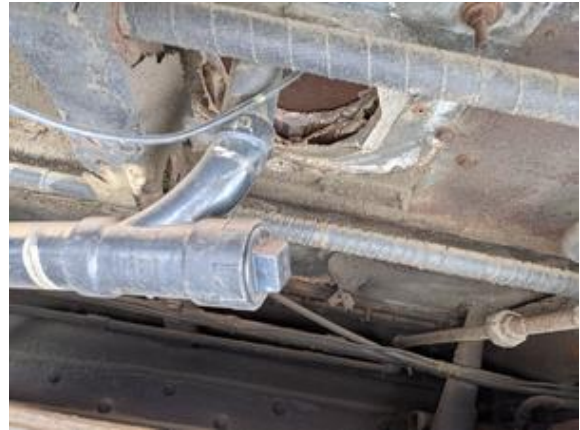
CHE-SP7077-170821-019 thru 021, 2.2% Asbestos, Gray sealant

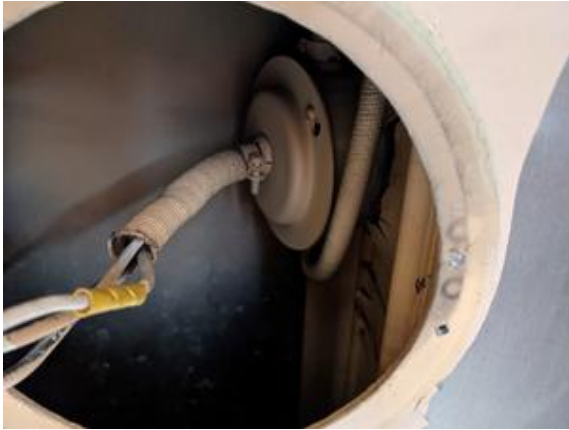
CHE-SP7077-170821-025 thru 027, Asbestos Not Detected, Black/brown electrical wire coating

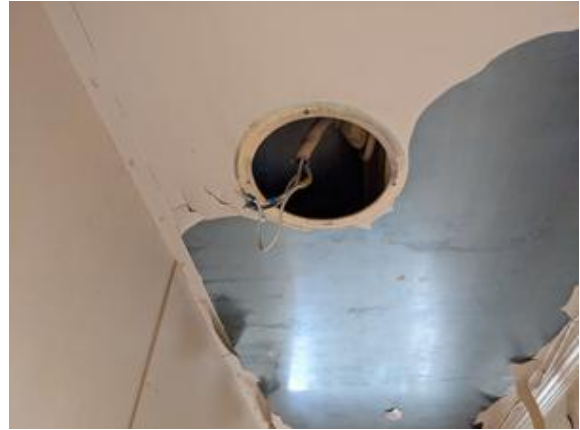
CHE-SP7077-170821-025 thru 027, Asbestos Not Detected, Black/brown electrical wire coating

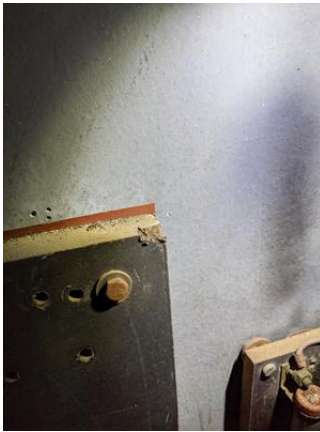
CHE-SP7077-170821-037 thru 039, 20% Asbestos, Gray fireboard

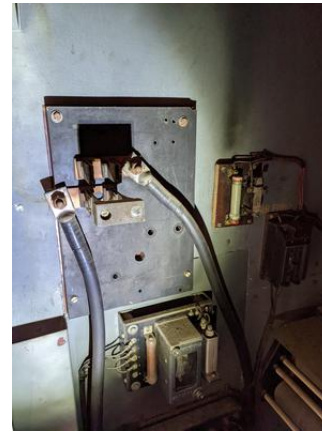
CHE-SP7077-170821-037 thru 039, 20% Asbestos, Gray fireboard

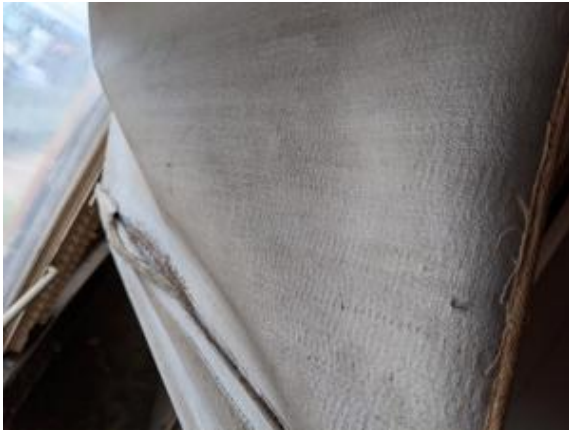
CHE-SP7077-170821-049 thru 051, Asbestos Not Detected, Silver coating

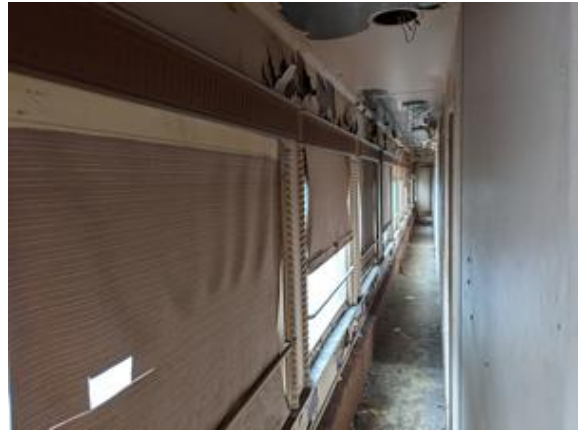
CHE-SP7077-170821-049 thru 051, Asbestos Not Detected, Silver coating

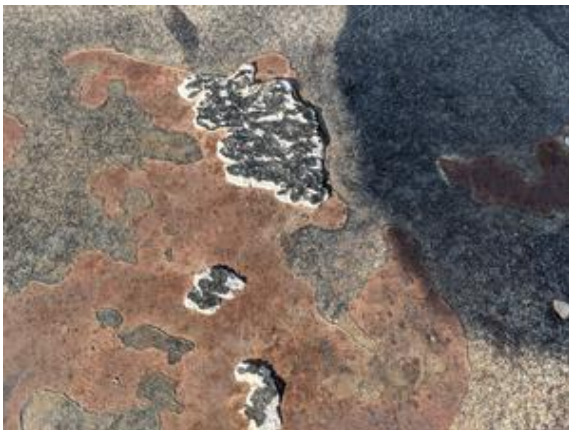
CHE-SP7077-170821-001L, 0.025% Lead, Black/gray

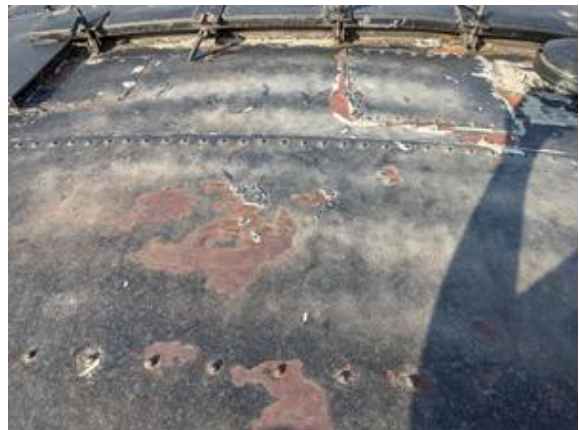
CHE-SP7077-170821-001L, 0.025% Lead, Black/gray

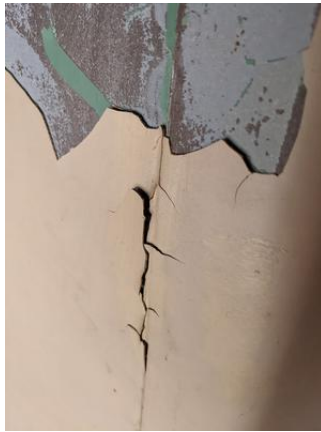
CHE-SP7077-170821-002L, 1.7% Lead, Beige

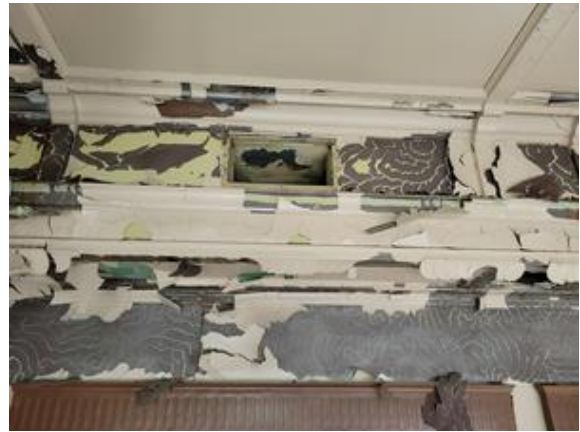
CHE-SP7077-170821-002L, 1.7% Lead, Beige

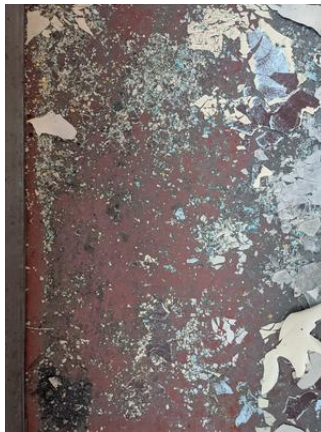
CHE-SP7077-170821-003L, 0.59% Lead, Red

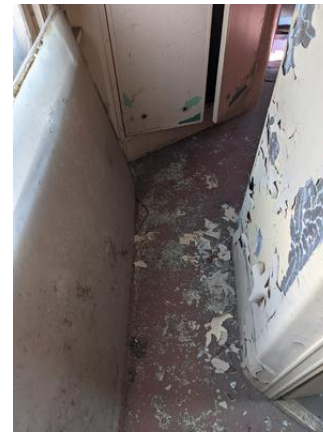
CHE-SP7077-170821-003L, 0.59% Lead, Red

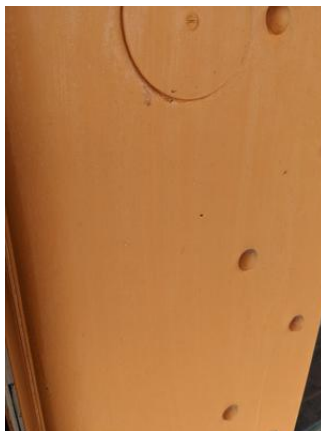
CHE-SP7077-170821-004L, 4.3% Lead, Yellow

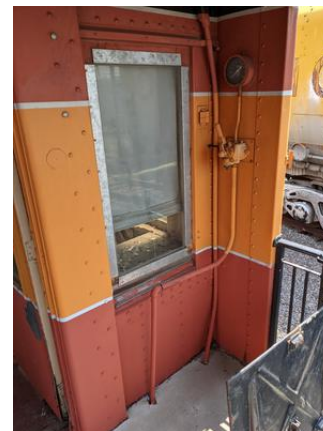
CHE-SP7077-170821-004L, 4.3% Lead, Yellow

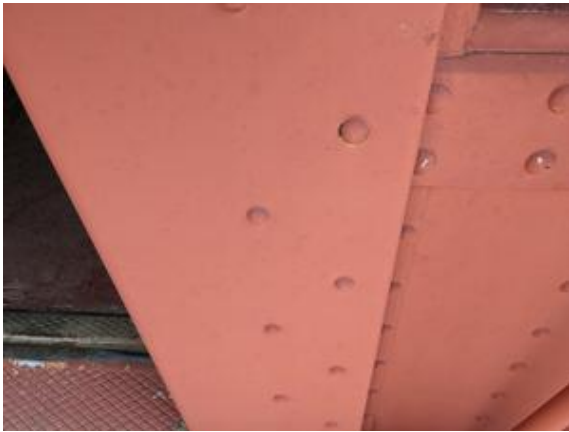
CHE-SP7077-170821-005L, 4.3% Lead, Light red

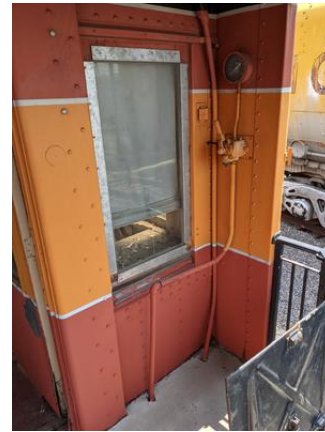
CHE-SP7077-170821-005L, 4.3% Lead, Light red

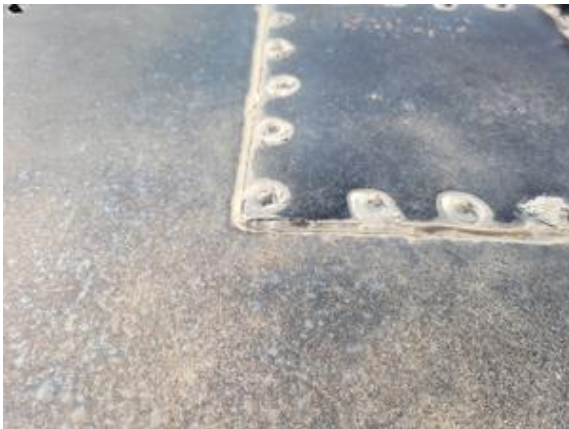
CHE-SP7077-170821-001P, PCB Not Detected, Clear silicone caulk

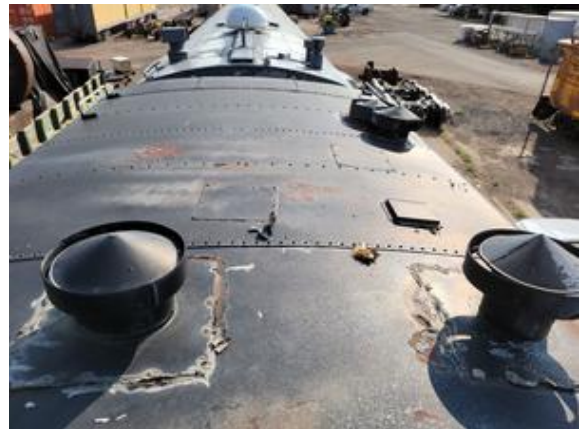
CHE-SP7077-170821-001P, PCB Not Detected, Clear silicone caulk

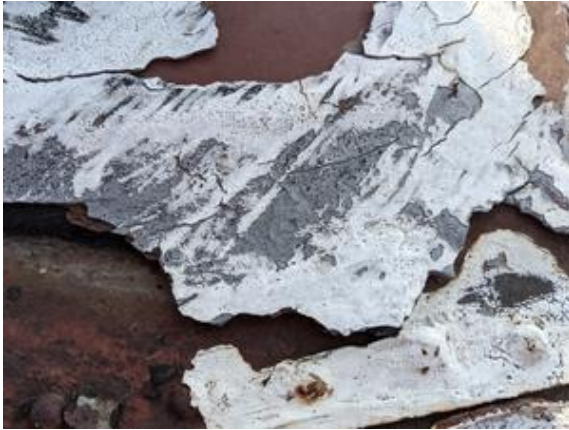
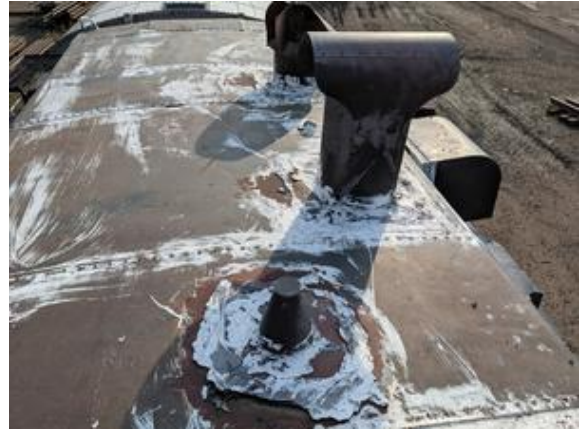
CHE-SP7078-180821-001 thru 003, 8% Asbestos, Black/gray sealant

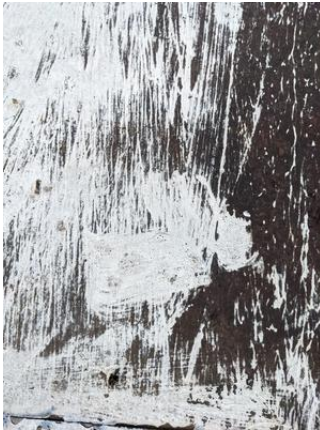
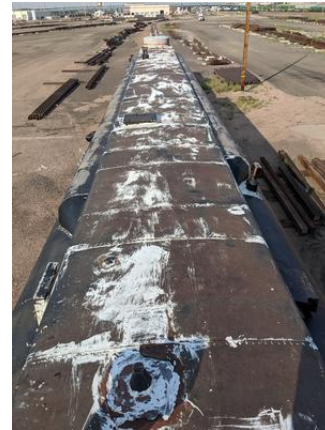
CHE-SP7078-180821-004 thru 006, Asbestos Not Detected, White sealant

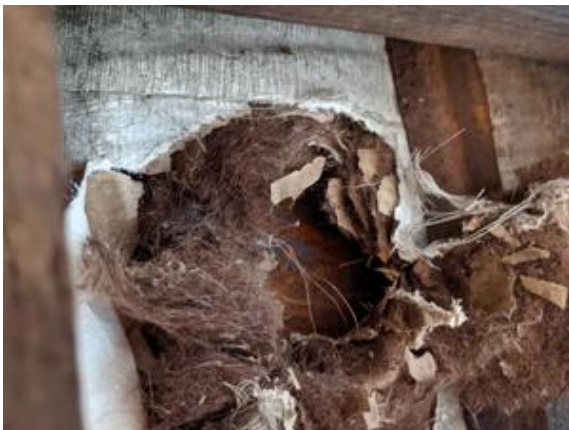
CHE-SP7078-180821-007 thru 009, 15% Asbestos, White/brown paper insulation

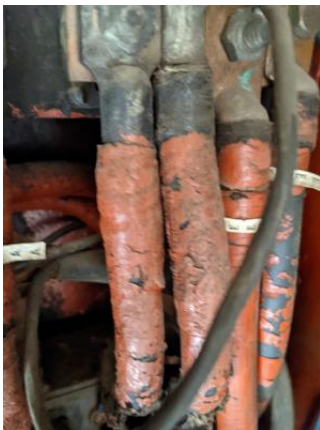
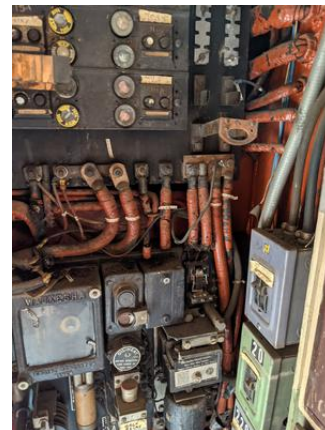
CHE-SP7078-180821-022 thru 024, Asbestos Not Detected, Red/Black wire coatings

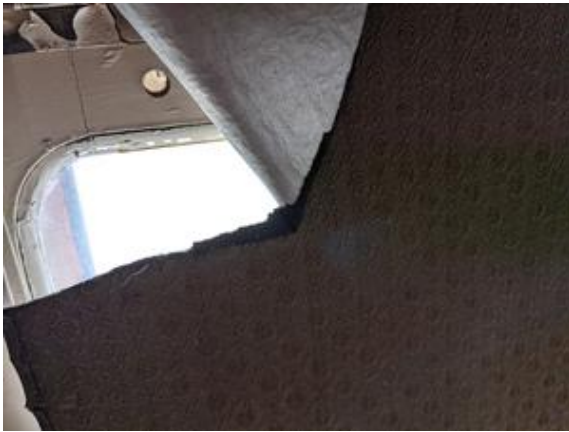
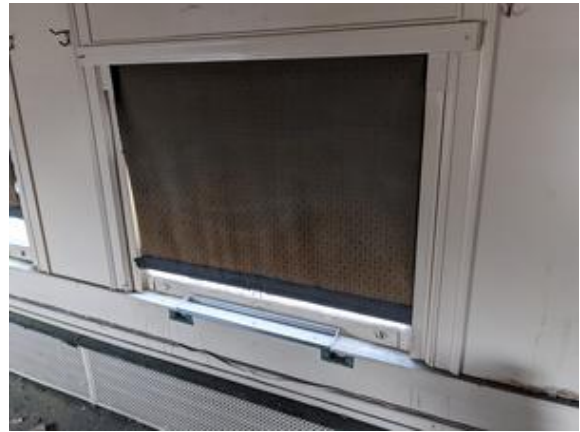
CHE-SP7078-180821-034 thru 036, Asbestos Not Detected, Silver coating

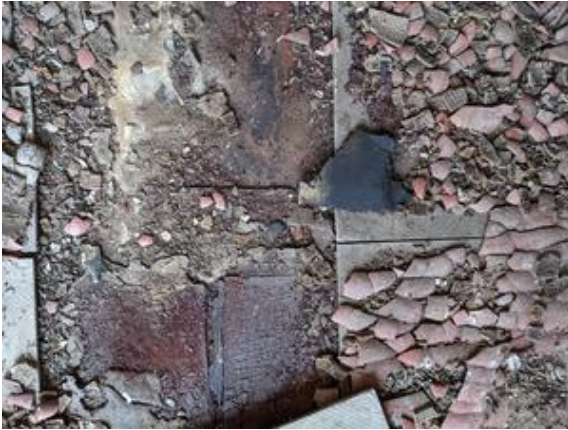
CHE-SP7078-180821-043 thru 045, 1.92% Asbestos, Red/black vinyl flooring

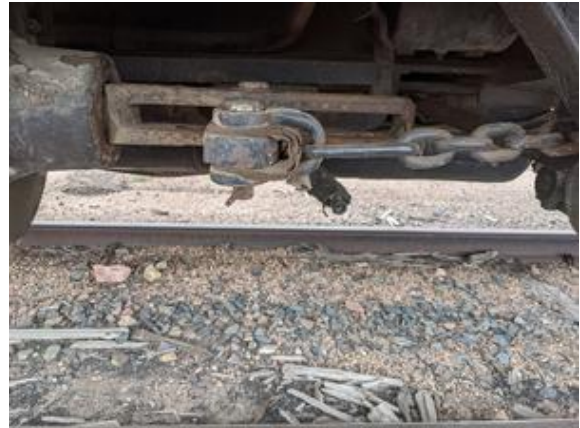
CHE-SP7078-180821-046 thru 048, Asbestos Not Detected, Vibration dampener and mastic

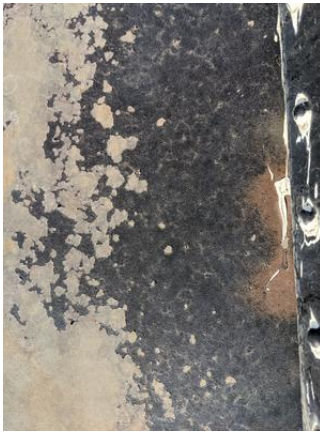
CHE-SP7078-180821-001L, 0.12% Lead, Black

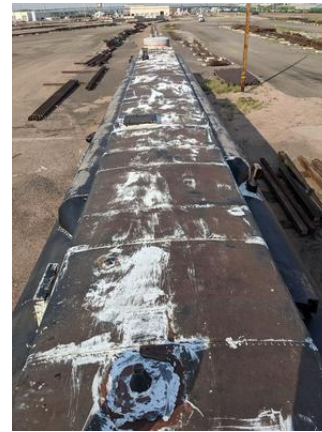
CHE-SP7078-180821-001L, 0.12% Lead, Black

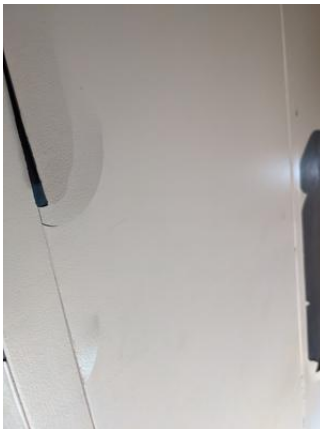
CHE-SP7078-180821-002L, 0.13% Lead, Beige

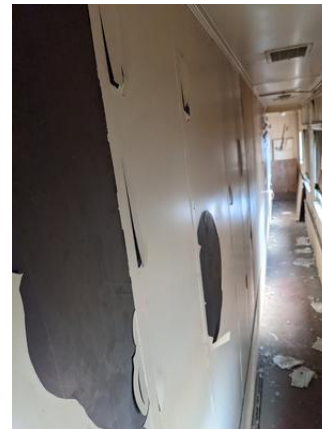
CHE-SP7078-180821-002L, 0.13% Lead, Beige

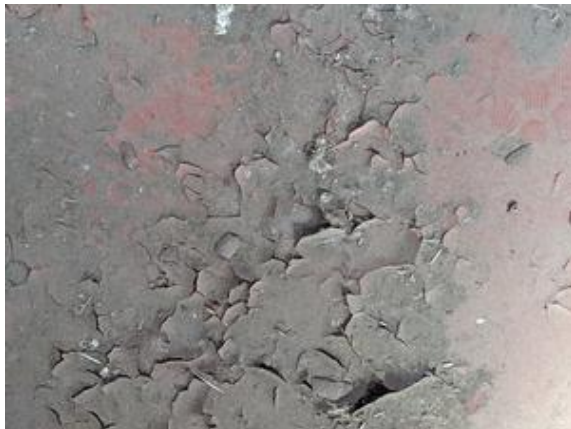
CHE-SP7078-180821-003L, 0.7% Lead, Red

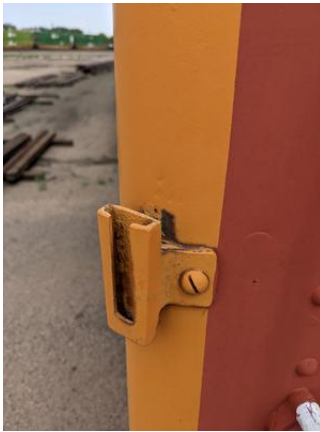
CHE-SP7078-180821-004L, 4.1% Lead, Yellow

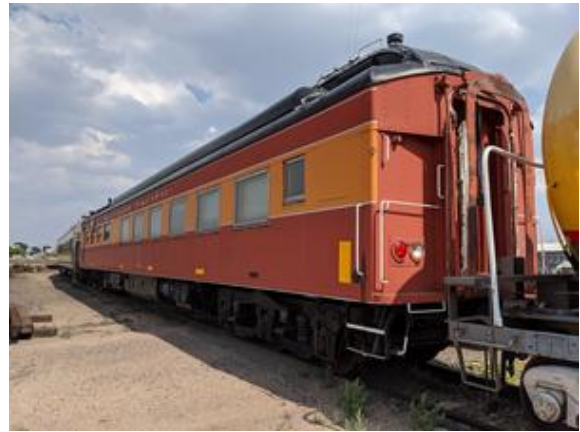
CHE-SP7078-180821-004L, 4.1% Lead, Yellow

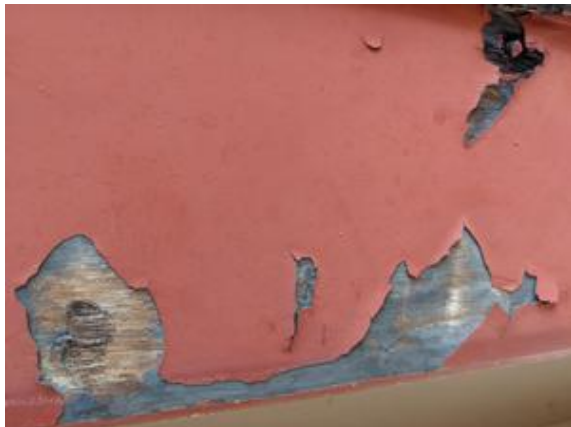
CHE-SP7078-180821-005L, 3.2% Lead, Light red

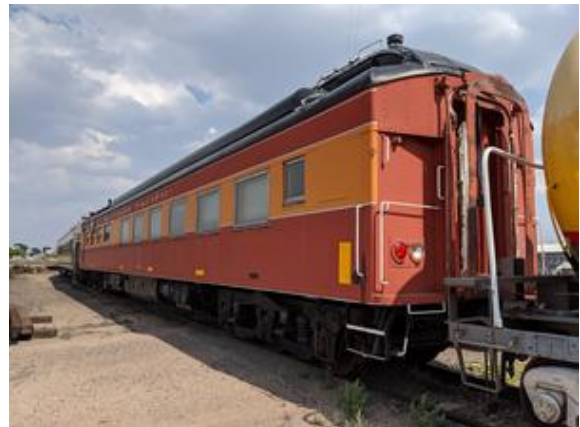
CHE-SP7078-180821-005L, 3.2% Lead, Light red

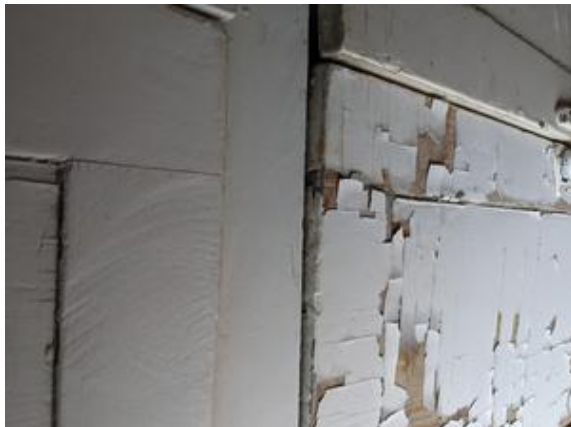
CHE-SP7078-180821-006L, 0.73% Lead, White

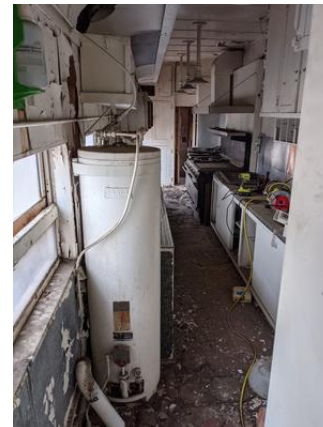
CHE-SP7078-180821-006L, 0.73% Lead, White

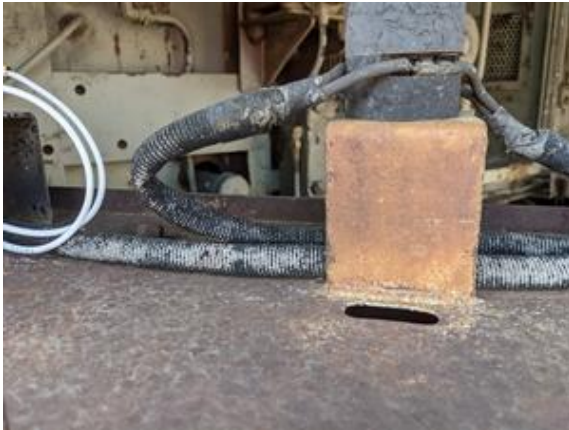
CHE-UP928-160821-004 thru 006, Asbestos Not Detected, White/black electrical wire wrap

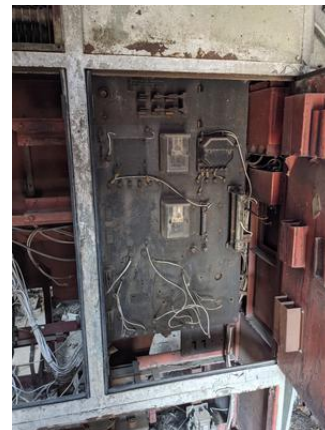
CHE-UP928-160821-007 thru 009, 40% Asbestos, Black Fireboard

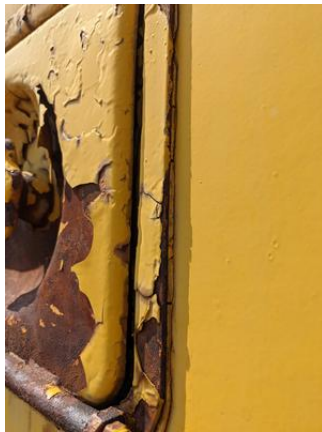
CHE-UP928-160821-010 thru 012, Asbestos Not Detected, Gray/Brown Gaskets

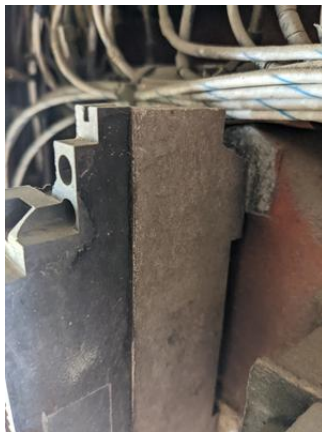
CHE-UP928-160821-013 thru 015, Asbestos Not Detected, Yellow/Black Penetration Gaskets

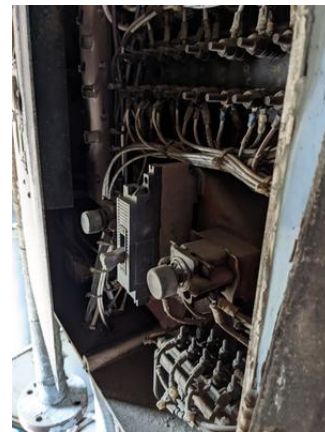
CHE-UP928-160821-016 thru 018, Asbestos Not Detected, Gray Bakelite

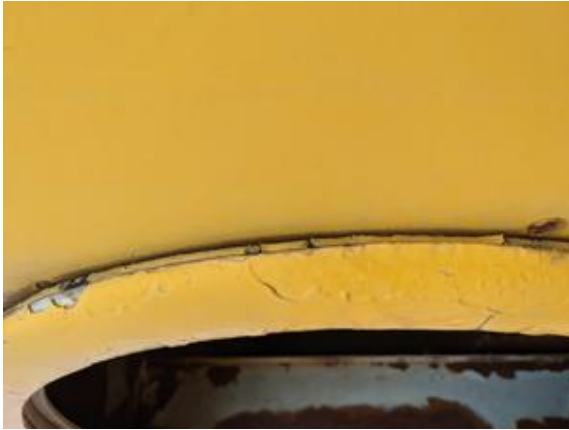
CHE-UP928-160821-019 thru 021, Asbestos Not Detected, Black window gasket

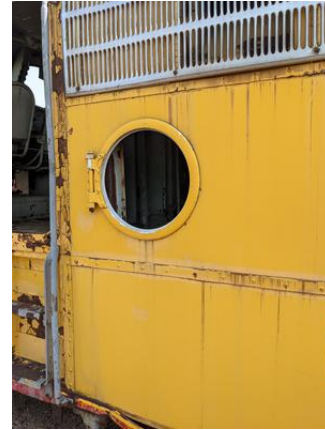
CHE-UP928-160821-019 thru 021, Asbestos Not Detected, Black window gasket

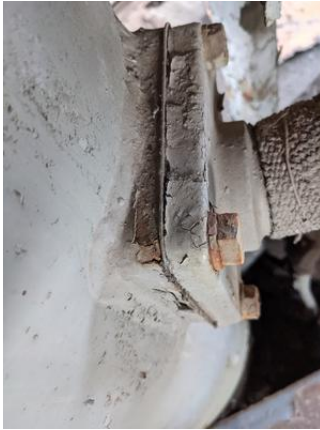
CHE-UP928-160821-028 thru 030, 30% Asbestos, Black gasket

Asset Number	UP 928	UP 928
Exposure Area	Interior loose bracing pieces	Interior pipe connections
Asbestos Containing Material	Gray transite	Black gasket
Sample Number	CHE-UP928-160821-025 thru 027	CHE-UP928-160821-028 thru 030
Size	NA	NA
Quantity	3 SF	1 LF
MATERIAL CONDITION (MC)	1	1
0 =No damage, excellent condition 1 =Very minor damage, no visible debris 2 =Damage is evident, small area 3 =Damage is easily seen, some debris 4 =Damage is widespread, debris is common 5 =Most or all material is damaged, hanging, and / or found as debris throughout the area		
BUILDING AGE (BA)	1	1
1 =>30 years old 0 =15 - 30 years old -1 =<15 years old		
MATERIAL TYPE		
Pipe Covering (PC)	NA	NA
1 =MAG/CAL Silicate -1 =Air Cell / paper		
Ceiling Plasters or Fireproofing (CP)	NA	NA
-1 =Cementitious (Monocoat) 0 =Standard 1 ="Cotton Candy" texture		
WATER DAMAGE (WD)	0	0
0 =No water damage 1 =Small amount of damage can be seen; damage is localized rather than widespread 2 =Good deal of water damage; widespread

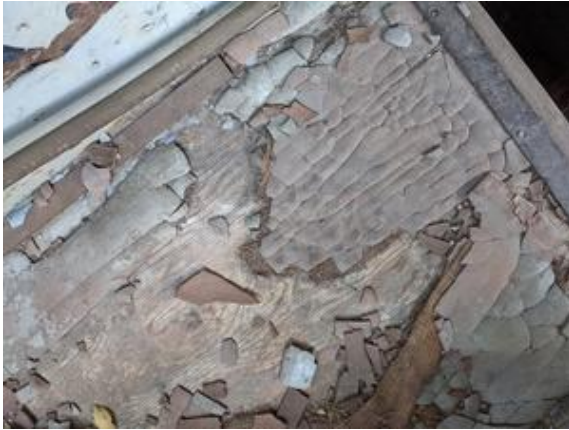
CHE-UP928-160821-037 thru 039, Asbestos Not Detected, Brown Vinyl Flooring (no mastic)

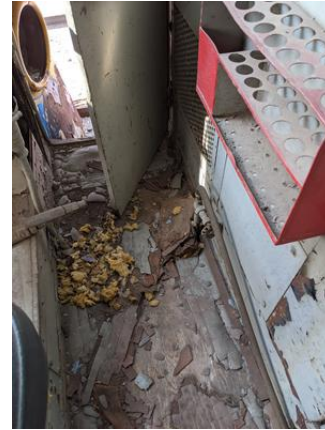
CHE-UP928-160821-037 thru 039, Asbestos Not Detected, Brown Vinyl Flooring (no mastic)

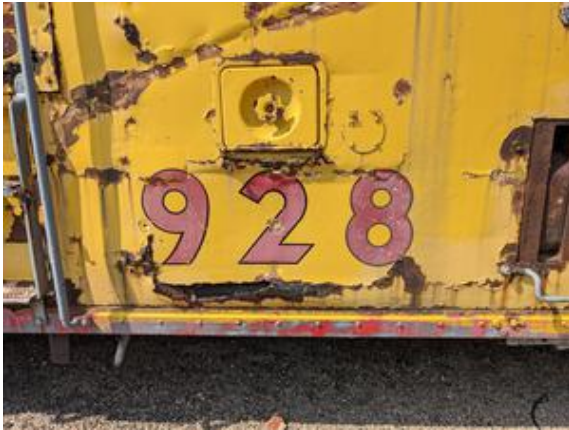
Sample Date	Sample ID	Description	Location	Lead Result	Condition
08/16/2021	CHE-UP928-160821-001L	Yellow	Exterior, except for back and roof	11 %	Poor
08/16/2021	CHE-UP928-160821-002L	Gray	Interior, plus exterior back and roof	0.21 %	Poor

CHE-UP928-160821-001L, 11% Lead, Yellow

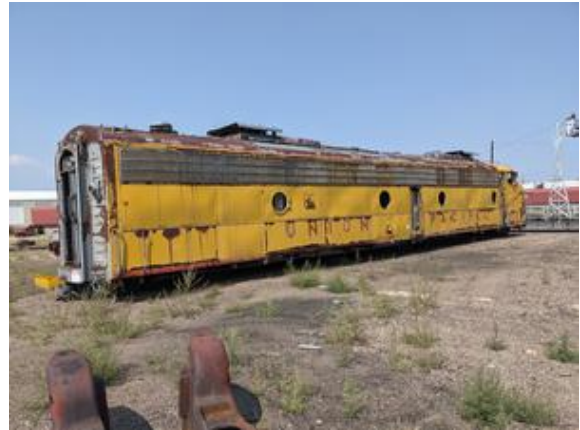
CHE-UP928-160821-001L, 11% Lead, Yellow
